Journal of the Roof Consultants Institute

Phenolic Insulation and the Building Envelope

By Don Kilpatrick and Michael G. Taylor, Esq.

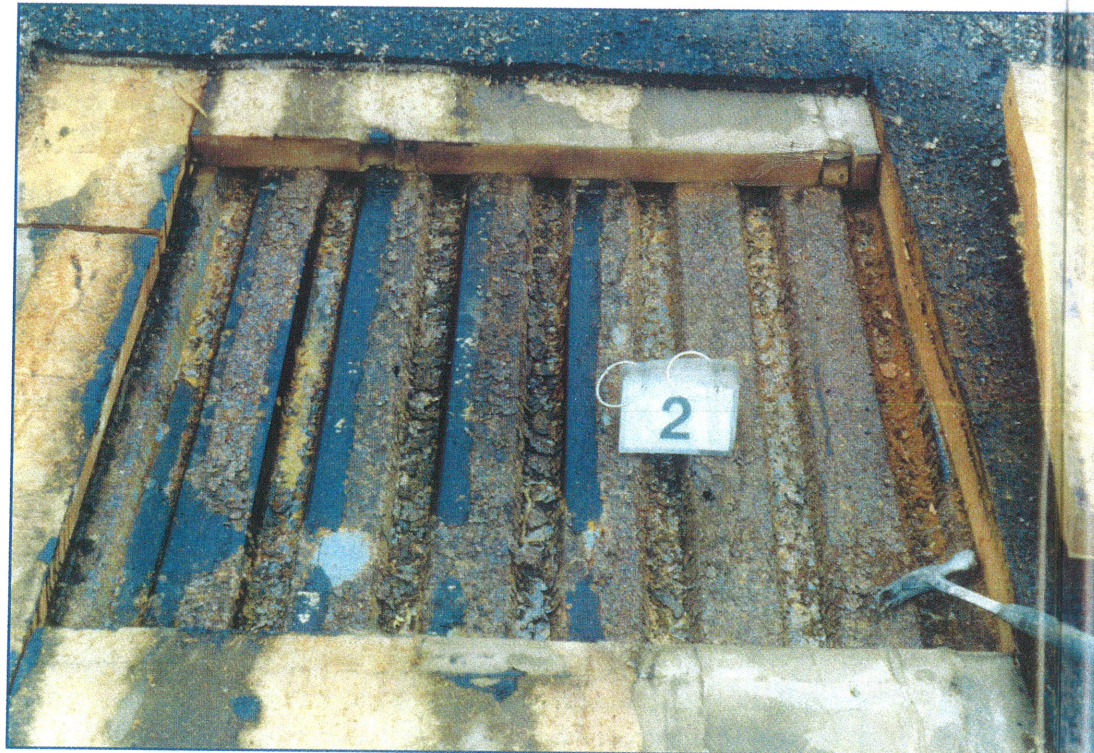
Photos 1 and 2 – A contrast in conditions is apparent and can be expected when phenolic insulation is installed over structural steel decking.

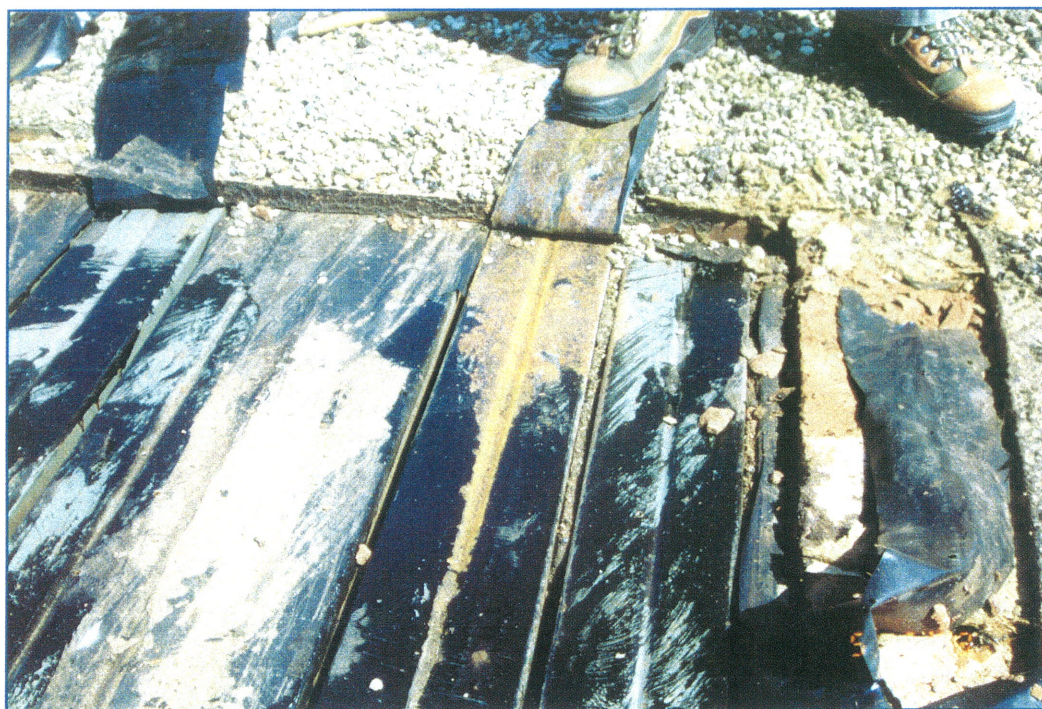
Photo 3 – The protection offered by a vinyl vapor retarder at this inspection opening is questionable, as the deck conditions presented no more than one foot apart ranged from near pristine to severely corroded.

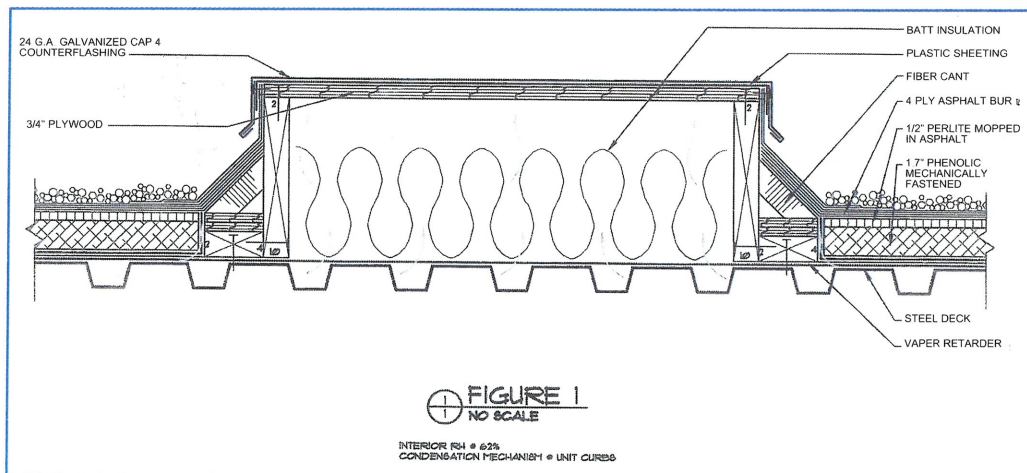
Figure 1

Another roof system feature was the numerous curbs, installed as part of the original construction, intended to accommodate the owners' needs relative to the predictable changes in occupancy. These curbs were wood framed and mechanically attached to the deck. The steel deck and vapor retarder were continuous through the confines of the curb, with the base and top layer of insulation terminating at the outside face of the curb. The curbs were in-filled with fiberglass batt insulation, covered with 3/4-in. plywood, a single layer of plastic sheeting, and a 24-gauge galvanized

metal cap (Figure 1). Severe corrosion was observed on the underside of the sheet metal cap (Photo 4). Condensation was also noted at these locations. The insulation around the curb was essentially dry.

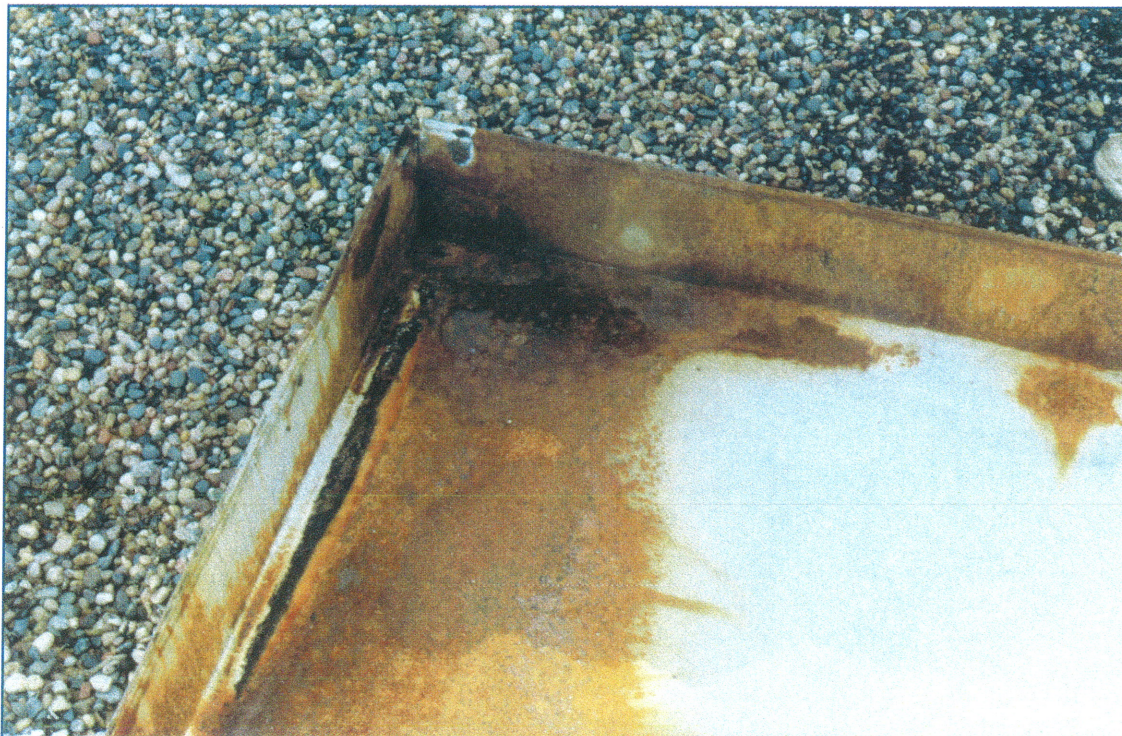
Photo 4 – Excessive corrosion of sheet metal accessories (cap flashing) not in direct contact with phenolic insulation. Free moisture, attributed to condensation, was present within the confines of the curb.

These observations suggest that movement of air through the building envelope (more specifically, the steel deck flutes discharging into deck openings at the expansion joint and curbs) may be a sufficient avenue for the released acids from the adjacent, essentially dry insulation. In this instance, the acids have migrated to locations subject to condensation due to breaches in the roof system components. This is supportive of the theory that essentially dry phenolic insulation may contribute to the corrosion of steel in contact with and close proximity to the offending materials. The moisture content of phenolic insulation – that identified as the

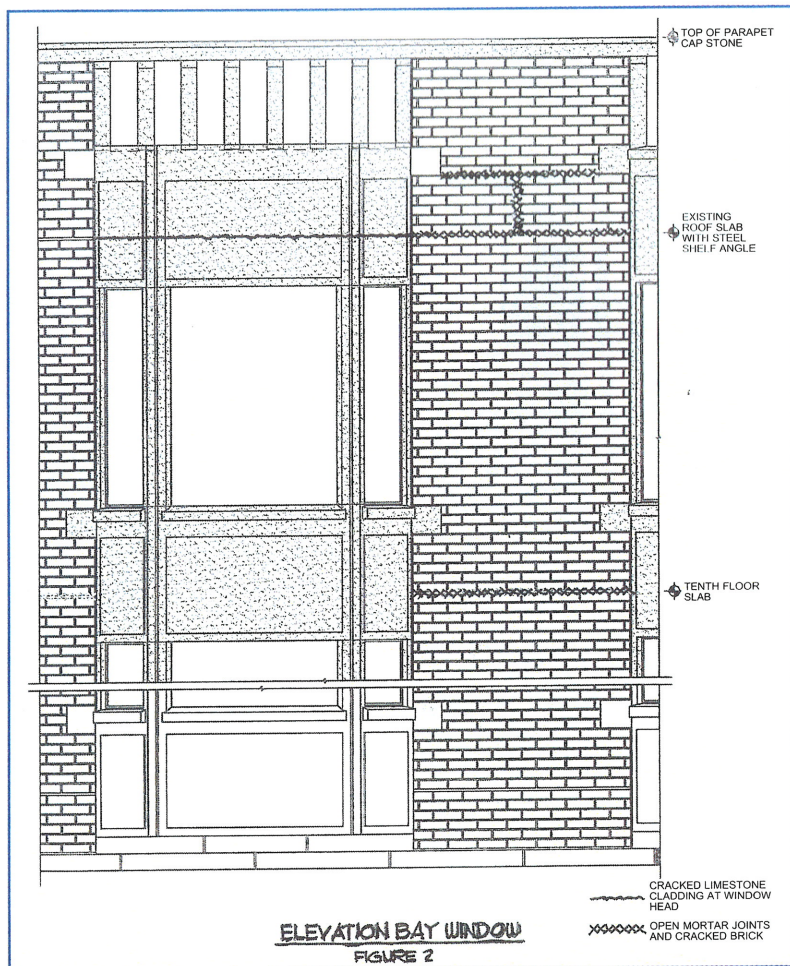
Figure 2

The author's firm was retained to perform a critical examination of façade components on a building in the upper midwest. The structure was ten stories with the exterior cladding consisting of a single wythe of brick tied to CMU back-up wall. An insulated cavity wall was present. A brick parapet wall extended approximately 3 ft. 6 in. above the horizontal plane established by the poured concrete roof deck. A series of limestone-clad, bay window assemblies was present at regular intervals across each elevation (Figure 2).

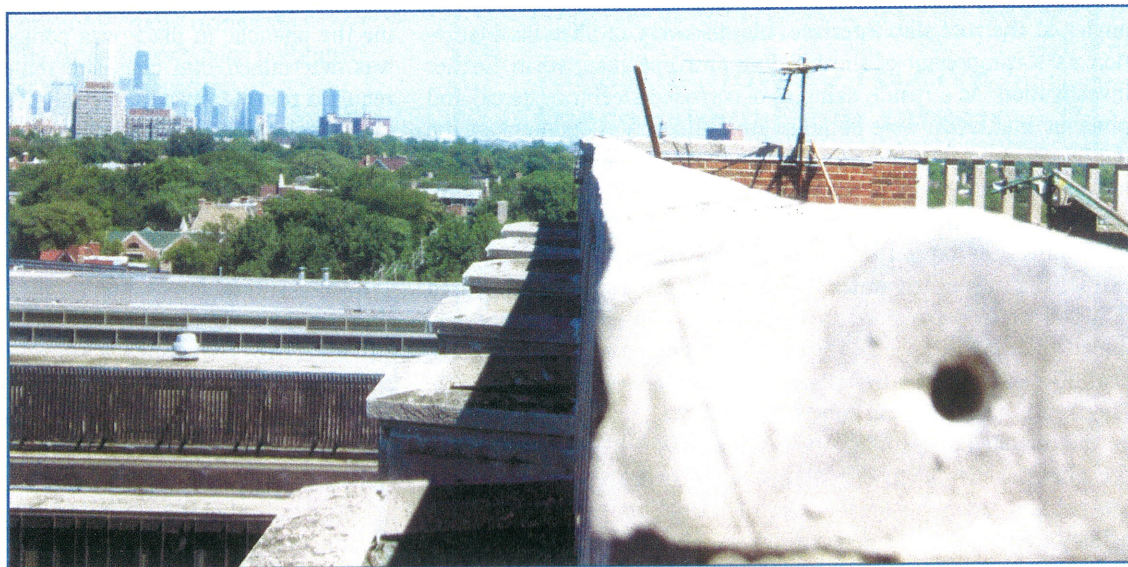
Photo 5 – Wall system movement at the parapet/roof slab interface resulted in the meandering upper limits of the balustrade capstones.

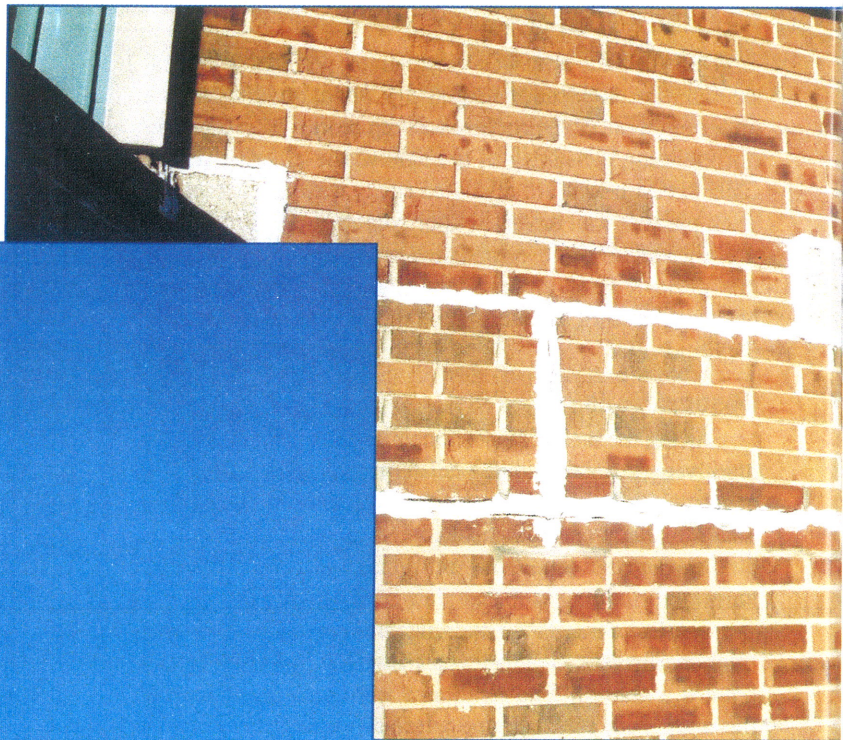
During the façade inspection, it became evident that the brick veneer was exhibiting concentrated levels of distress and out-of-plane conditions at the juncture of the roof deck and outside face of the parapet wall (Photos 6 and 7). Similar distress conditions were observed across the cut-limestone cladding at the window heads (Photo 8).

Photo 6 – Previous caulking repairs at open joints and cracks of the brick in-fill between the window bays.

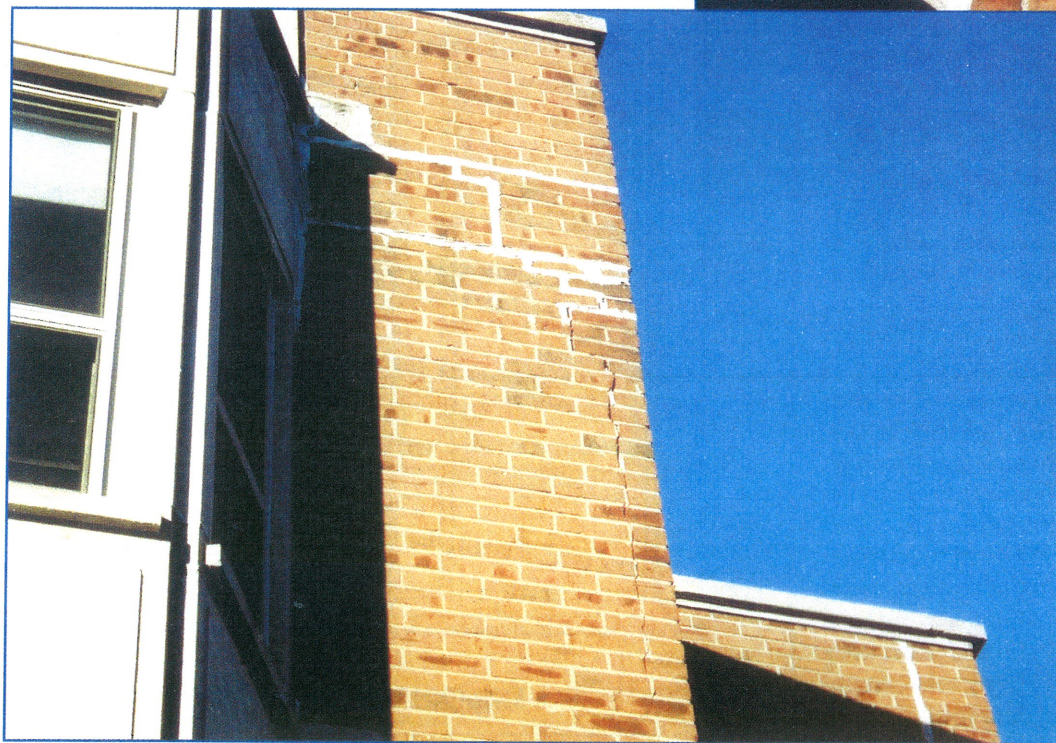
Photo 7 – At outside corners, the established horizontal pattern of caulking repairs at open joints was supplemented by additional vertical cracks.

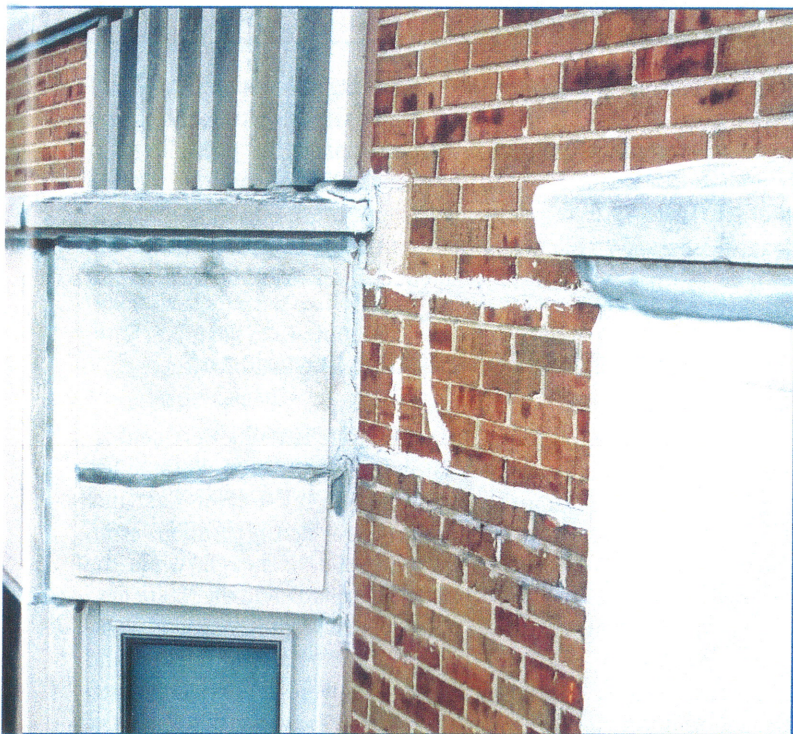
Photo 8 - Repetitive pattern of horizontal cracks across the limestone-clad window heads. The distress conditions presented were typical of the building's four primary elevations.

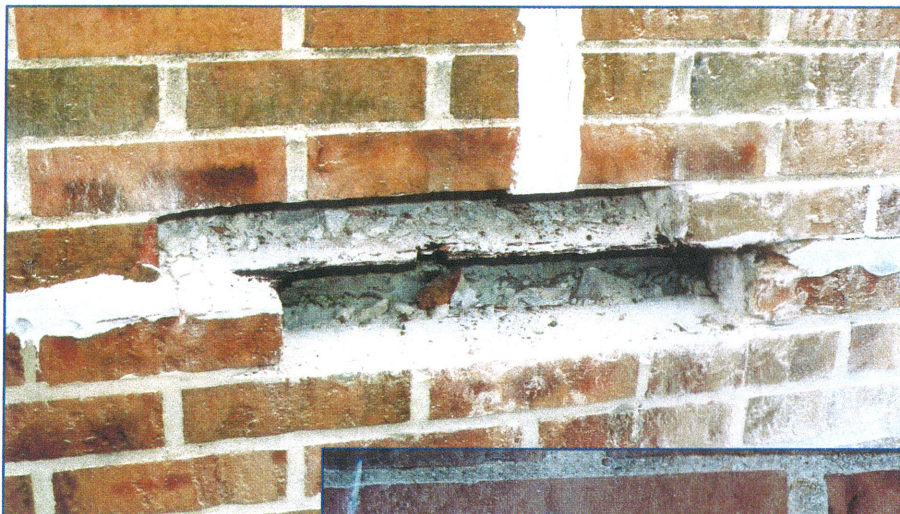
A series of inspection openings in areas of localized distress confirmed significant corrosion of the shelf angles (Photos 9 and 10). The conditions were most prominent at the tenth-floor roof slab and parapet interface, with conditions improving at the juncture of the eighth-floor slab and brick veneer (Figure 3). On the remaining similar floor slab interfaces with the brick veneer, the deflection was present but not as pronounced as that of the tenth floor. The subsequent shift of loads from the upper limits of floors 10-8 was distributed to the remainder of the shelf angles mechanically fastened to the outside face of the floor slabs on floors 7-3. As a result, the integrity of the anchorage mechanisms was compromised. It was determined that replacement of the shelf angles and brick veneer would be required on floors 3-10.

Photo 9 – A severely corroded shelf angle, and subsequent rust jacking, was determined to be the apparent cause for the out-of-plane conditions observed at the brick in-fill between the window bays.

role of the phenolic insulation as a catalyst for the corrosion, leaving the phenolic in place was considered an unacceptable risk. It was determined that complete removal of the phenolic would be required prior to introducing the new steel shelf angles that would be necessary as part of the wall repair contract.

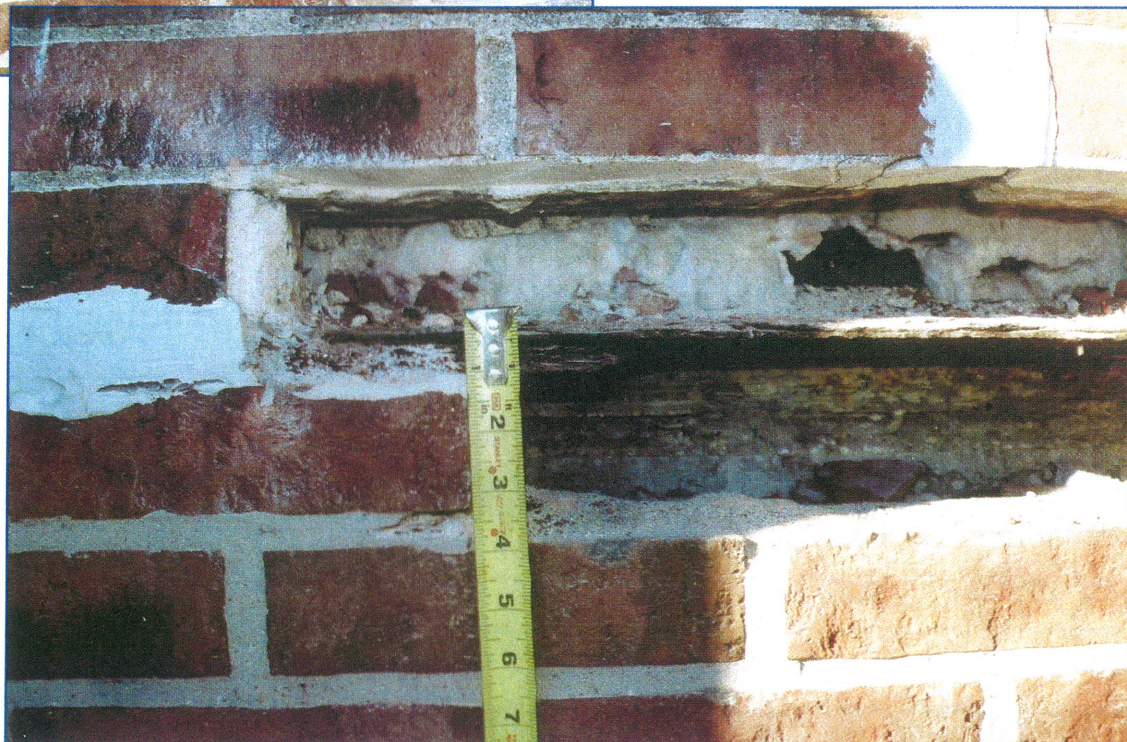
Photo 10 – Volumetric expansion of the steel shelf angles at the parapet/roof slab interface.

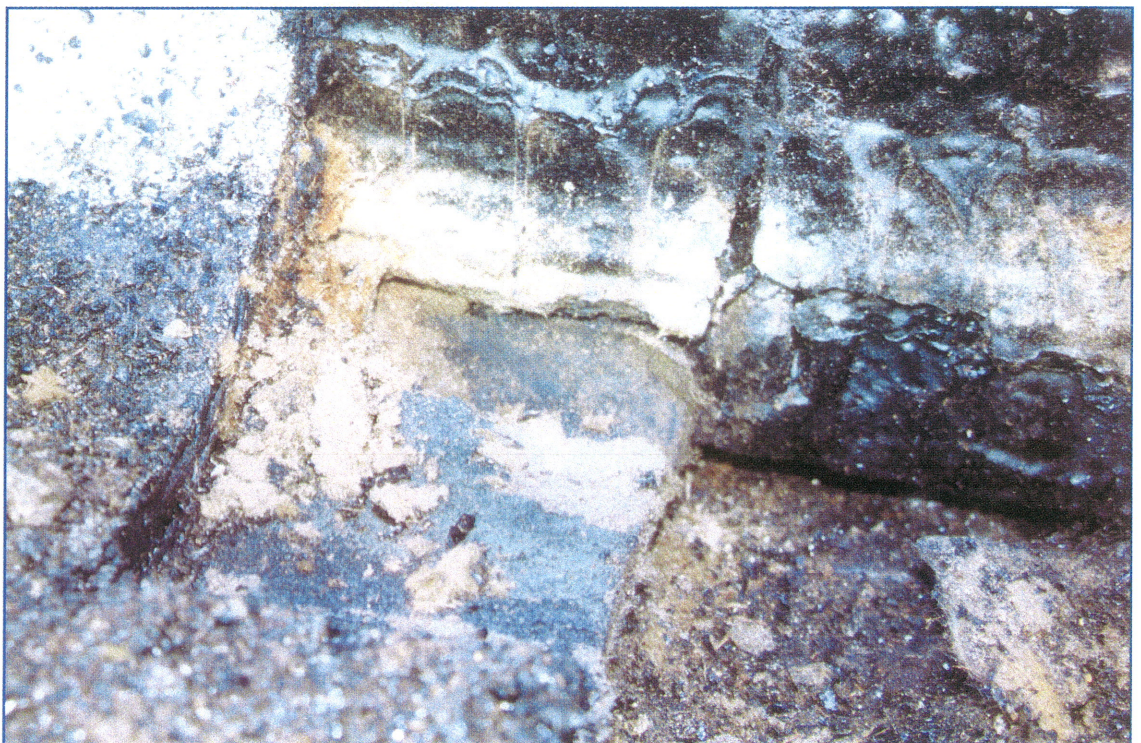
The lack of mopping asphalt, in conjunction with the porous fiberglass felts, results in a felt-ply envelope in a critical location that is less than watertight. It is at this location that the soluble acids carried by the excess moisture that could no longer be retained in the insulation made its way into the wall cavity, resulting in the accelerated corrosion of the shelf angles (Photo 11). At no time since the roof was installed has the owner reported disruption of

Photo 11 - Apparent breach in the two-ply vapor retarder at the transition from the horizontal plane of the roof deck and adjacent wall. The tear in the felt plies and gap between the roof slab and parapet wall are present due to the corrosion of the shelf angle, subsequent rust jacking, and upward movement of the wall section. It is at these locations that free moisture carried water soluble acids from the wet phenolic insulation into the wall cavity.

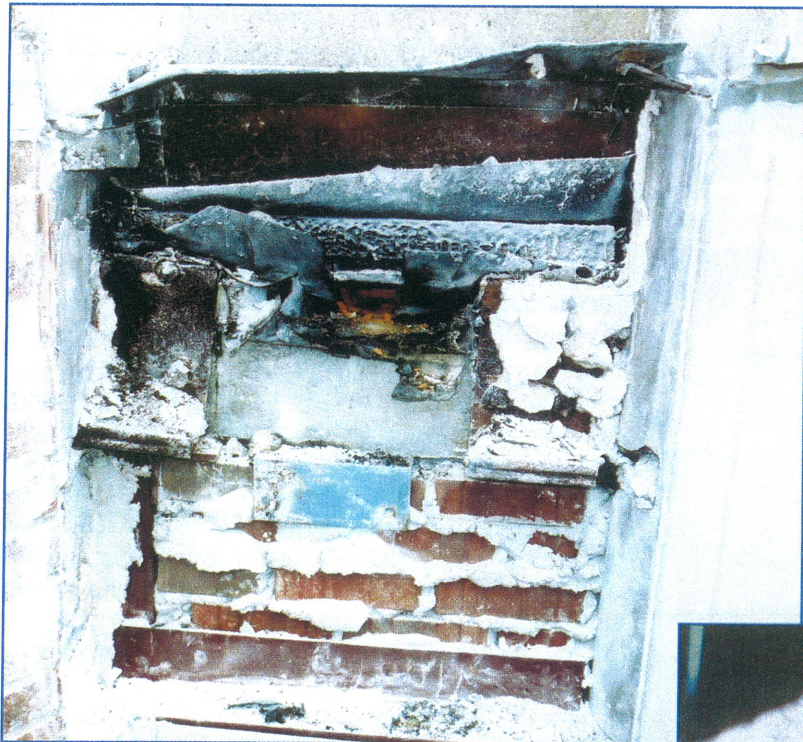
occupancy due to water leakage into the building interior, in spite of the large quantities of wet insulation. Free moisture that could no longer be retained in the saturated insulation moved laterally, discharging into the wall cavity and making contact with structural steel support mechanisms for the limestone cladding and brick veneer (Photos 12, 13, and 14).

Photo 12 – Relationship of segmented shelf angle providing support for the limestone cladding, outside face of poured concrete deck, phenolic insulation, and related roof system components.

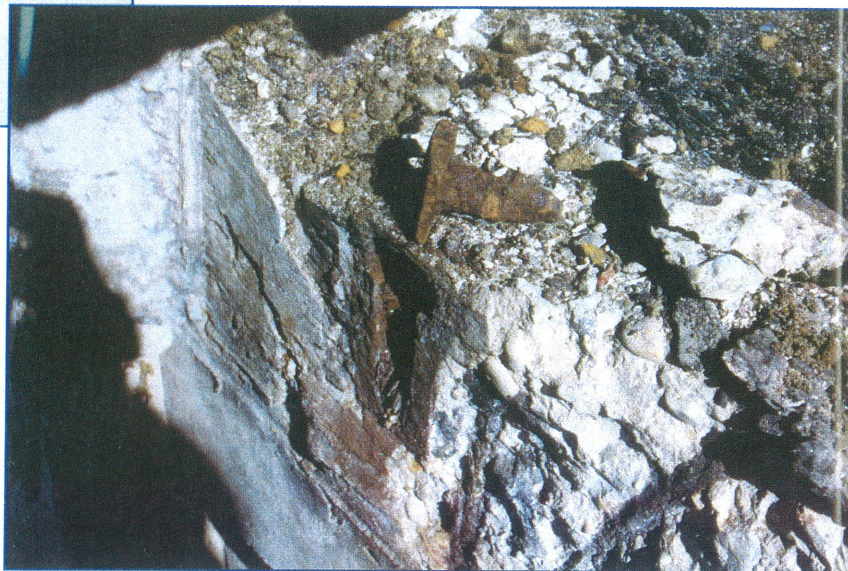
Photo 13 – Overall poor condition of cast-in-place receiver and anchor bolt for shelf angles at outside face of poured concrete roof deck.

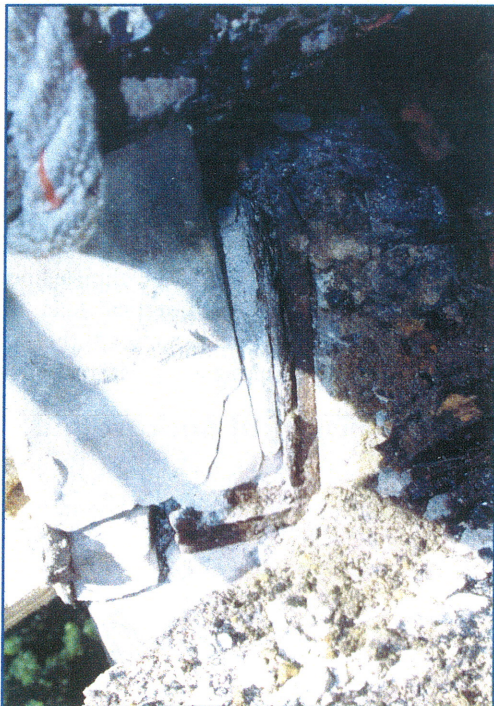
Photo 14 – Cracks in the outside face of the limestone cladding were caused by the rust jacking of both the horizontal and vertical legs of the steel shelf angle.
