# REINTEGRATION

## OF SANCTORUM:

### Multidisciplinary Historic Rehabilitation of Rockefeller Memorial Chapel

By Donald Kilpatrick and Barry O'Quinn

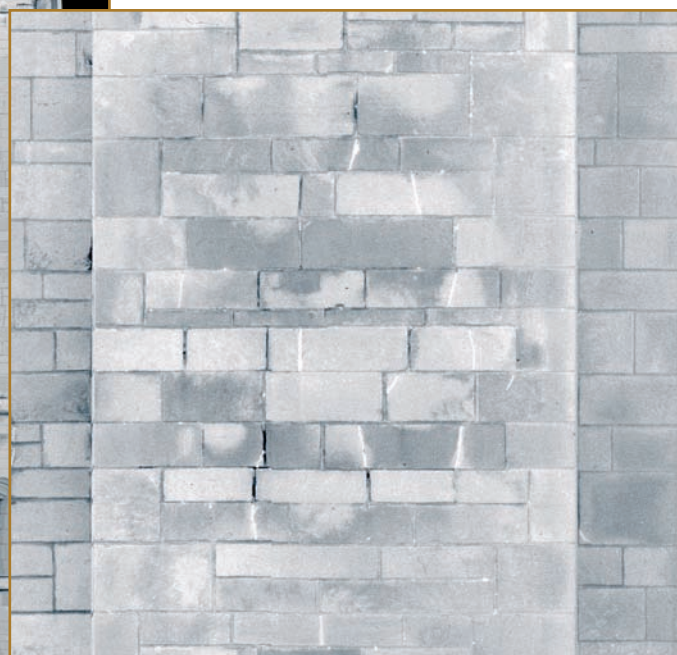
*Photo 7 – Enlarged area of localized distress below tower balcony roof with failed drain leader.*

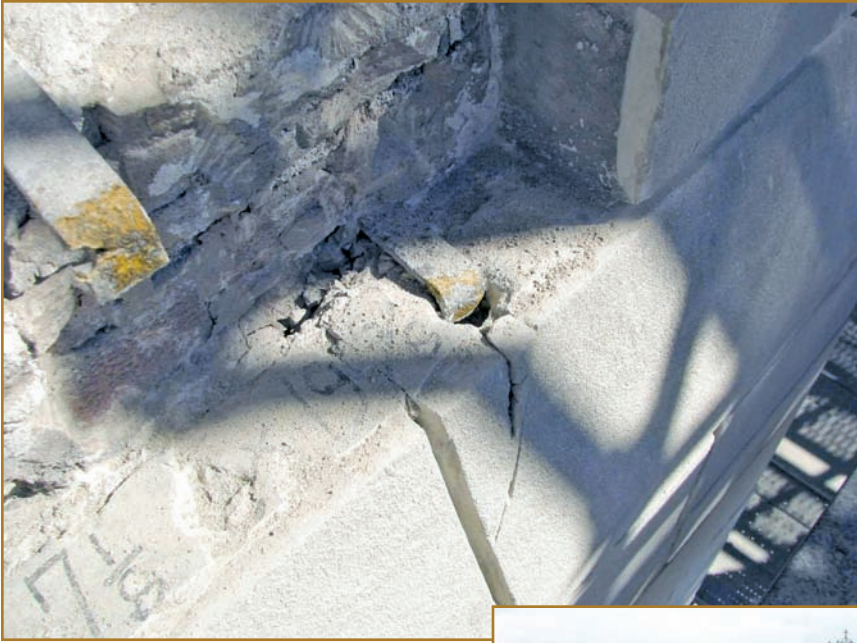
*Photo 8 – Typical stone distress resulting from corroded steel strap and/or the open cell (receiver) in the stone subjected to freeze/thaw damages.*

With corrodible metal within two inches of the outer wall, cyclical exposure to moisture had resulted in rusting, volumetric expansion of the steel, and cracking of the stone (*Photo 8*). At the stone mullions of the major window openings, similar conditions exist, with the corrosion causing cracking that radiates from the centrally located steel pins. All replacement anchors, pins, and straps required for setting and repairing stone are stainless steel. The tower turrets and pinnacle features above the nave roof

on the north and south ends of the building will be completely torn down and rebuilt using stainless steel pins with provisions for new, galvanized tension rings.

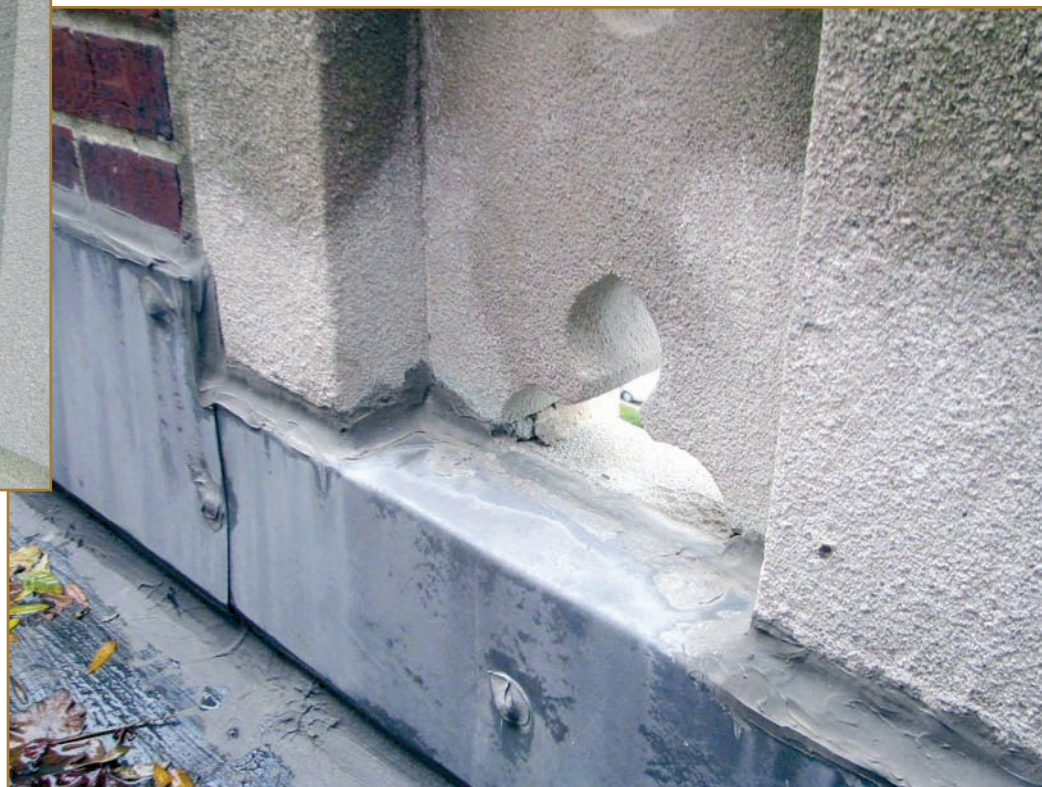
In addition, the revised finished height and slope of the new integral gutter sections will invariably result in less-than-desirable flashing conditions at the portal openings in the parapet wall. To address these conditions, the original design included replacement of the three-stone set establishing the portal opening with a new single stone of matching ornamentation, less the opening through the wall-in section. Early dialogue with City of Chicago Landmarks, including mock-ups using limestone blanks to in-fill the openings from the building side of the parapet wall, was critical to approval of this minor change in building aesthetics that, when completed, will not be readily discernable from grade.

*Photo 11 – Area of stone infill on roof side of parapet wall required to accommodate revised height of finished gallery roof.*

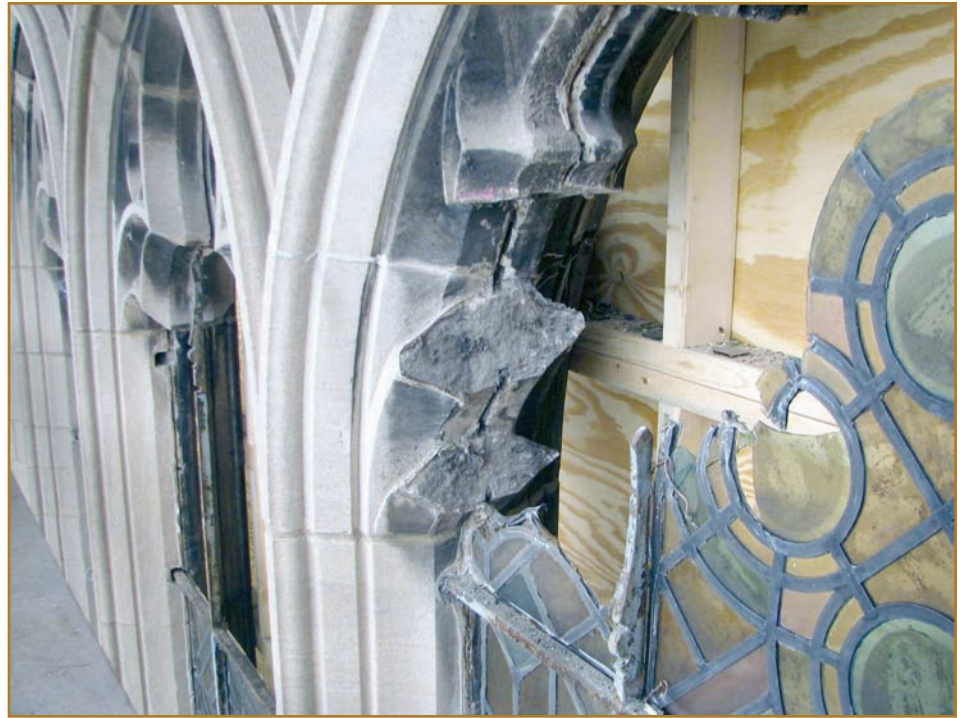
Widespread corrosion was noted on the exterior support bar framing, with section loss noted at the pockets where the steel

*Photo 12 – At some locations, the stained glass and exterior support framing provided supplemental support to damaged stone tracery.*

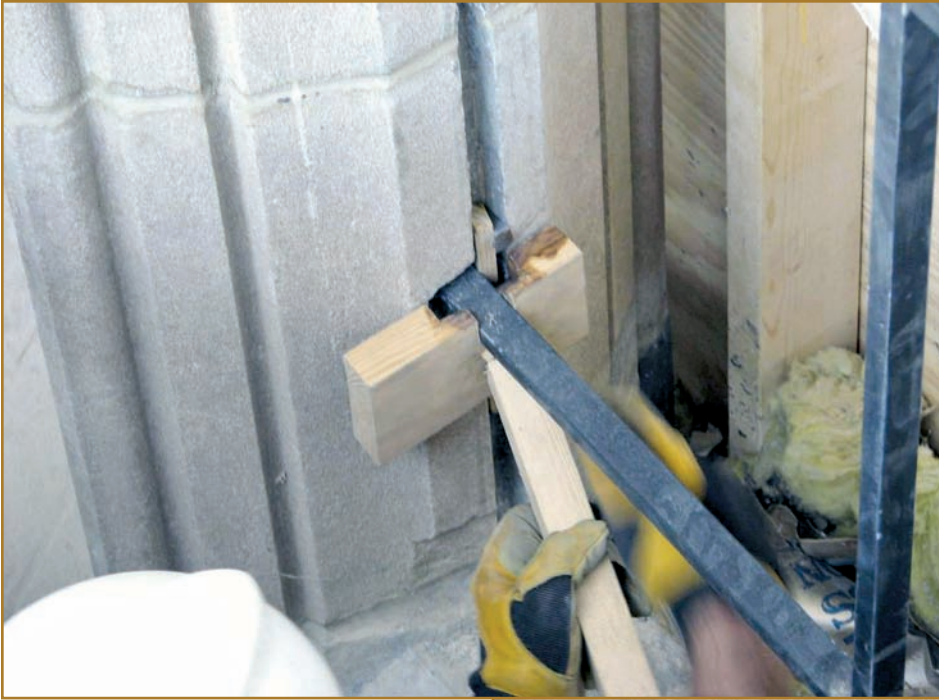
*Photo 13 – Wood forms set in advance of pouring molten lead to fill the pocket in the stone surround.*

paint layers were black in color. The restorative effort included surface preparation to a white blast and rebuild of the areas of loss

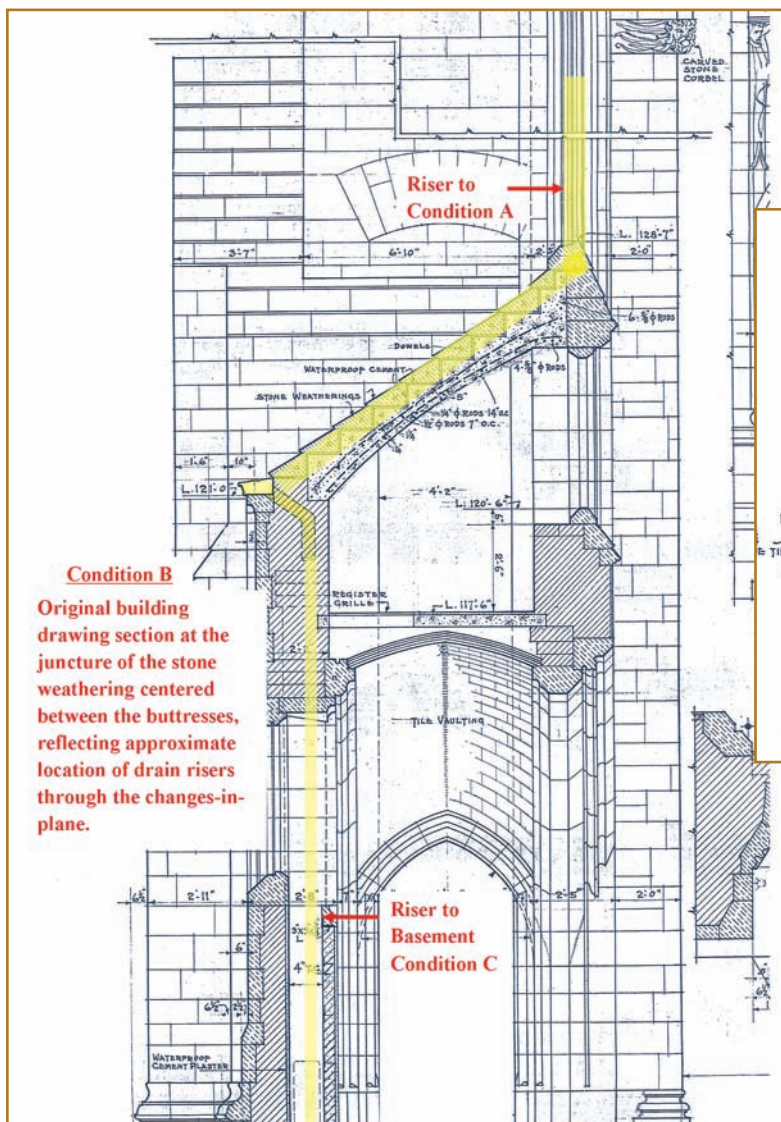
The typical risers in the buttresses service separate drain heads; one each servicing the gutter and leader of the lead-coated, batten-seam roof of the nave, with the other connected to the large integral gutter serving the narrow band of roofing behind the

high parapet walls (*Figure 1, Condition A*). Both drain heads are routed to the nave attic interior, where accessory lead-coated copper piping is interfaced with the cast-iron risers, continuing into the masonry walls at the base of the vaulted ceilings. The risers continue down the interior side of the buttress and turn toward the building exterior, where the piping follows the contours established by the steel-reinforced, poured concrete deck for the stone weathering. The stone weathering roof areas are served by lead-coated copper gutters with one drain per segment on each side of the buttress as presented on the building exterior (*Figure 1, Condition B*). These drains are combined with the single riser dedicated to the nave drains, and again are presented, with cleanouts, at regular intervals in the basement (*Figure 1, Condition C*).

Figure 1, Condition A – Original drawings reflecting the current configuration of drain heads servicing the nave, lead-coated copper batten-seam roof assembly, and the integral gutter combined into a common riser.

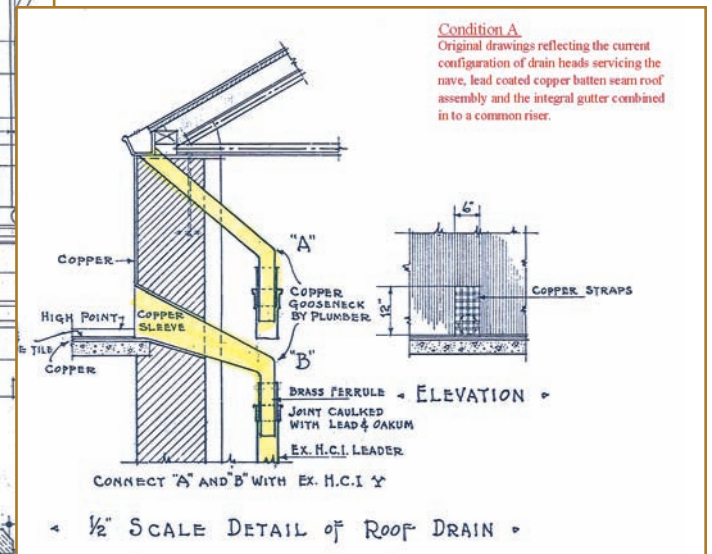
Figure 1, Condition B – Original building drawing section at the juncture of the stone weathering centered between the buttresses, reflecting approximate location of drain risers through the changes in plane.

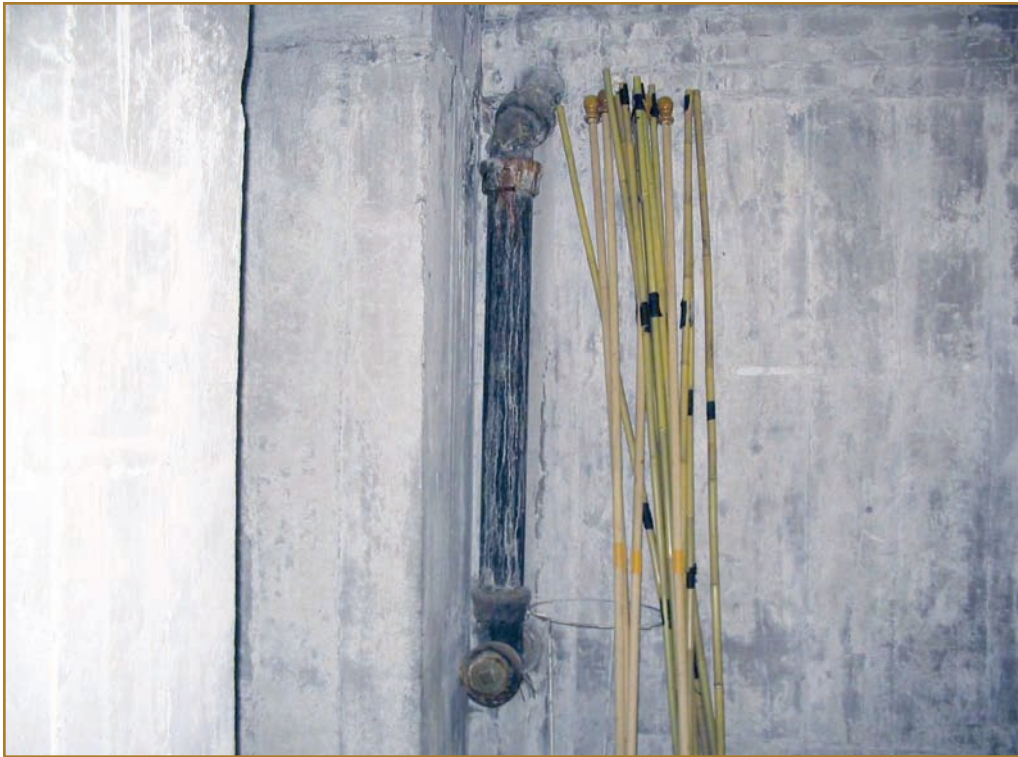
This condition left the assembly susceptible to moisture damage, most notably in the form of corrosion of the steel beams, resulting in volumetric expansion and loss of concrete cover (fire protection). (See *Photo 15*.) Additional distress specific to this condition was noted in the outside face of the limestone cladding at and below the roofline. The drains, as small triangular roofs, are completely restricted to the extent that water builds to level, exceeding the height of the membrane and accessory flashings. As a result, a significant volume of water has essentially been pumped into the high-mass walls, driving accelerated corrosion of mild steel straps anchoring the 4-in ashlar stones to the multiple-wythe masonry backup.

*Figure 1, Condition C – Typical drain leader exiting the buttress as presented in the basement.*

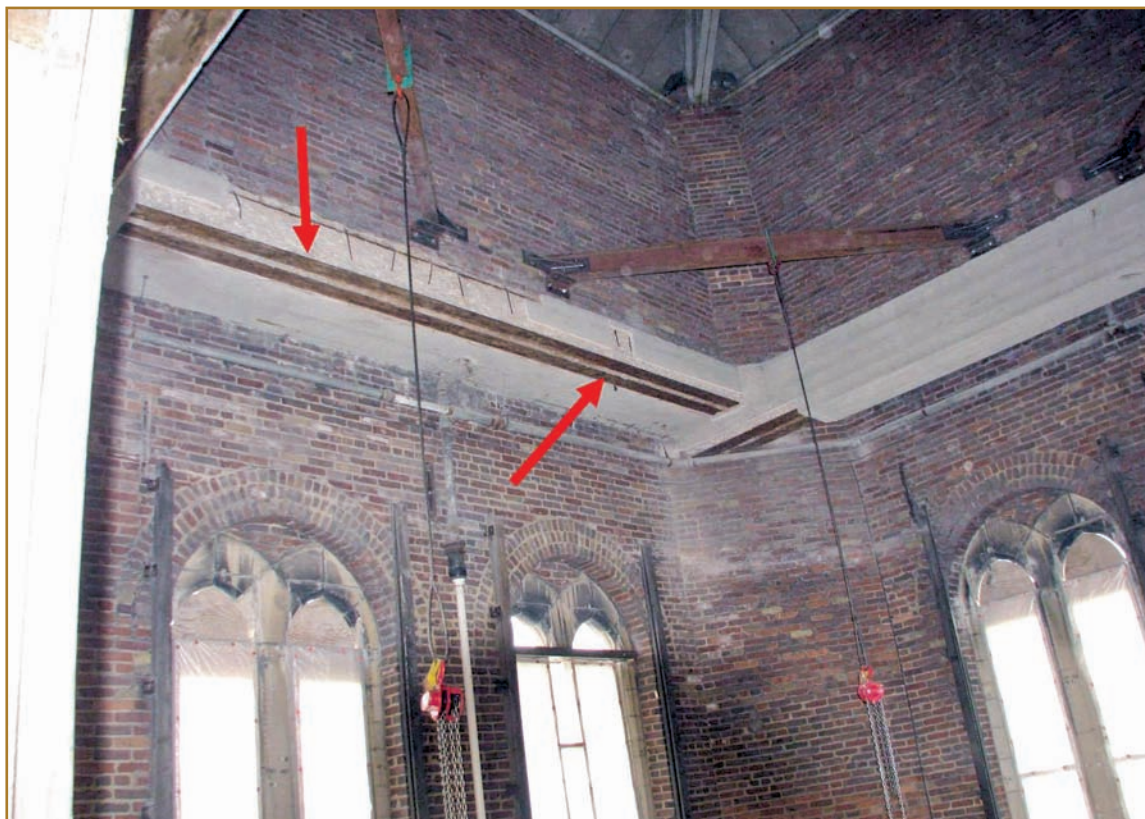
*Photo 15 – Loss of concrete cover (fireproofing) at upper tower limits resulting from recurring water entry.*

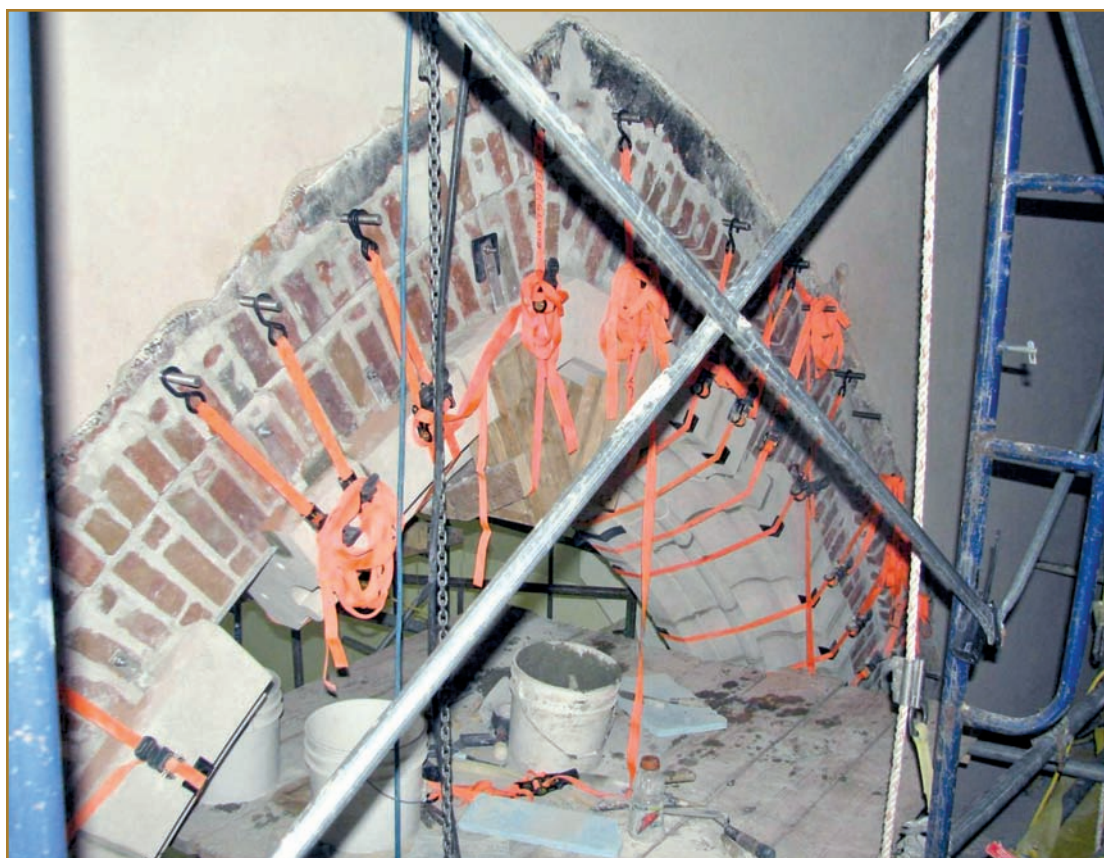
*Photo 17 – Final setting of cut limestone surround in tonal opening.*

month. A new structural steel arch was introduced to the rough opening after demolition of the 10-in-thick in-fill of brick and plaster finishes, followed by a cut limestone surround patterned after that found on the clerestory windows of the nave (*Photo 17*).

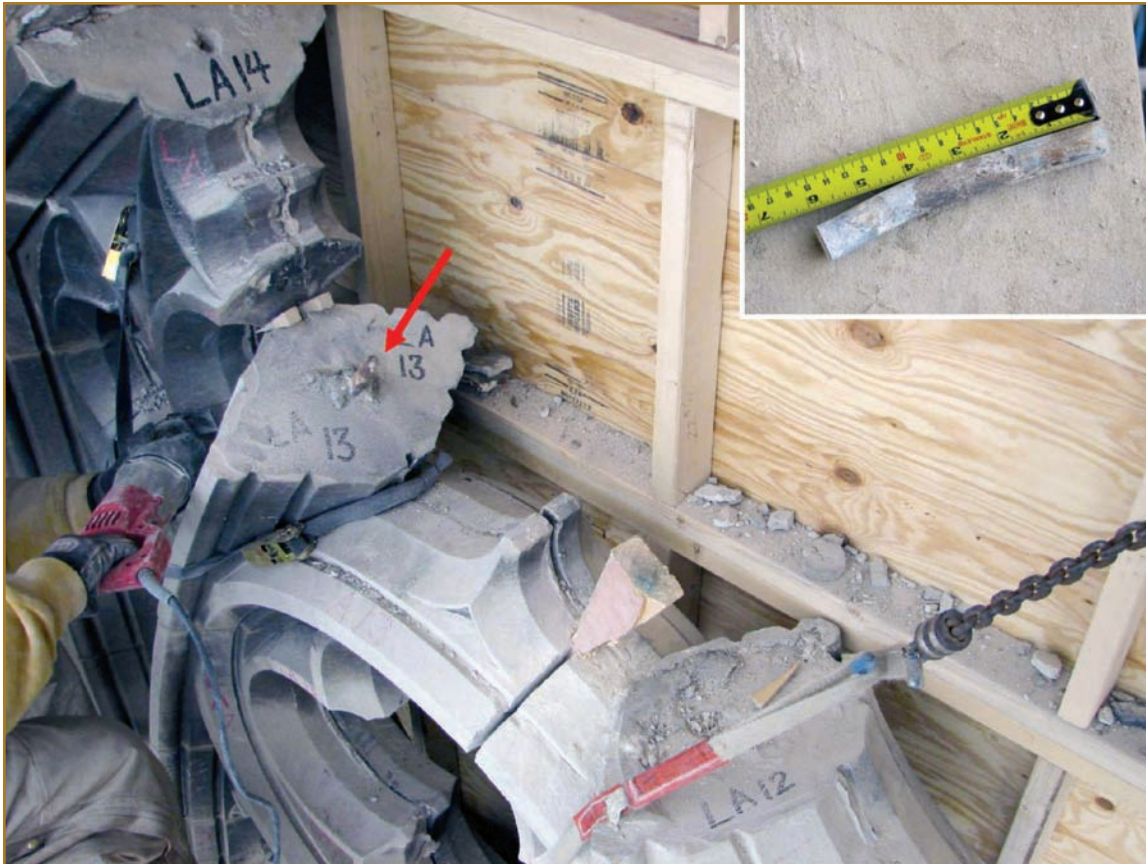
The findings were very instructional, and the integrity of steel pins at the stone joinery was determined to be satisfactory, which was useful in establishing work scopes for the balance of the major window openings (*Photo 18*). The single pin, centered in the 18-in-deep tracery stones, was exhibiting mild surface rusting, with no evidence to suggest that corrosion was contributing to stone distress. This work was in part considered a large-scale inspection opening, while at the same time it provided assurance that the restored Skinner organ would not be subjected to damage from leaking windows.

Photo 18 – Overall condition of steel pins at stone cusps from the organ loft window location.

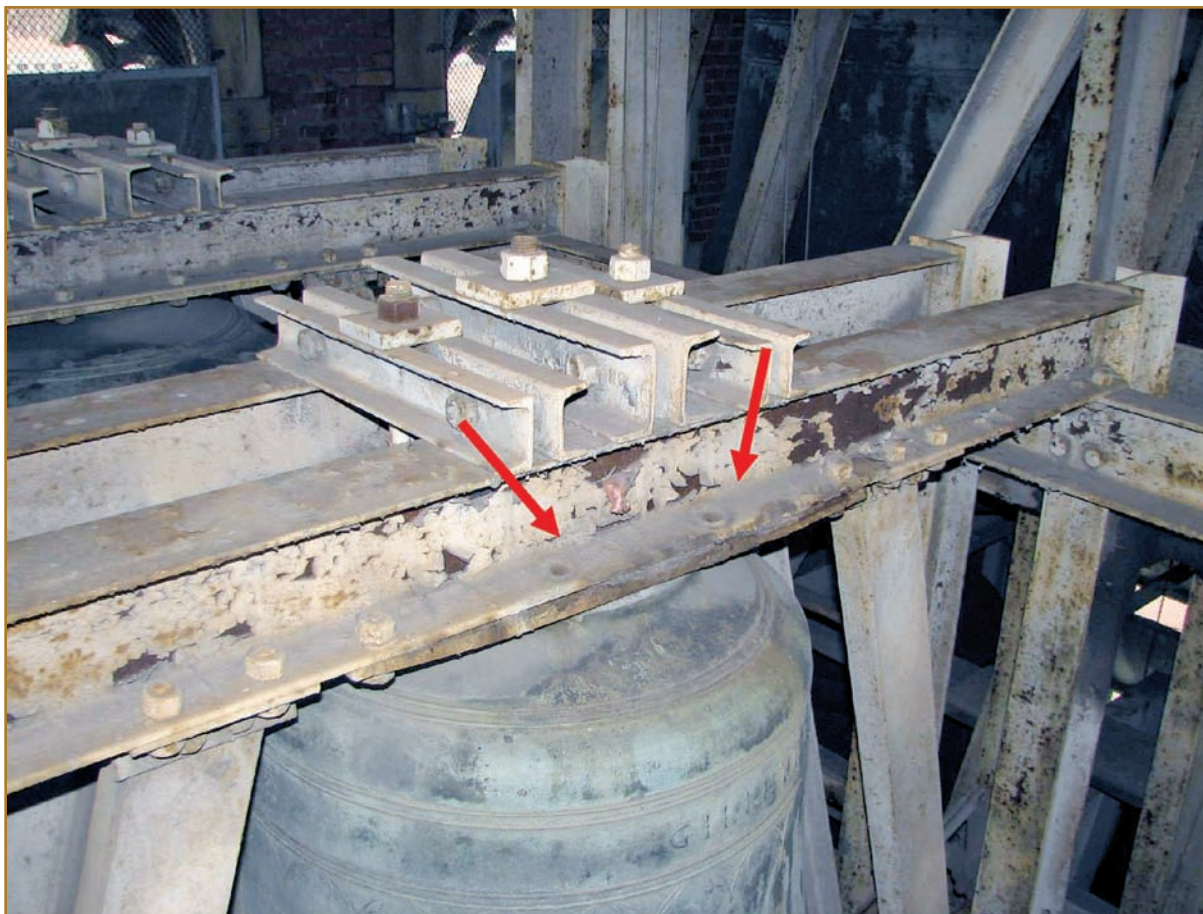
This increased work scope was deemed appropriate and necessary, based on present-day conditions affecting the structural steel framing, which was exhibiting severe

*Photo 20 – Wind-driven rains entered the tower interior, resulting in heavy corrosion of steel plates and failure of bolted connections.*

areas of localized corrosion and measurable deflection, most notably in the floor slab of the playing cabin. It was also noted that mounting plates of the upper bells below the cabin had been subjected to damage from corrosion, with significant deflection. In some instances, three or four bolts of an eight-bolt pattern had sheared due to the volumetric expansion of the plate steel (Photo 20). The cause of the corrosion was determined to be stone tracery at the upper limits of the large louver openings, admitting water during heavy, wind-driven rains. The revised louver design includes provisions for a custom louver assembly of minimal depth that will be installed behind the tracery to minimize the volume of wind-driven rain that enters the tower interior.
