ROOF LEAKAGE DECEPTION

Exterior Walls May Be the Culprit

By Pam Jergenson, CCS, CCCA

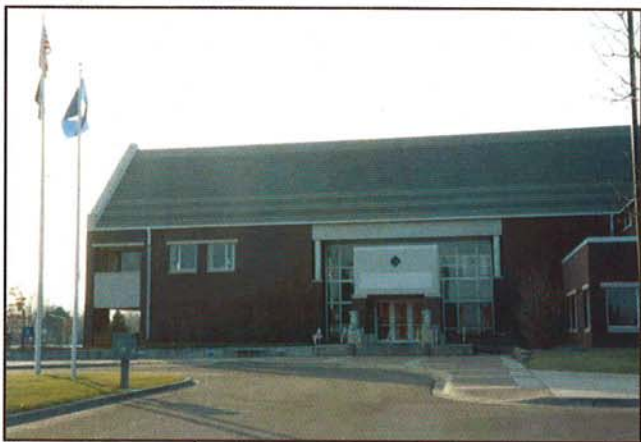
*Photo 1 (above)
- Brick, stone,
stucco, and a
tile roof grace
this nine-year
old city hall.*

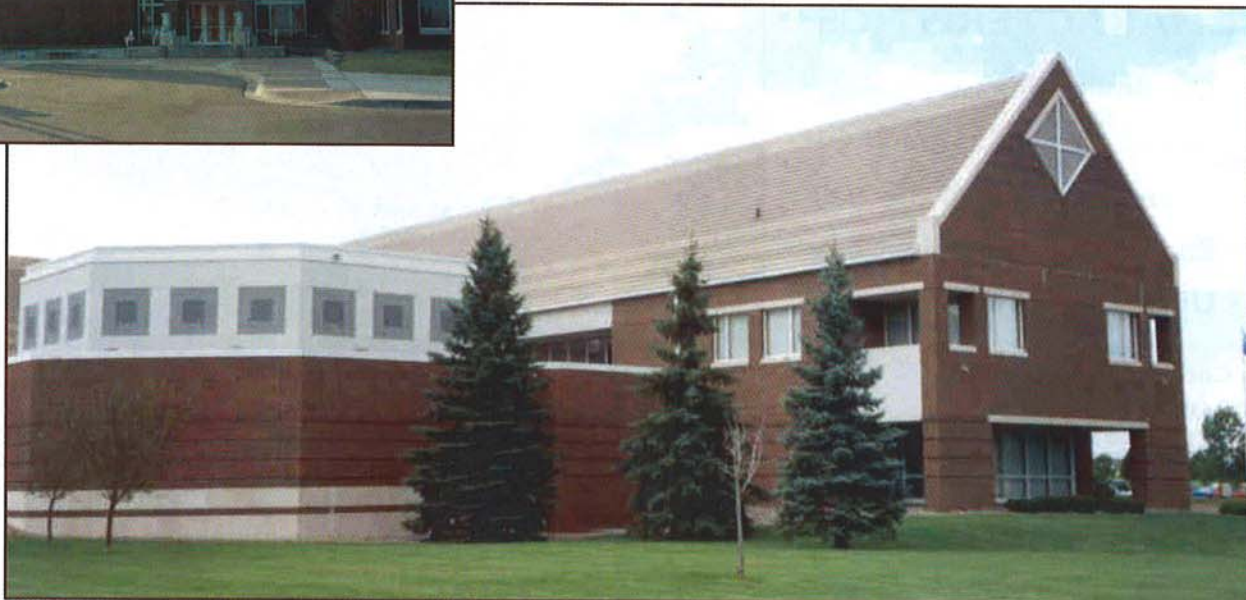
*Photo 2 - The
ballasted,
EPDM roof
eventually
proved
innocent.*

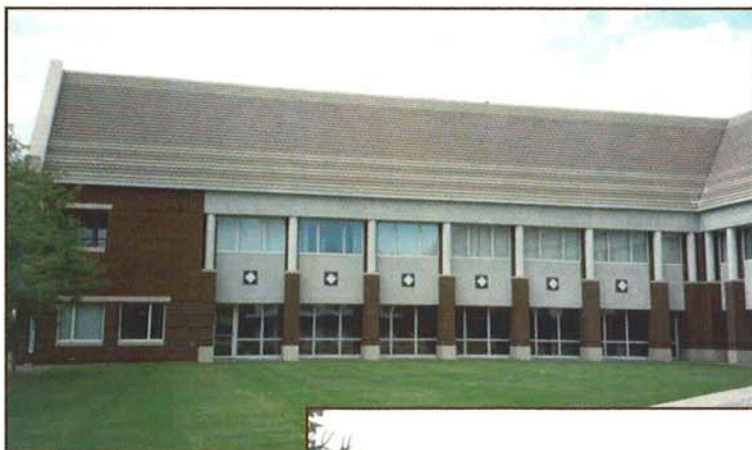
Photo 3 - A closer look at all the windows was warranted.

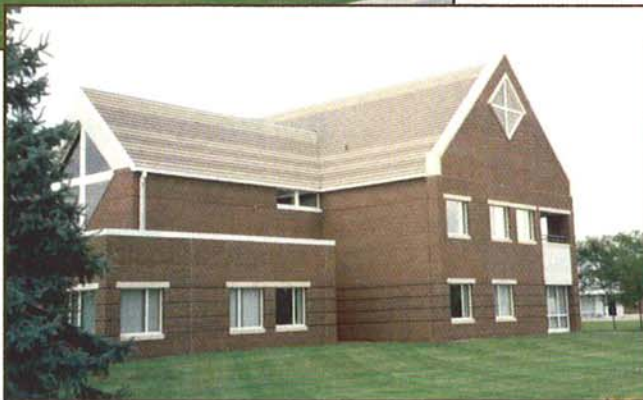
Photo 4 - The diamond-shaped windows were suspect in the investigation.

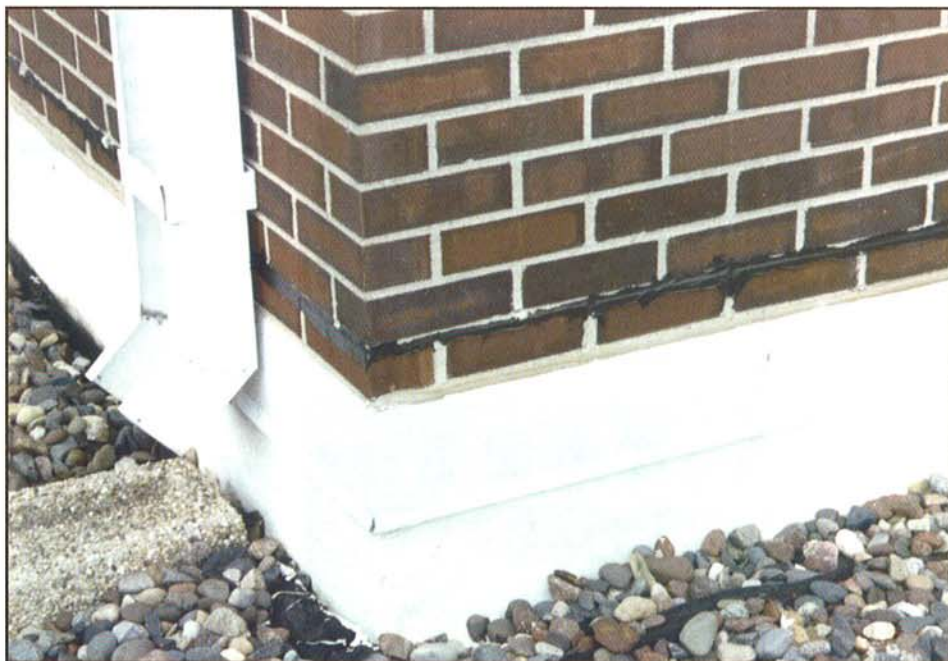
Photo 5 - Repair to through-wall flashing deficiencies needed more than joint sealant or spot tuckpointing.

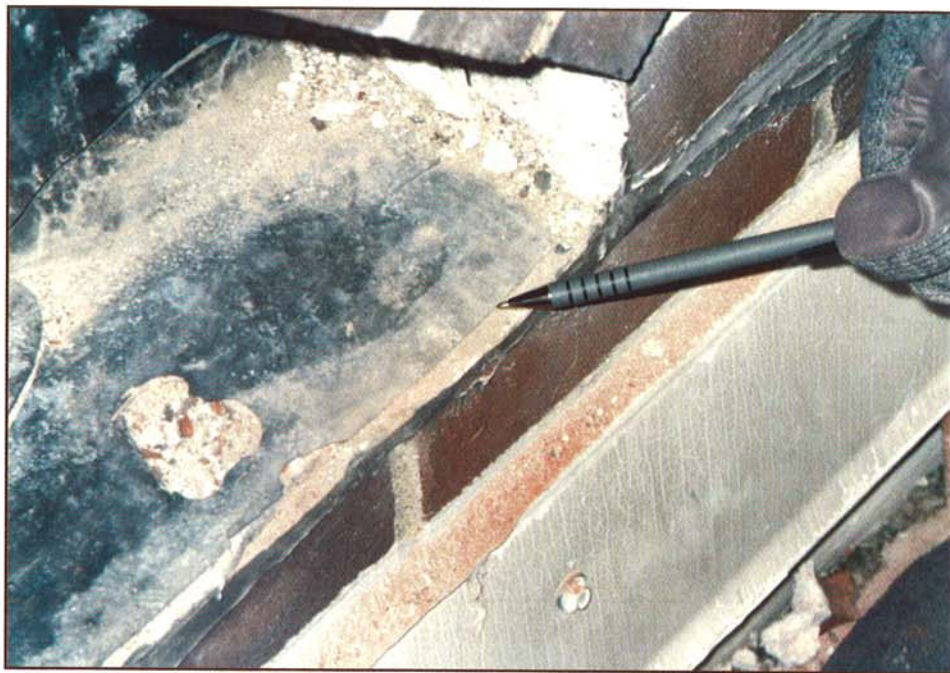
Photo 6 - Test opening performed between the diamond-shaped window and roof-to-wall transition.

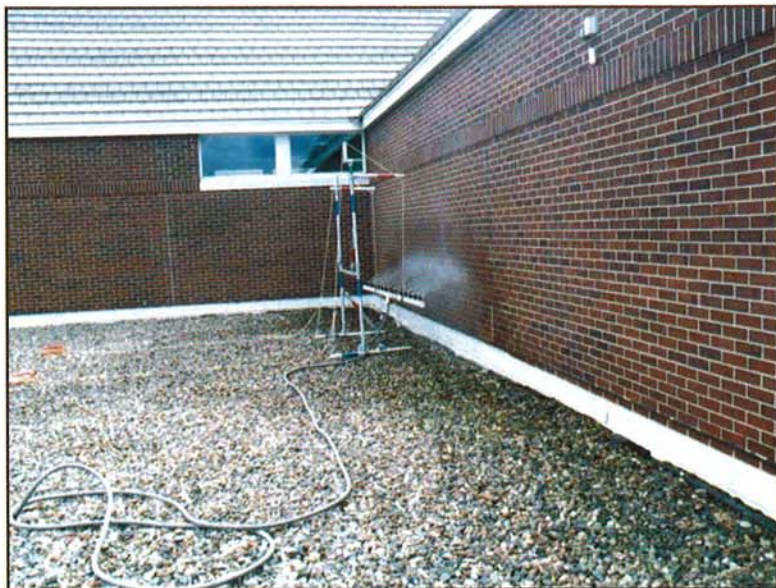
Water testing occurred at the roof-level walls, spraying at the through-wall flashing and the diamond-shaped windows. This testing, intended to simulate wind-driven rain, demonstrated that the through-wall flashing had deficiencies that contributed to the leakage (Photo 7). The diamond-shaped windows also leaked. The roof membrane was blameless.

Photo 7 - Leak testing simulates wind-driven rain.

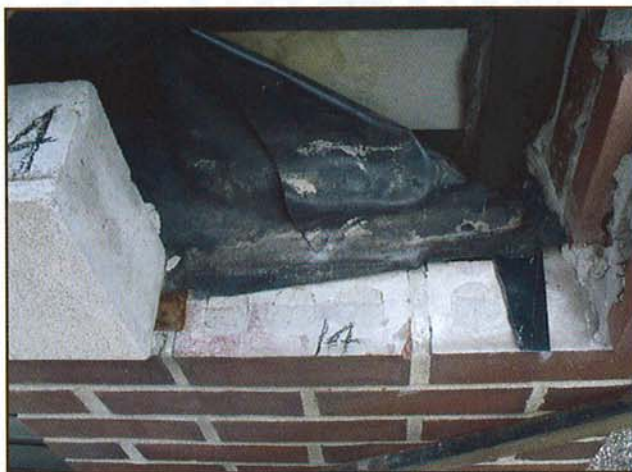
flashing membrane, no end dams, no flashing extension beyond the brick face, improper laps and seals, rusted shelf angles, and unsecured top termination (Photo 8). The correlation of the through-

Photo 8 - Test openings revealed numerous deficiencies.

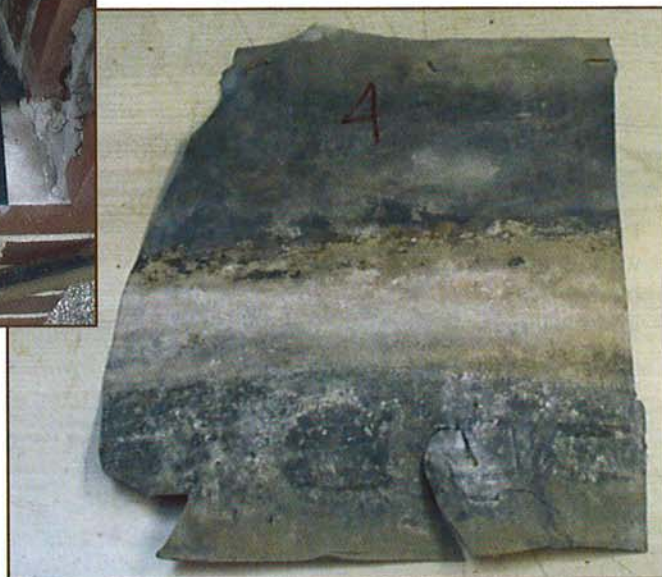
ing. The subjective rating of the brittleness was a scale of 1 to 5, with 1 being flexible and 5 being brittle and cracked, as determined by touch and visual observation (Photo 9). Solvent extraction and gas chromatography served as the chemical analysis methods used in

the testing. The outcome was twofold: the horizontal portion was almost always more brittle than the vertical portion in the subjective rating, and the PVC membrane installed within the past nine years had a plasticizer loss of up to 57% more in the horizontal portion than the vertical portion.² The plasticizer loss meant the PVC membrane was not nearly as flexible as when it was first installed and had actually become brittle

Photo 9 - Brittle PVC sample tested by chemical analysis to show level of plasticizer loss on PVC through-wall flashing membrane.

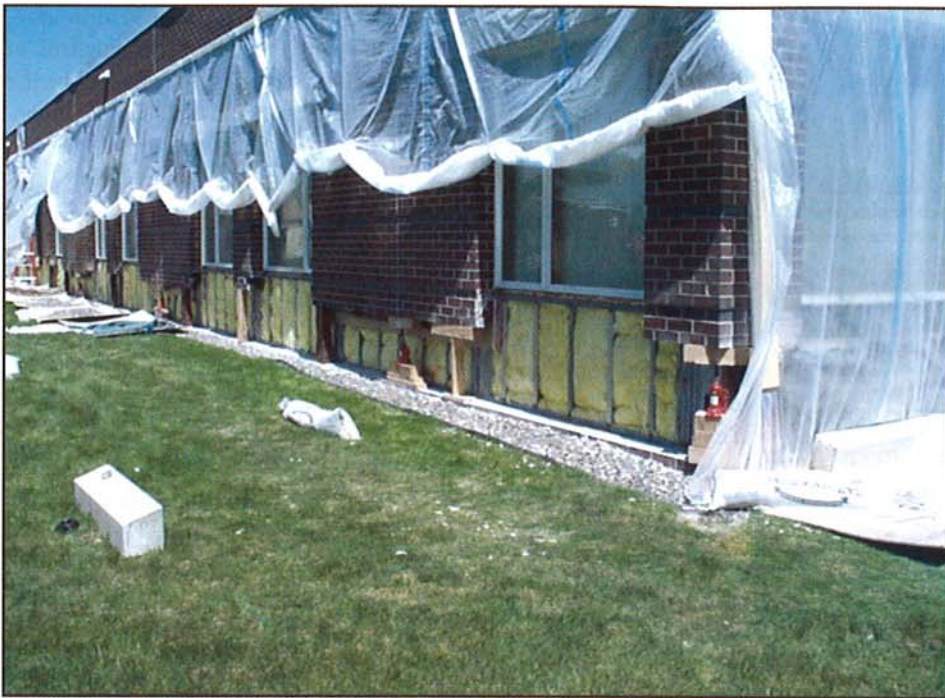
Photo 10 - Through-wall flashing was replaced at grade, window sills, lowers, shelf angles, and other areas.

The through-wall flashing was replaced at grade (Photo 10), below windowsills and louvers, above window heads, at low roof connections to upper walls (*detail*), shelf angles, and under parapet coping stones. When the through-wall flashing was replaced, water-damaged exterior gypsum sheathing and batt insulation were replaced and rusted steel studs were cleaned and painted (Photo 11). To properly design and specify such a repair project, coordination and communication between the engineer and industrial hygienist were imperative to create a complete set of detailed construction documents that would not invite change orders.

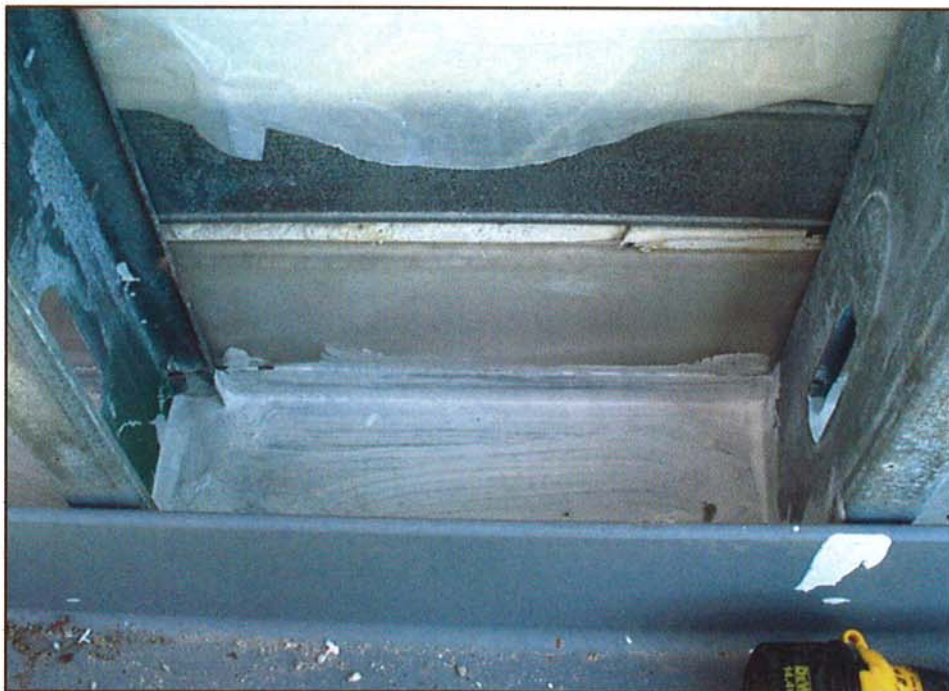
Photo 11 - Water-damaged exterior gypsum sheathing and batt insulation were replaced while rust was removed from existing metal components.
