Interface

FAÇADE INSPECTIONS – BEYOND THE

VERTICAL PLANE

BY DON KILPATRICK

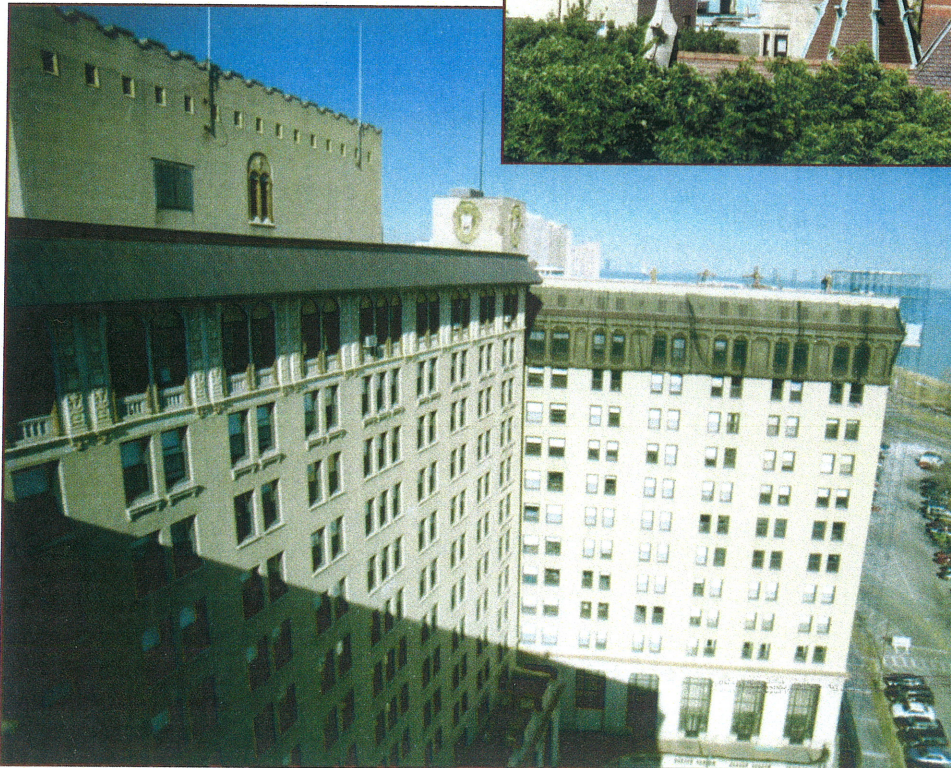
Above: Figure 2 – Suspended scaffolds are routinely used as a means to access the varied cladding features.

Through hands-on, tactile inspection of the building cladding features, the engineer of record establishes building condition indices, including the presence of isolated, widespread, or in some instances, systemic areas of distress in the component (Figure 2). The tools of the trade include sounding (pounding on the exposed surface of the cladding features with a hammer) dovetailed with a working knowledge of the mechanical elements of the exterior wall section. Moreover, it is required that the engineer of record performing the inspection have a depth of knowledge representing each type of cladding material and its respective nuances.

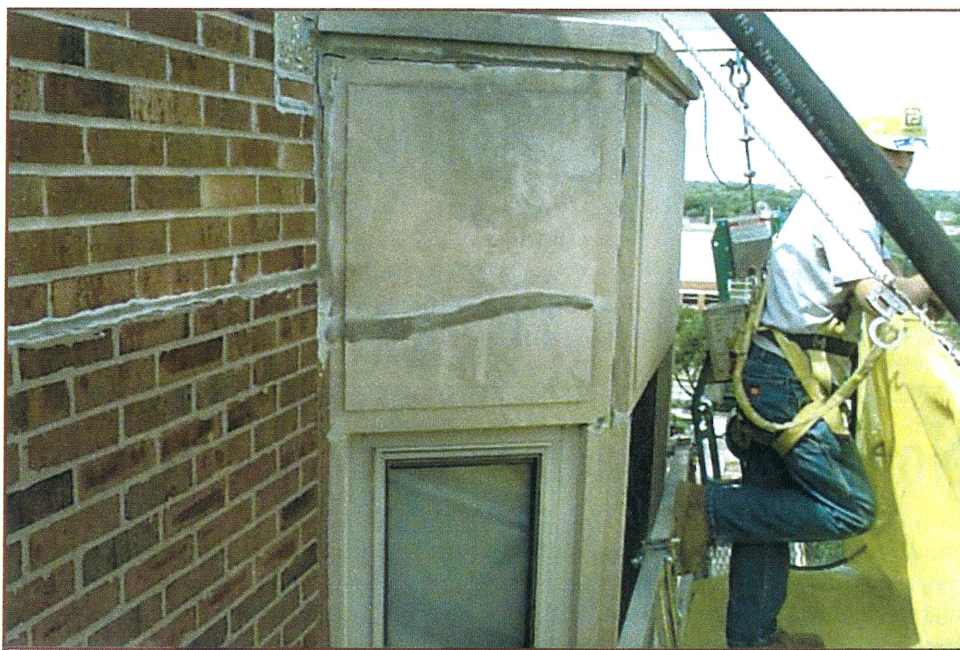
Following a visual inspection and review of original architectural and structural drawings, suspect areas may be targeted for inspection openings either required by code-specific language or determined as necessary by findings of the tactile inspection (Figure 3). Through these inspection openings, the engineer of record acquires detailed knowledge related to the anchoring and support mechanisms for the particular cladding features (Figure 4).

Figure 3 – Area of localized distress in cut limestone cladding.

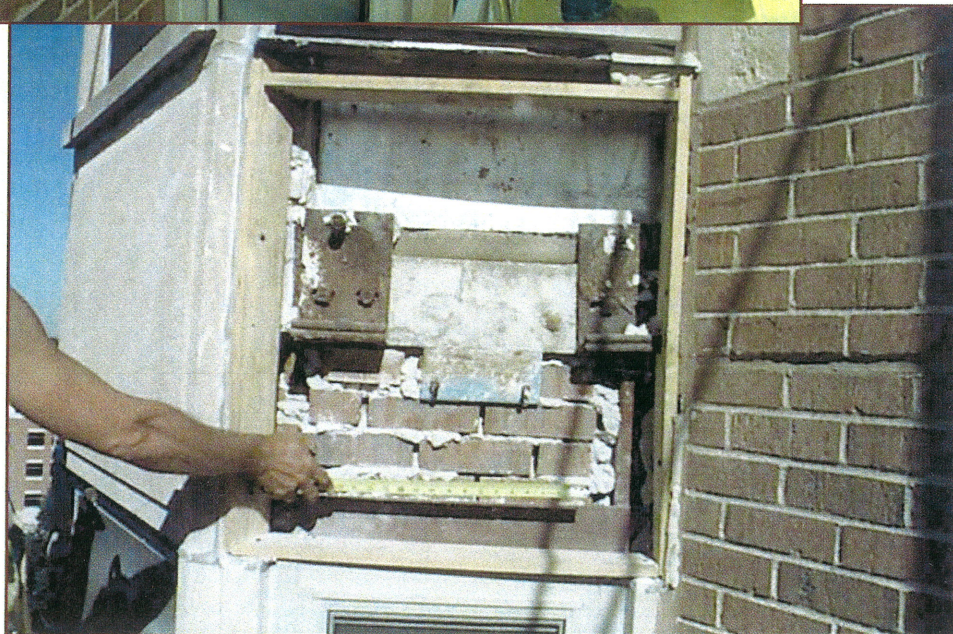
Figure 4 – Inspection opening to establish as-built condition(s) contributory to the cause of the distressed cladding feature.

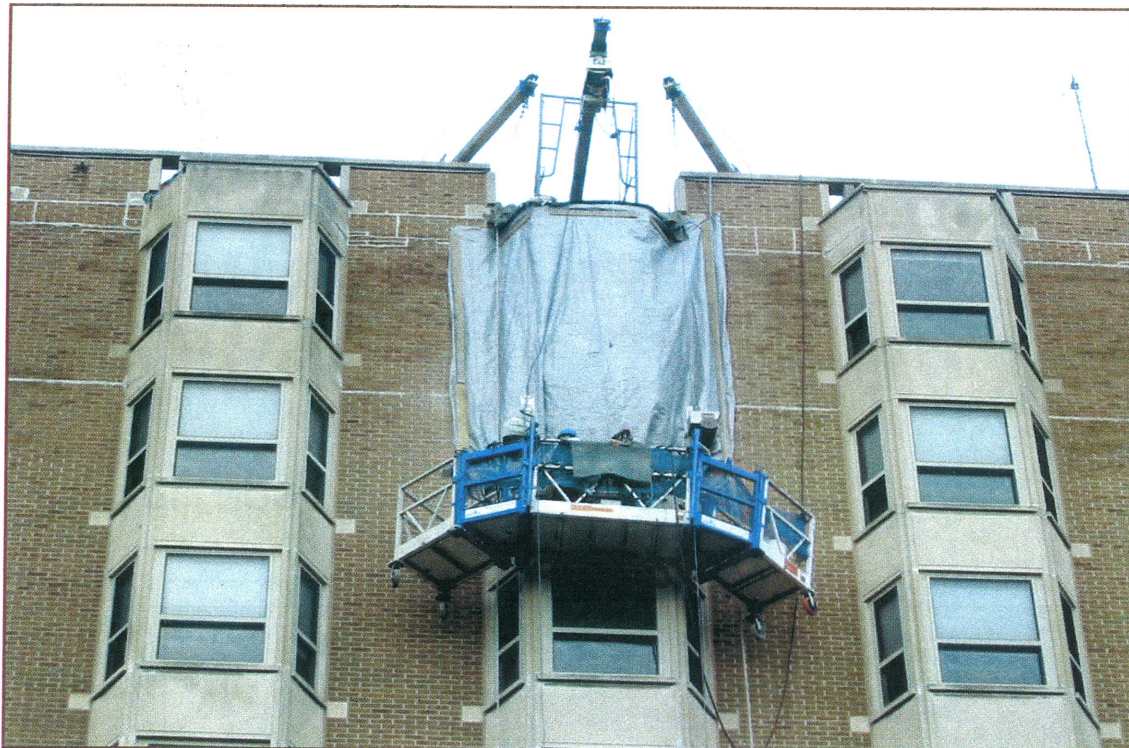
Figure 5 – Large-scale selective removals of cladding features.

a large-scale opening to gather additional information before designing the wall repair (Figure 5). Often, on the brick and mortar

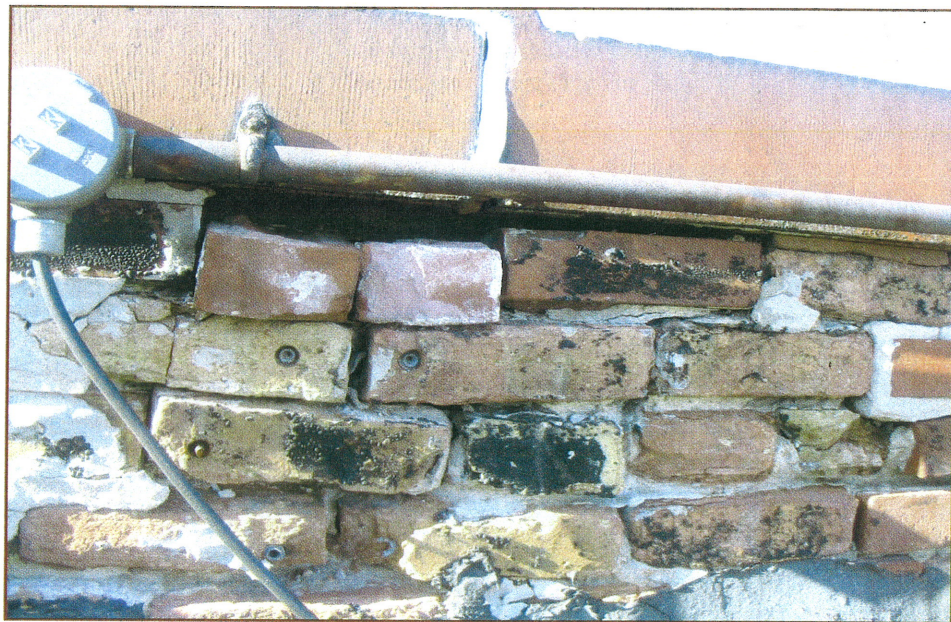
Figure 6 – Typical conditions observed on the inboard face of multiple-wythe parapet wall.

Most have witnessed projects where a multiple-wythe masonry parapet, often capped by a clay tile or terra cotta coping, extends above the primary roofline (Figure 6). Few have stepped foot on a roof and been favorably impressed by the condition of same. It could be said that this is where the divide begins, at the interface of the wall and roof, where overall performance is measured and realized by one component relying on another, establishing the desired leak-free occupancy. Telltale signs of moisture-driven damages at this critical interface include spalled and cracked brick on the parapet interior and out-of-plane conditions, the limits of which are often isolated to the features of the building above the roofline. At this location, roof leaks get repaired (active leakage), and

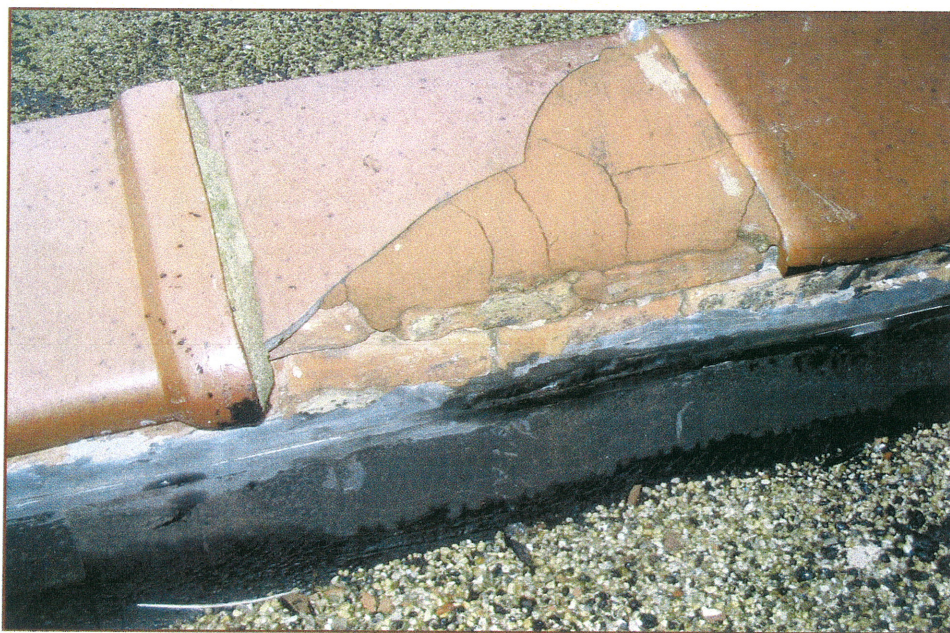
Figure 7 – Typical, overall poor condition of above-roofline parapet wall and coping.

the above-roofline masonry is the receiving substrate for liberal applications of plastic cement (Figure 7).

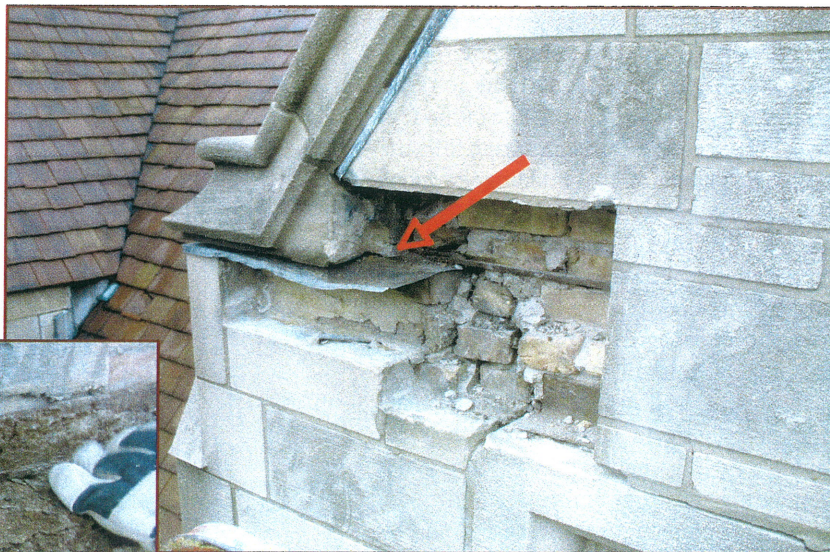
Figure 8 – A lack in continuity of the 1930s-era through-wall flashing below the stone coping resulting in out-of-plane conditions.

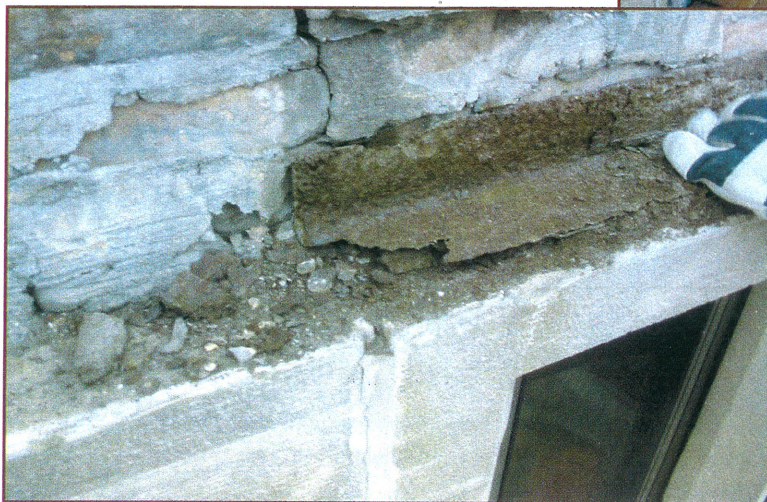
Below: Figure 9 – Heavy corrosion of steel window head lintel. Note the minimal bearing tolerances at the end of the steel lintel and cut limestone “surround” of the window opening.

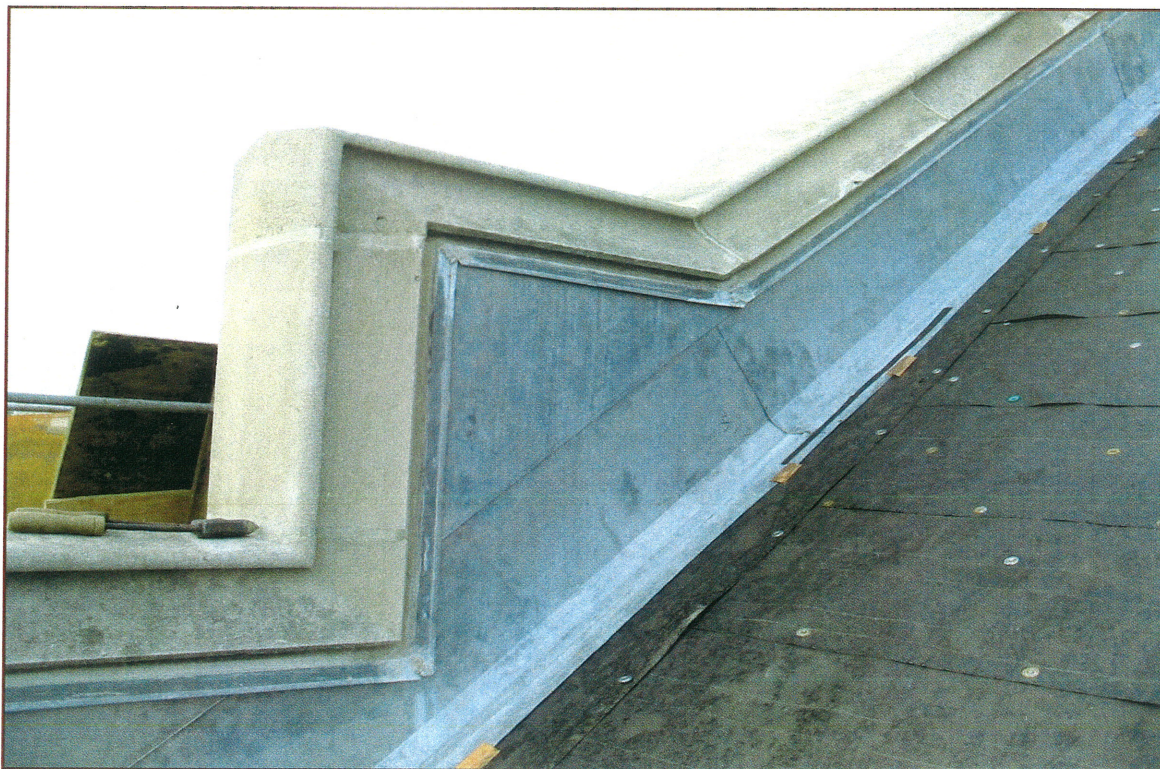
Figure 10 – Above-roofline masonry offered protection by sheet metal cladding interfaced with a new, continuous through-wall flashing below the limestone cladding.

underside of the sheet-metal cap flashing or stone coping, down the parapet wall interior, lapped on top of the finished membrane flashing (Figure 10). Many large expanses of masonry have been successfully over-clad with continuous concealed flashings and sheet metal counterflashing to minimize the predictable continual maintenance of the underlying masonry construction.

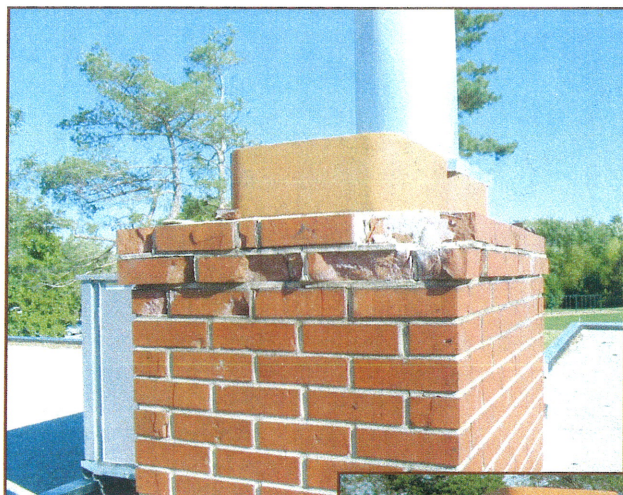
Left: Figure 11A – Typical chimney damage due to water infiltration and subsequent freeze/thaw damage (2002).

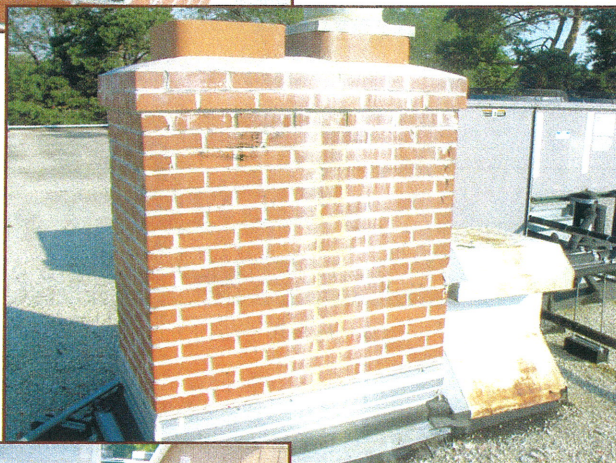
Right: Figure 11B – Post repair water damage due to water infiltration (efflorescence and spalled brick).

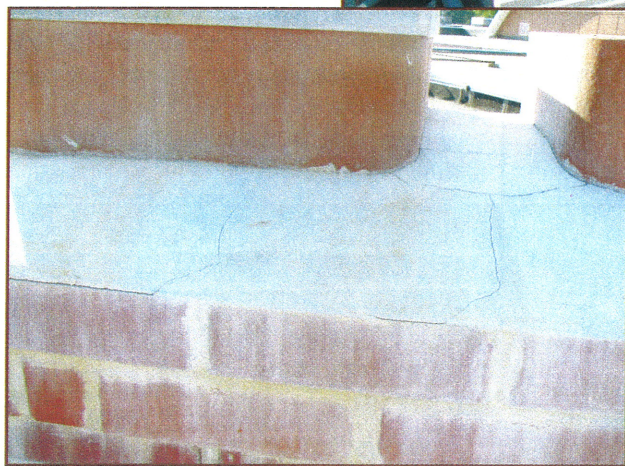
Left: Figure 11C – Latent defects in mortar-topping material contributory to the cause of the efflorescence and spalled brick (2004).

with the flue extending a few inches above the top course of brick. A concrete topping is then installed, mounded to shed water similar to that of a pourable sealer pan on a roof. Predictably, the desired long-term performance of this type of detailing is rarely achieved. The concrete topping cures, shrinks, and cracks, establishing a path of least resistance for water, resulting in cracked flues, friable mortar joints, and spalled brick (Figures 11A, 11B, and 11C). A properly designed and installed chimney cap can easily be fabricated using a variety of available sheet-metal products.

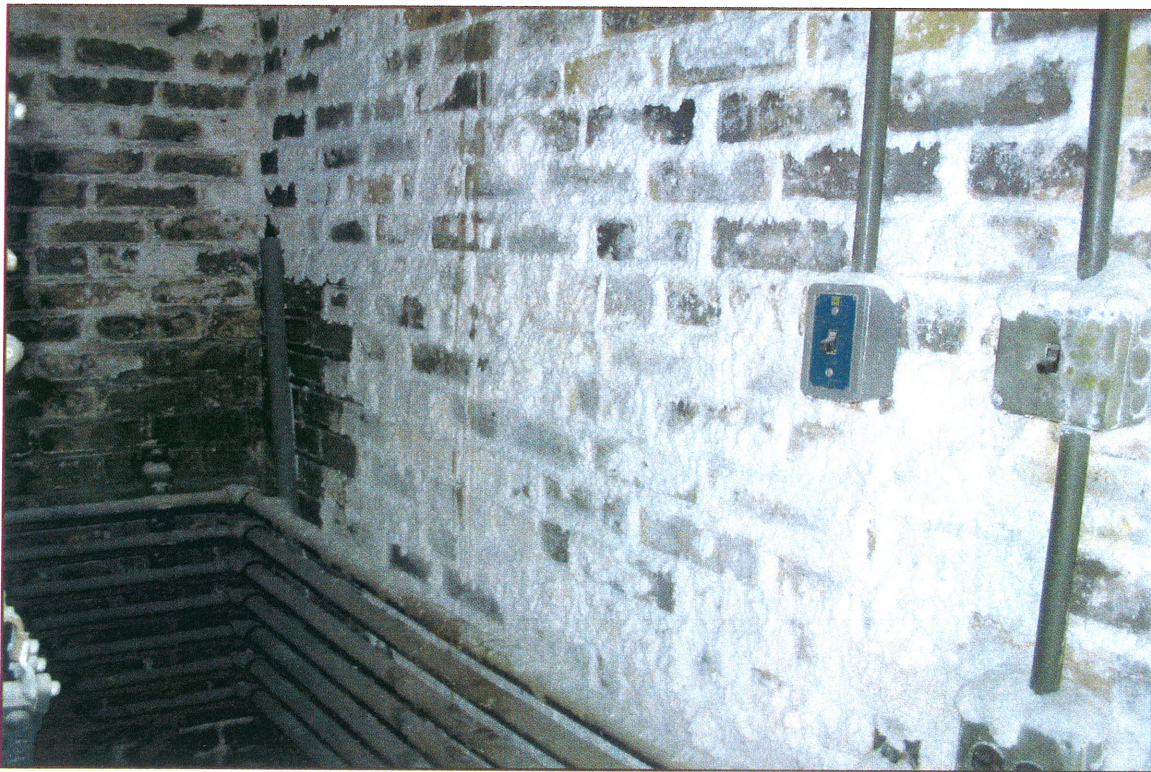
Figure 12 – Heavy concentration of efflorescence on the interior of outside walls is a clear indicator of moisture infiltration.

identified as free moisture that enters the confines of the wall-in section and is not presented on the building interior (Figure 12). These solid-wall structures were not afforded the benefit of current-era, cavity-wall construction; more specifically, the presence of a drainage plane intended to harmlessly discharge moisture from the component assembly. In some instances, efforts to introduce modern materials (through-wall flashings and weep systems) into the repair of solid wall construction may be impractical, as the surrounding components of the assembly fail to benefit from the perceived added value and cost of same.

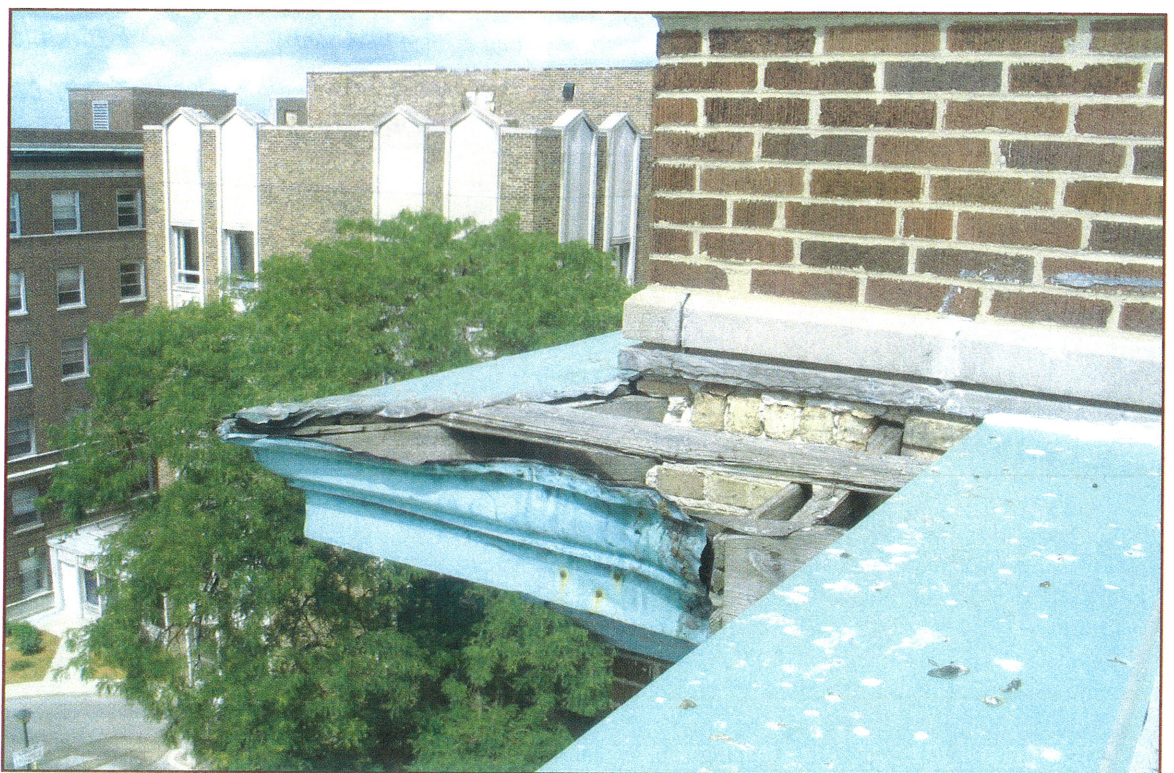
Figure 13 – Damage to wood-framed, copper-clad cornice feature.

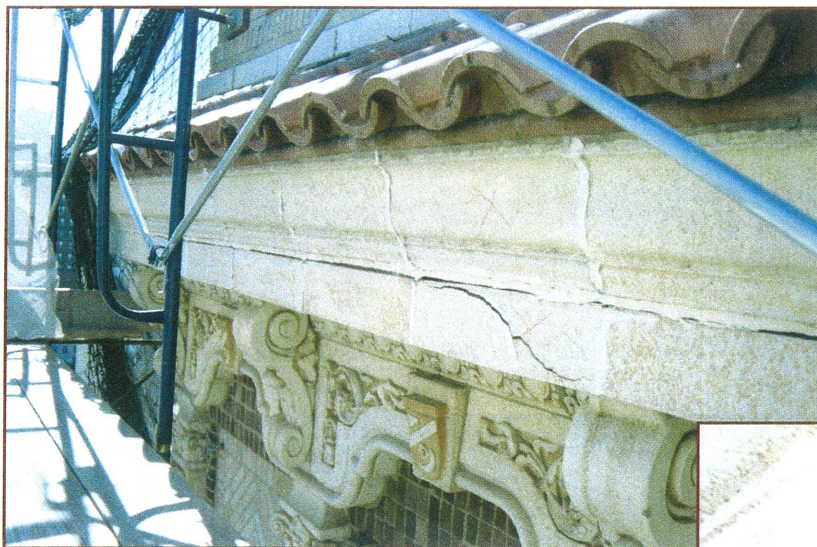
Left: Figure 14 – Terra cotta cornice classified as in an unsafe condition.

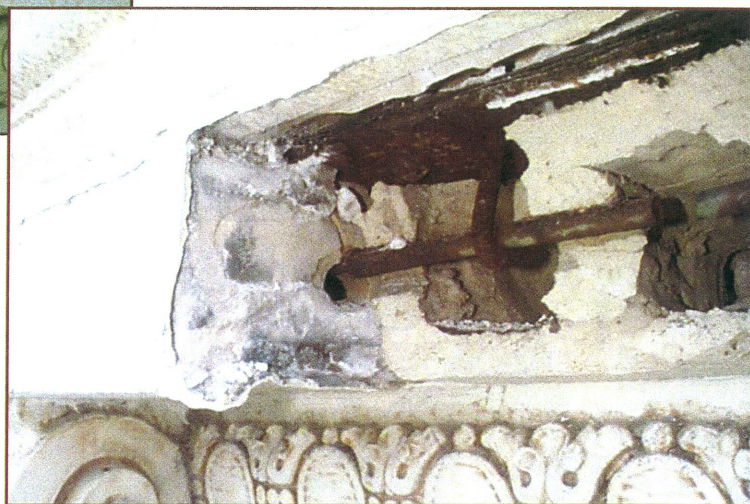
Below: Figure 15 – Concealed structural support mechanism for terra cotta cornice.

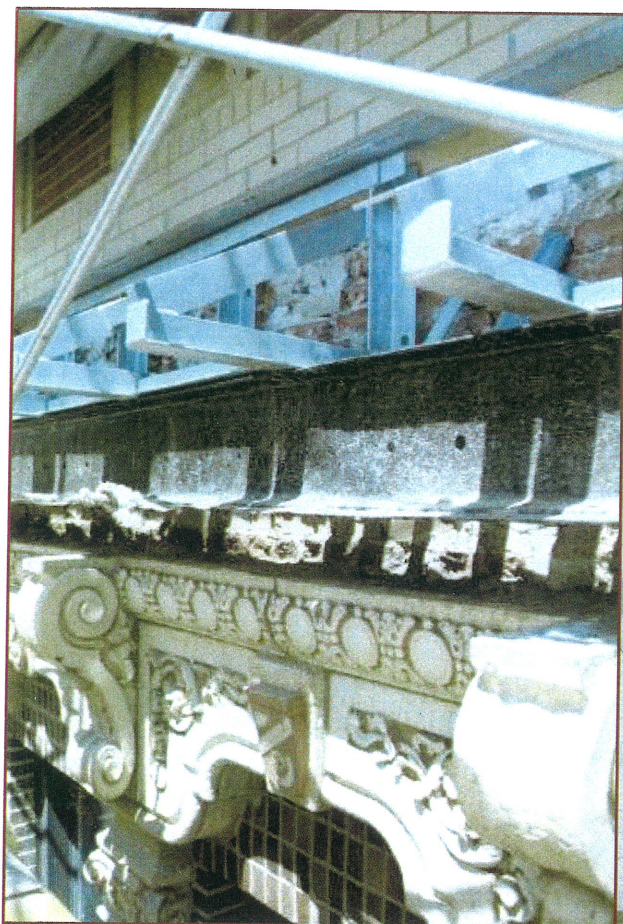
Figure 16 – Mock-up in area of removed terra cotta cornice with new steel framing intended as anchor points for replacement GFRC.

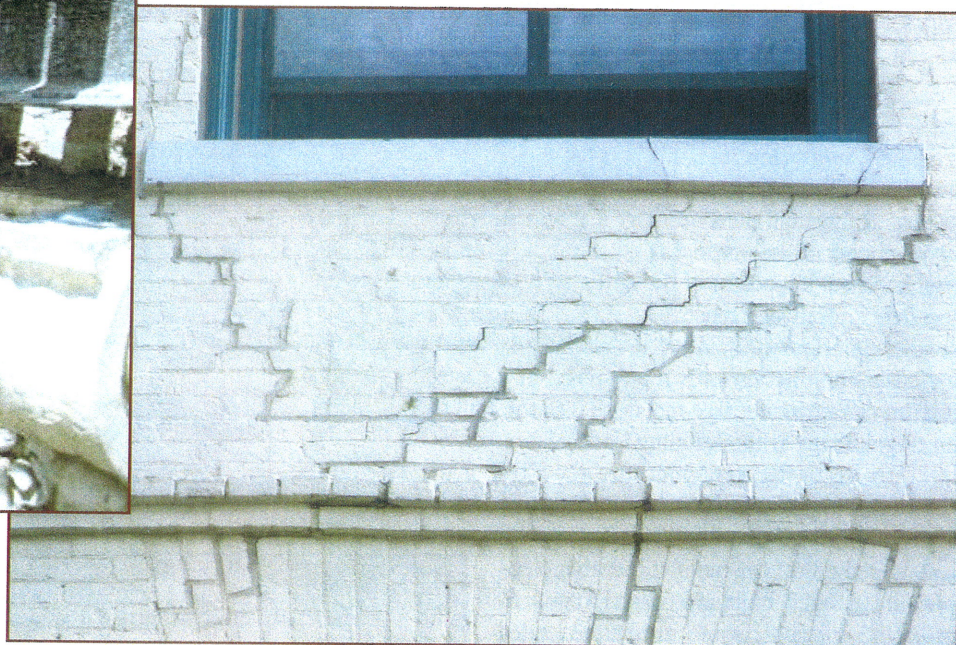
Figure 17 – Stair cracking common to window openings in solid wall construction.

as part of the original construction to carry the load of cladding materials across the span of a window-head opening. They can be affixed to the structural steel frame of the building, masonry back-up materials, or set loose, placed with the horizontal leg bearing on the exterior jamb-cladding component of the window opening. The process of corrosion and resultant volumetric expansion across the horizontal plane of the steel angle results in stair cracking, usually presented at the upper inside corners of the window opening (Figure 17).
