A Project Profile: Benefits of Front-End-Heavy Due Diligence

By Don Kilpatrick

This article will impart our recent experience in delivering a multimillion-dollar restorative effort for a student dining facility at the University of Chicago. Bartlett Dining Hall, originally built in 1901, was initially commissioned as a field house, with various sport-related fixtures including a swimming pool, a running track at the mezzanine level, and a basketball court. Previously (in 2002), the facility underwent major renovations that would abandon the sport-centered use in favor of kitchens and student dining (**Fig. 1**).

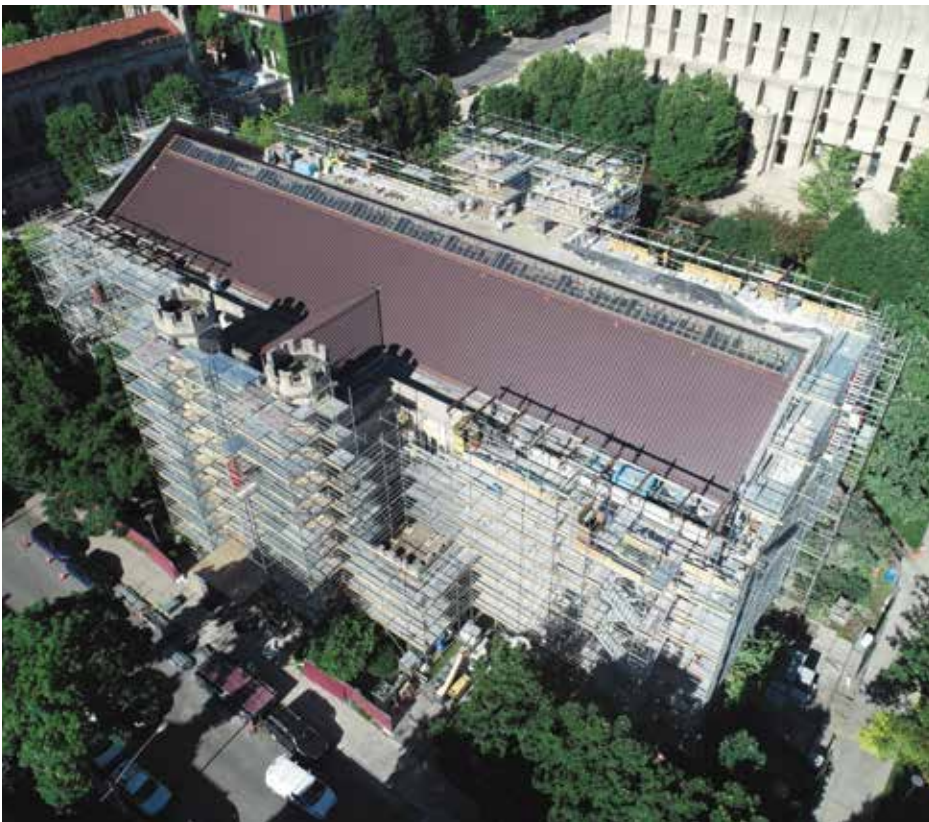
Figure 1. In September 2022, the building was fitted with scaffolding, hoisting bays, and monorails prior to roof and skylight replacement work scopes.

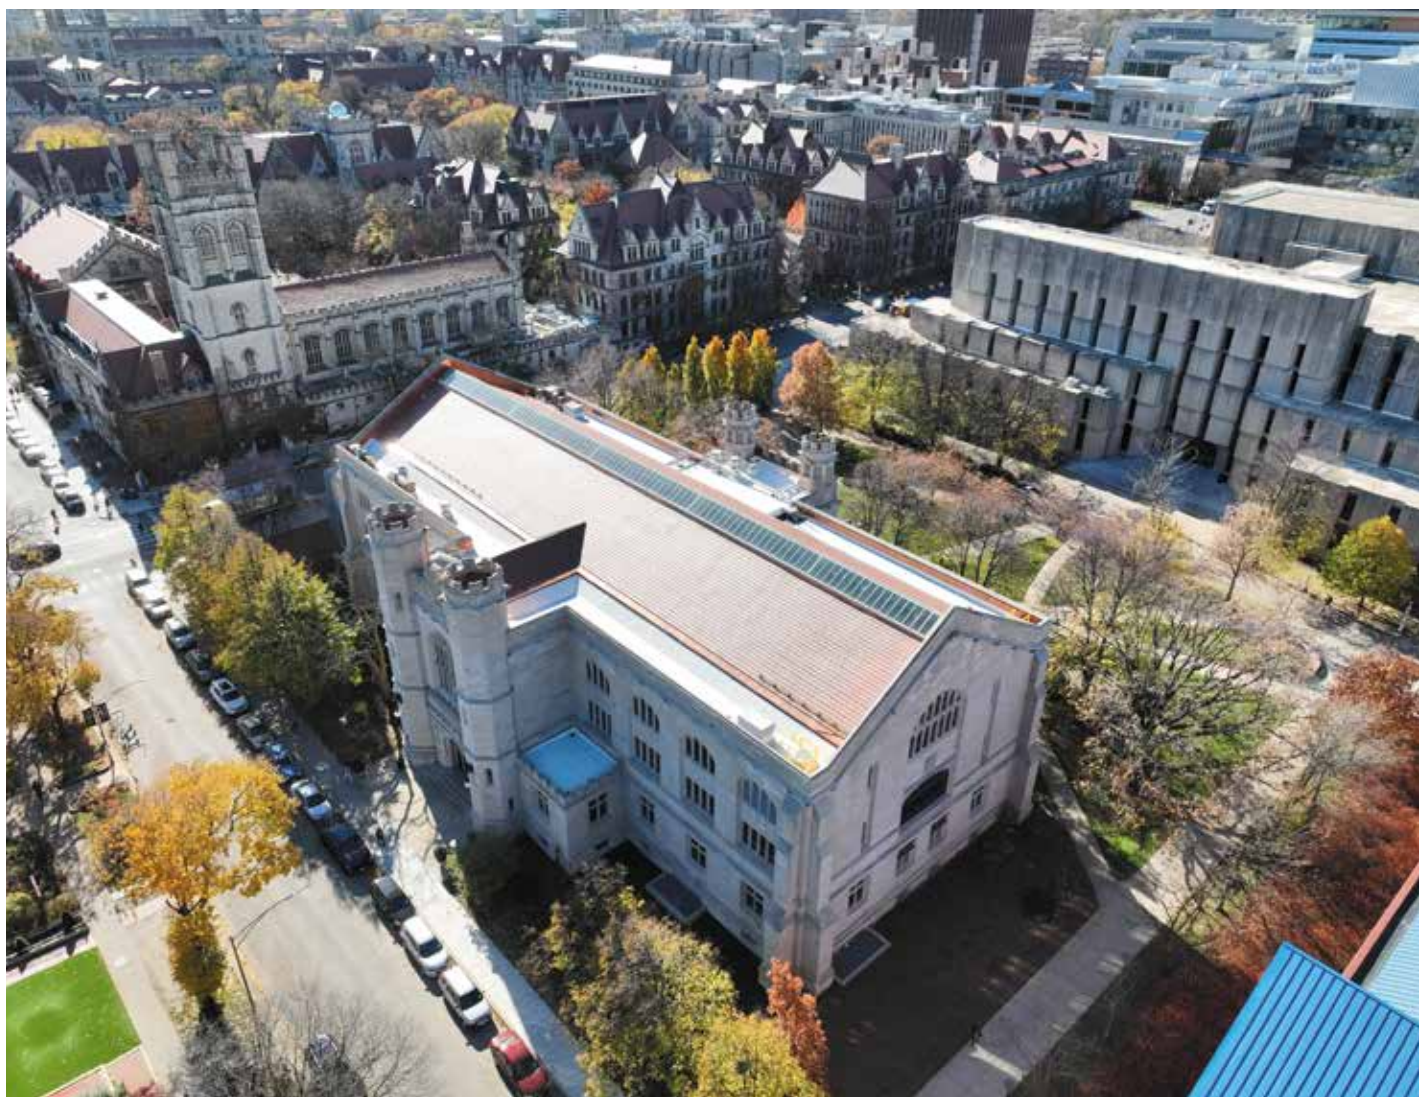
Figure 2. Project was substantially completed prior to the start of the fall 2023 quarter.

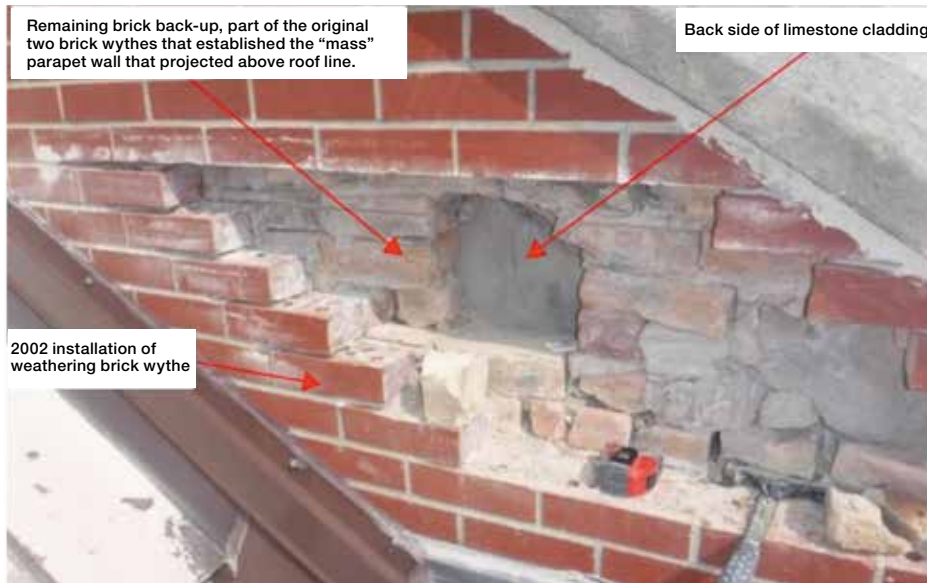
Figure 3. Through targeted removals it was determined that the exposed brick installed in 2002 as part of the conversion from field house to food services did not include brick ties. In addition, the bedding mortar that was present in the remaining wythe of brick (Chicago pinks) between the weathering wythe and stone cladding on the outboard side of the parapet wall had reverted to sand. A pocketknife could be used to pull brick from that area of the wall.

the new brick showed no evidence of a header coursing, visually the brickwork looked great, and it even passed the sounding test. However, with lift access to the opposite side of the parapet wall exterior, sounding suggested a dead wall. A targeted inspection opening was made off the roofline into the otherwise new brick masonry backup wall, and it was determined that the interior parapet wall repairs of 2002 only included the exposed weathering brick wythe. Existing headers were detached, and the new brick wythe was installed without any brick ties at the interface of the brick backup that remained as part of the repair. The bedding mortar of the brick backup that remained from the original construction was compromised and was friable, with no structural integrity (Fig. 3).

From there, the team refocused on the limestone cladding on the gable end wall, including pockets of deflection and changes in plane of the limestone cladding. Sounding, paired with visual examinations, determined that most of the stone cladding on the gable end wall (both north and south ends) would minimally require removal and reinstallation, using stainless steel clips, pins, and fasteners.

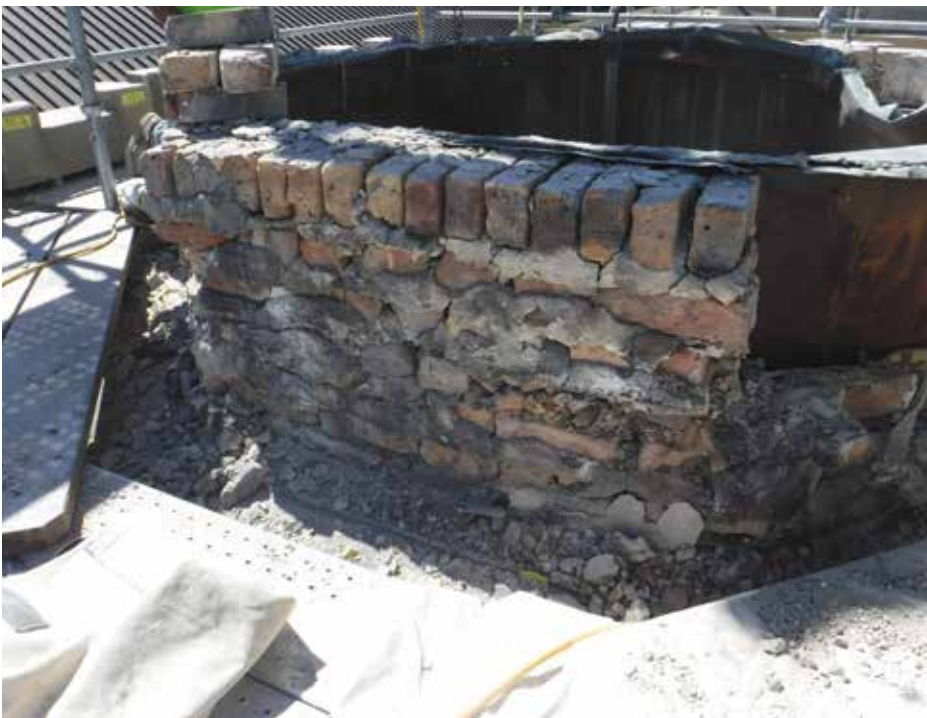
Figure 4. Overall poor condition of existing brick masonry backup wall found to be typical on each of the four turrets.

Demolition and reconstruction of the four turrets were required, from the crenelated top of same, to the stone copings of the adjacent main roof line parapet wall below, including the brick masonry backup (Fig. 4).

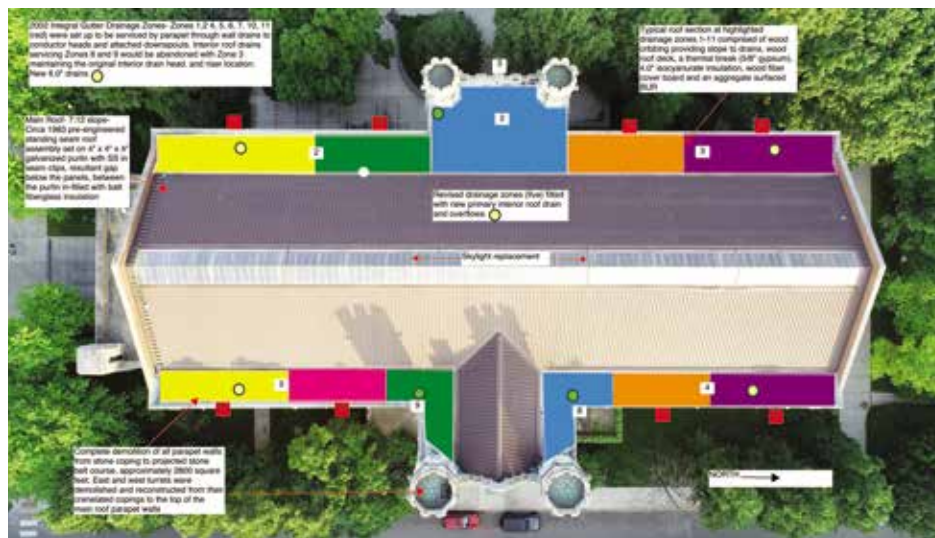
The main building's plan view geometry established 11 primary roof drainage zones (Fig. 5).

Figure 5. Graphic showing scope of work.

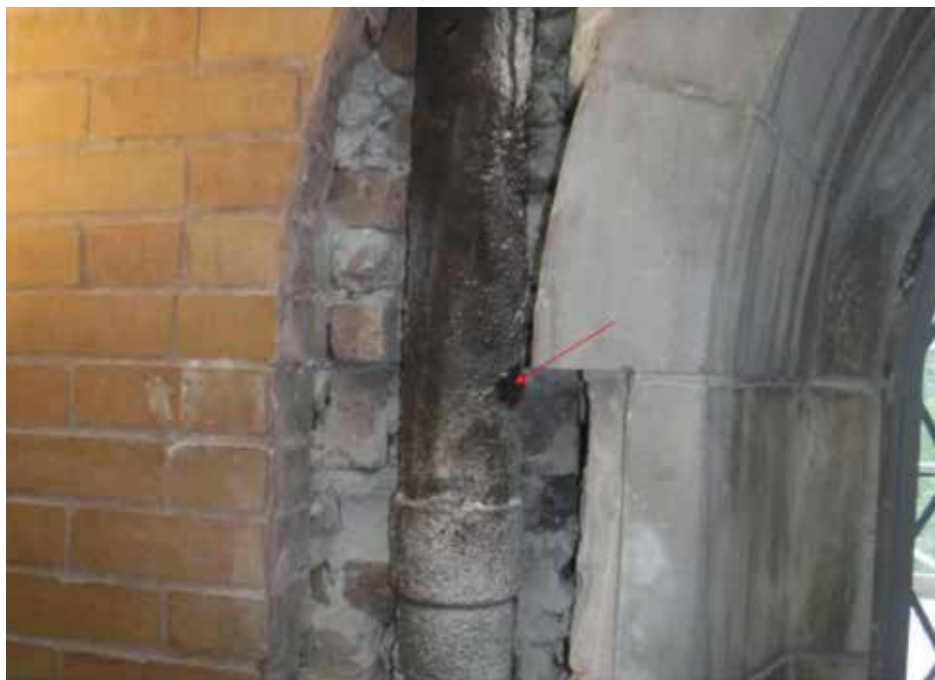
Figure 6. Original drain riser buried in the mass wall. Corrosion of the piping resulted in damage to the stone surrounding the adjacent window opening.

the 4 in. (100 mm) cast drain risers for extended durations, resulting in complete failure of the piping (Fig. 6).

In addition, the 4 in. (100 mm) risers were choked down to 2 in. (50 mm) at the roof line through the introduction of drain inserts, resulting in a 75% reduction in capacity.

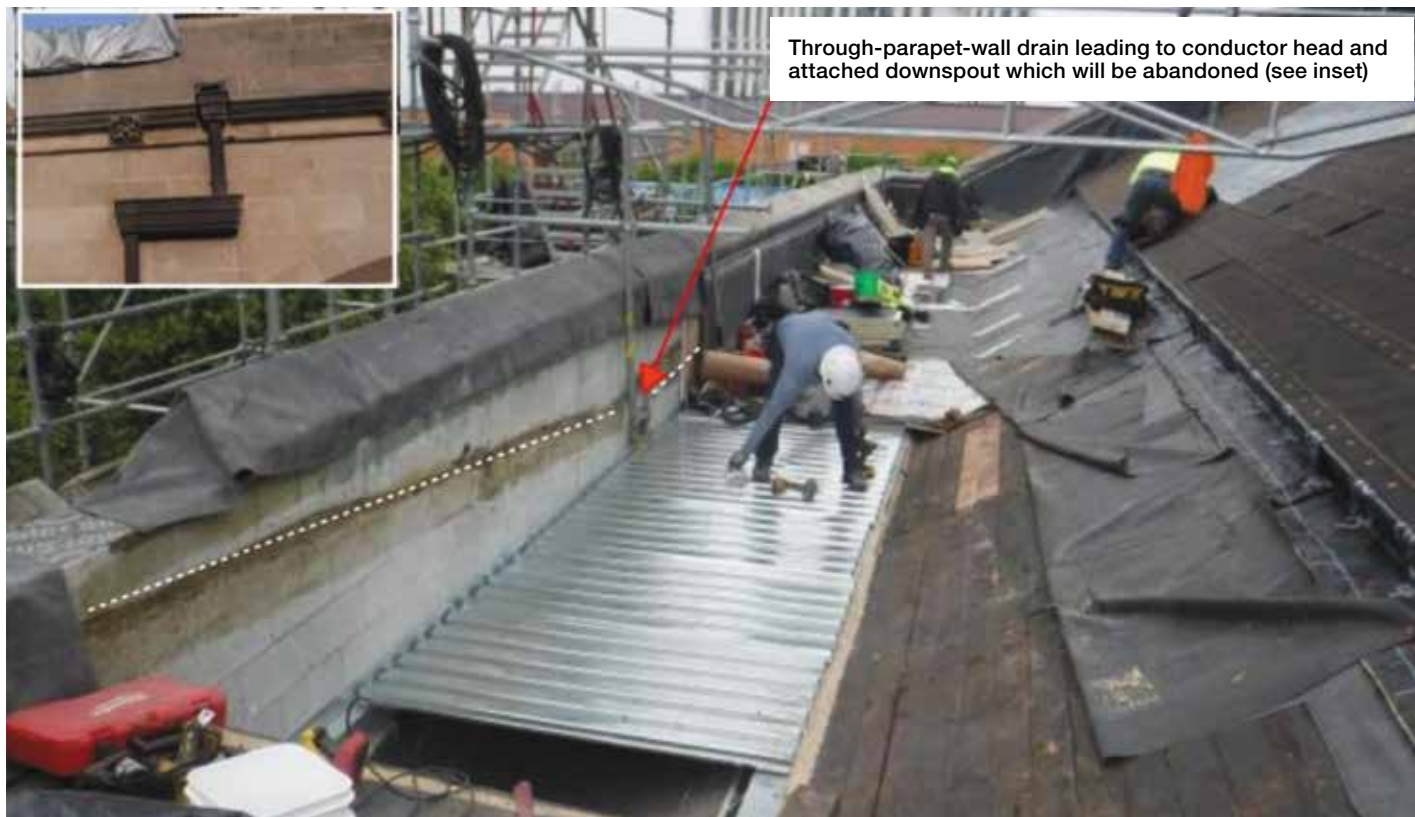
Through-parapet-wall drain leading to conductor head and attached downspout which will be abandoned (see inset)

Figure 7. The introduction of new galvanized steel roof deck and framing members into one of the four primary drainage zones. The line on the back side of the new steel-reinforced, grouted concrete masonry unit backup wall represents the location of the slope to drain feature that was accommodated by the wood cribbing that was original to the building. A fully tapered insulation atop the new steel deck will move water to the new drains at new locations (see Fig. 5).

risers that were buried in the mass wall (see **Fig. 7 inset**).

- The below-grade laterals carrying roof drainage to the City of Chicago stormwater system were also centered between the windows. This allowed the connection of the new downspouts to the existing subgrade drainage features. The revised condition was prone to significant ice dams (see Fig. 7 inset), which resulted in leakage to the building interior.

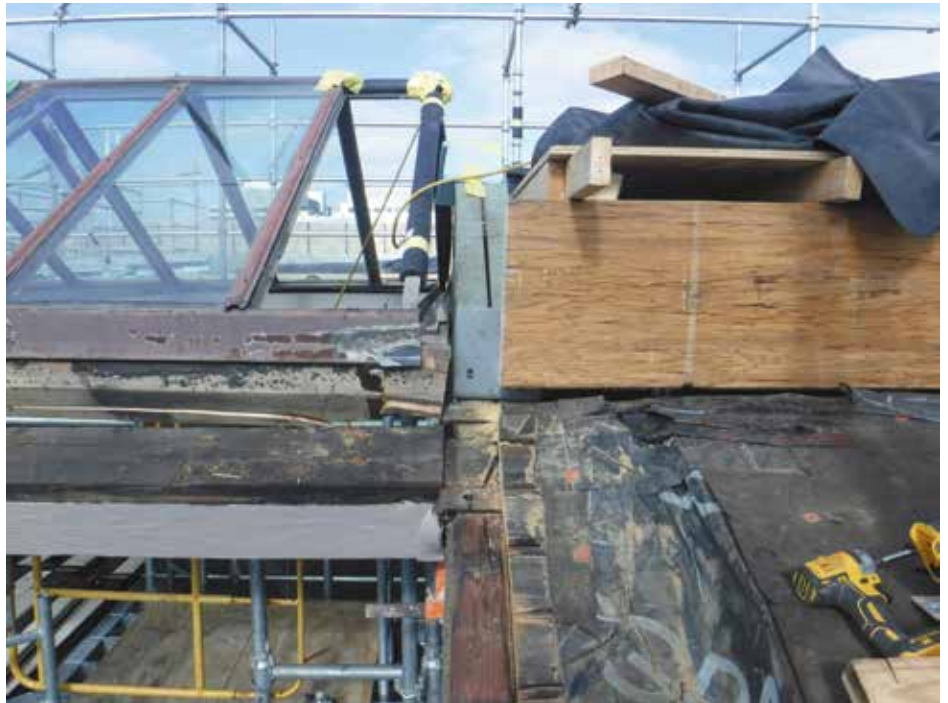
The existing skylight frame and curb were believed to be original to the building. The original 2002 rehabilitation required the installation of new, uninsulated safety glass in the existing skylight frame. In the design phase, it became apparent that the previous introduction of a standing-seam metal roof in 1983 left the interface of the skylight curb, sheet metal accessory closures, and metal roof panels in a compromised condition (see the "Roofing: Existing Conditions" section below). The flashing that extended from the skylight curb to the closure at the sheet metal pan heads was left dead flat or slightly back pitched to the skylight curb. Repeated incursions of water occurred at

this location to the extent that previous repairs also required the replacement of heavy timber beams that carry the skylight curb. Leakage was additionally reported at locations downslope, assumed to be sourced from this condition.

Figure 8. Original 1901 skylight curb on the left side with new curb on the right. Increased height was required to accommodate increased insulation thicknesses.

This project is the second steep-sloped roof on the campus where the design could consider the introduction of above-roof deck insulation. The generous height of the parapet walls easily accommodated R-30 insulation above the roof deck with room left for tapered materials in the integral gutters. The introduction of all above-deck roofing components made it necessary to introduce a new skylight curb (Fig. 8).

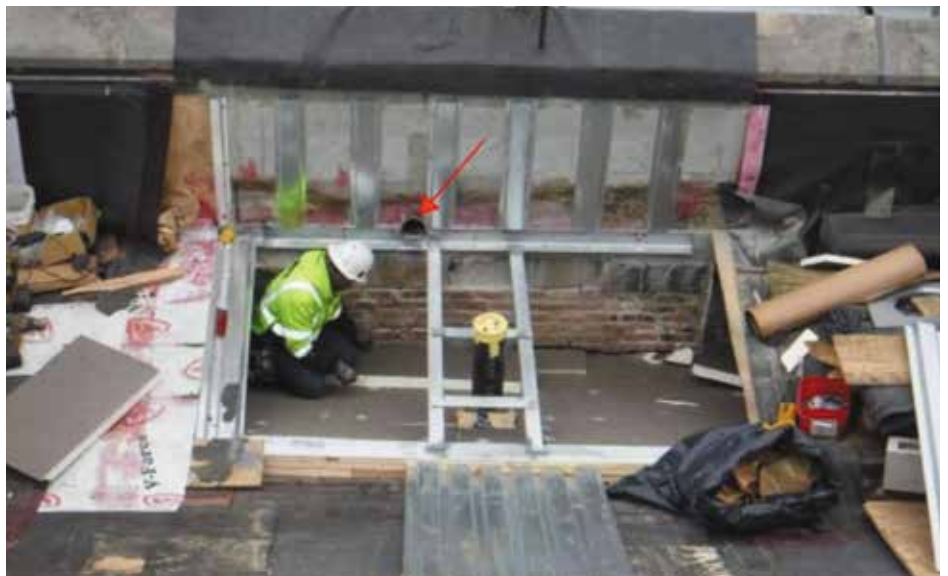
Figure 9. Crew installing the structural steel framing intended to carry the new galvanized decking and hat channels on the roof side of the parapet wall that is the receiving substrate for the plywood sheathing, establishing the substrate for the new flat-lock-seam copper panels. The existing through-wall drain will be closed off and the new parapet wall section will be cored through, establishing provisions for overflow drainage for each of the four roof drainage zones.

The original design intent and existing cribbing for the four integral gutters would be demolished and reconstructed, featuring four new drain heads paired with through-wall overflow scuppers. Eleven drains were present in the existing as-built conditions. New galvanized steel cribbing and decking were introduced to the assembly (Fig. 7 and 9), followed by the

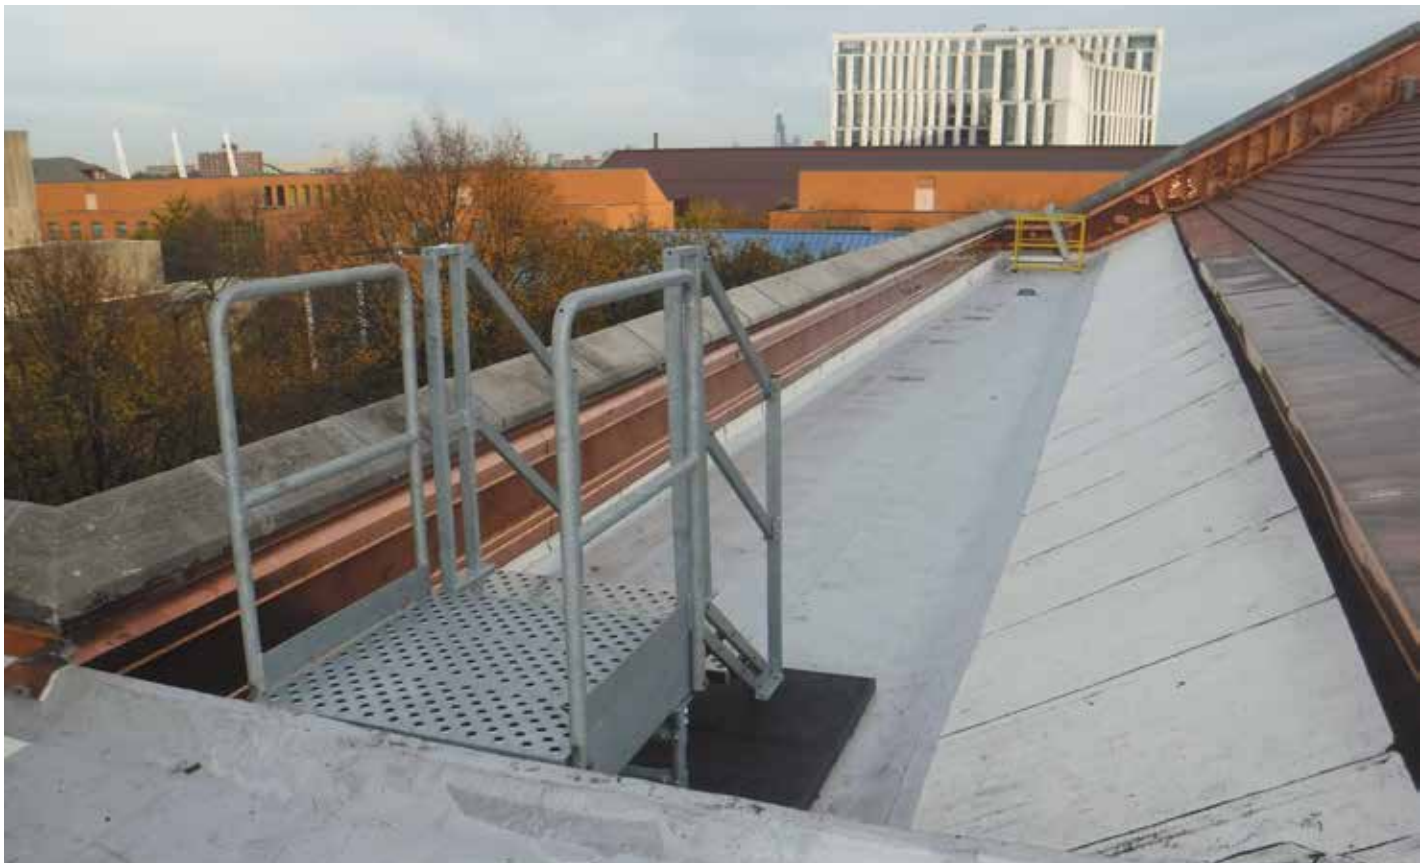
Figure 10. Overall completed northwest integral gutter drainage zone.

introduction of thermal break, temporary roof using asphalt-based self-adhered underlayment, tapered insulation, cover board, and a new three-ply torched styrene-butadiene-styrene (SBS) modified bitumen membrane (**Fig. 10**).

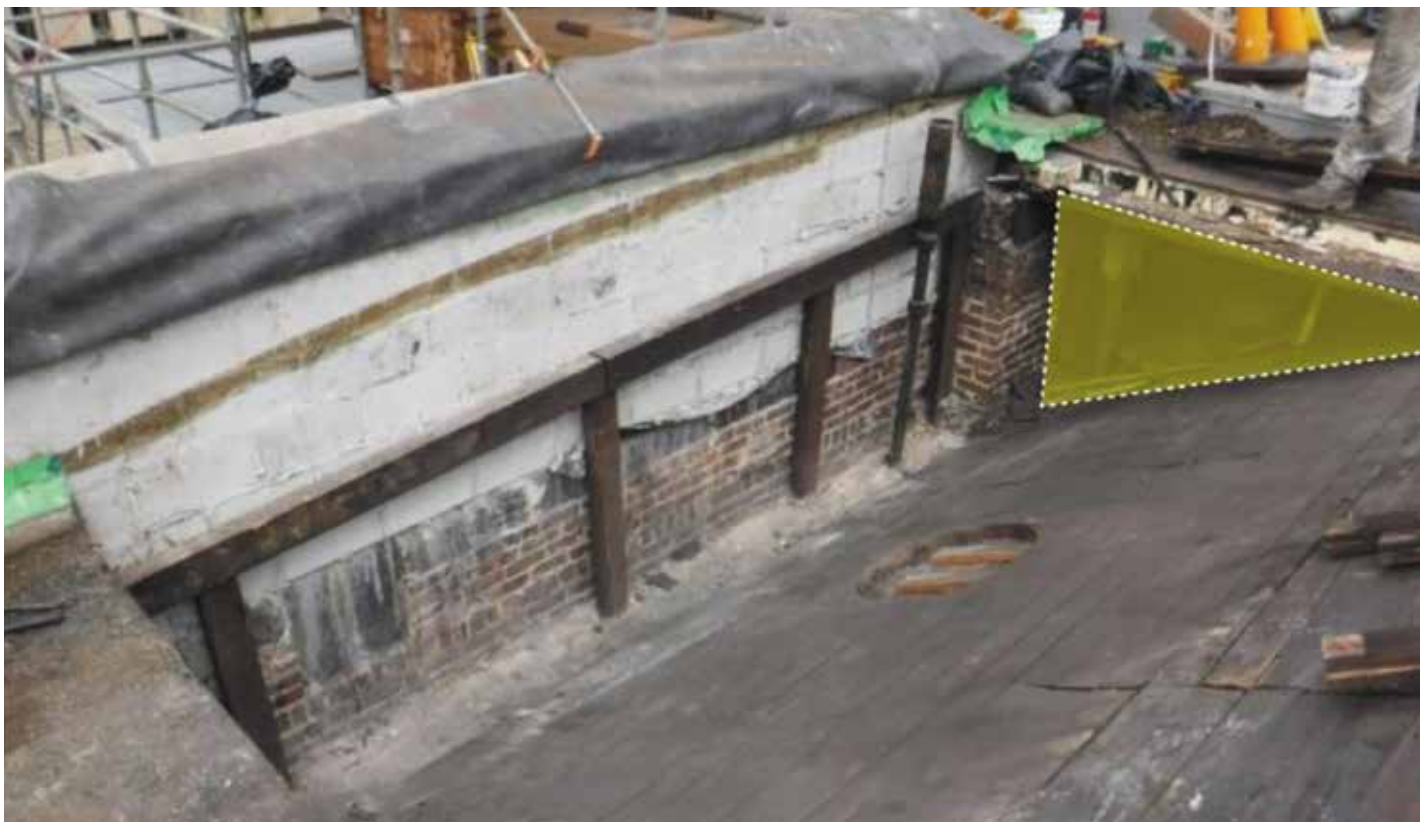
Figure 11. Typical condition as encountered in each of the four integral gutters. See Fig. 9 and 12 for additional information related to new design intent and solution for venting of the triangulated, “dead” air space that will be maintained as part of the new as-built condition. New insulation was required from the interface of the parapet wall upslope to the skylight curb.

To address the triangulated, “dead” air space between the new steel roof deck of the integral gutter and continuum of the 7:12 slope of the main roof (**Fig. 11**), the interior parapet wall was designed to function as a vent, offering the opportunity for air changes/movement by convection from the otherwise “closed” space (**Fig. 12**).

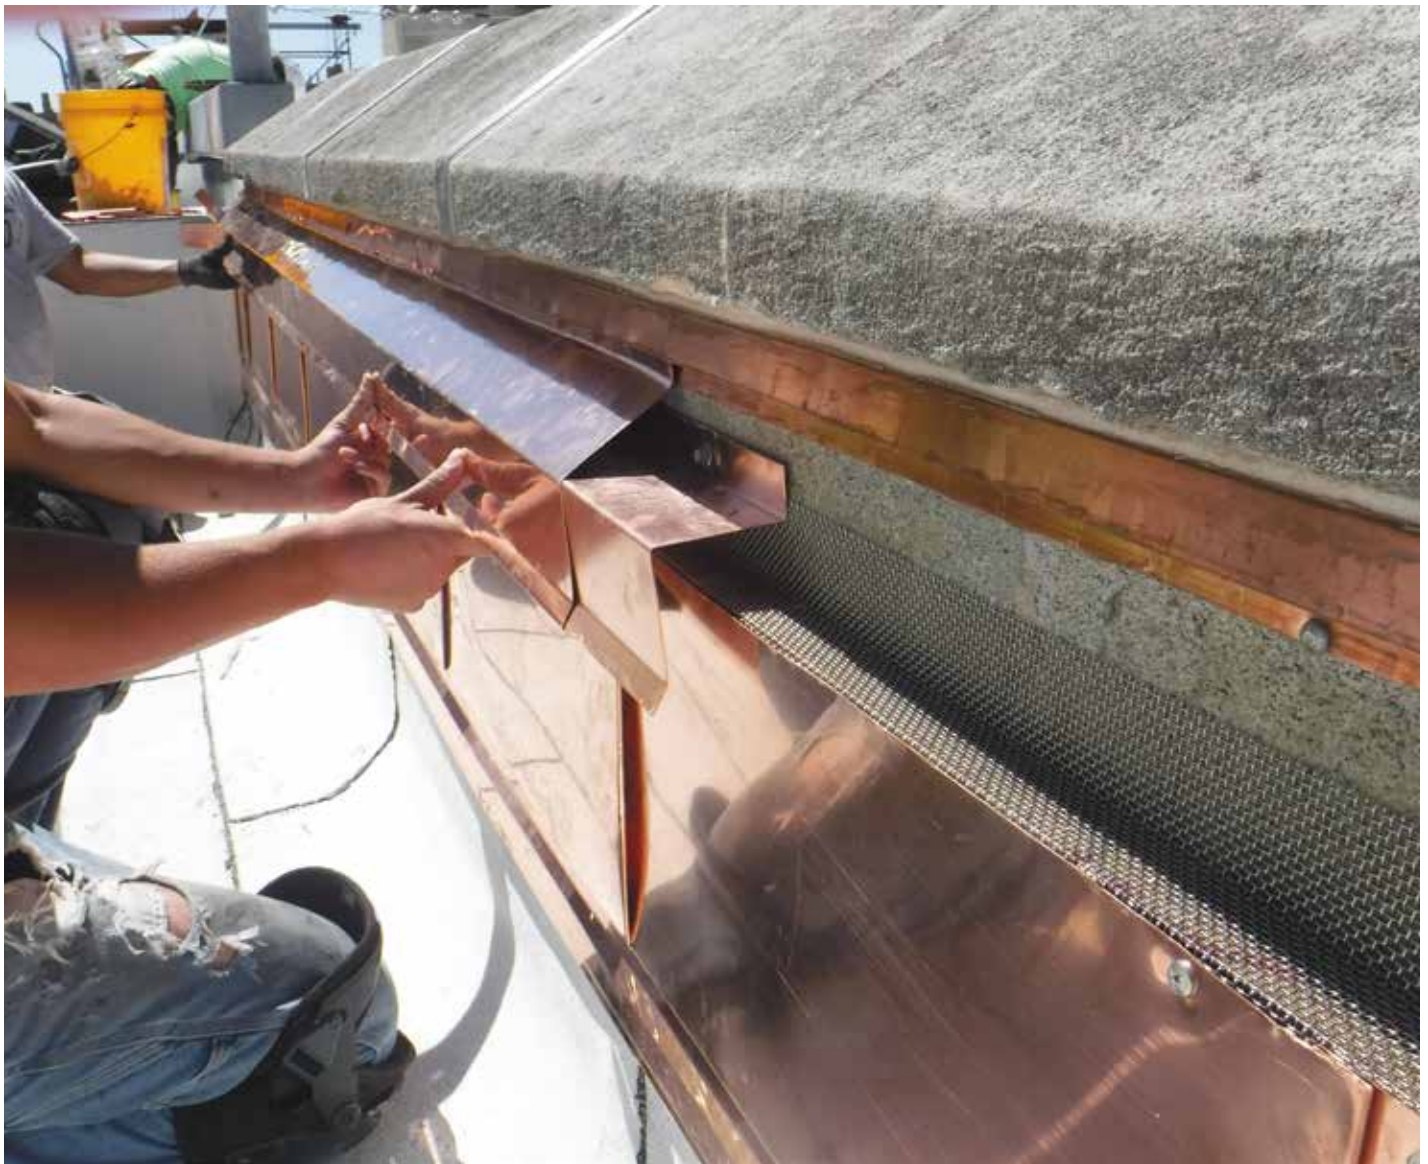
Figure 12. First in-place work of vented parapet wall assembly, including stainless steel insect screen and 32 oz copper hook strip for cap/counterflashing, providing a continuum of protection from above receiver for the through-wall flashing.

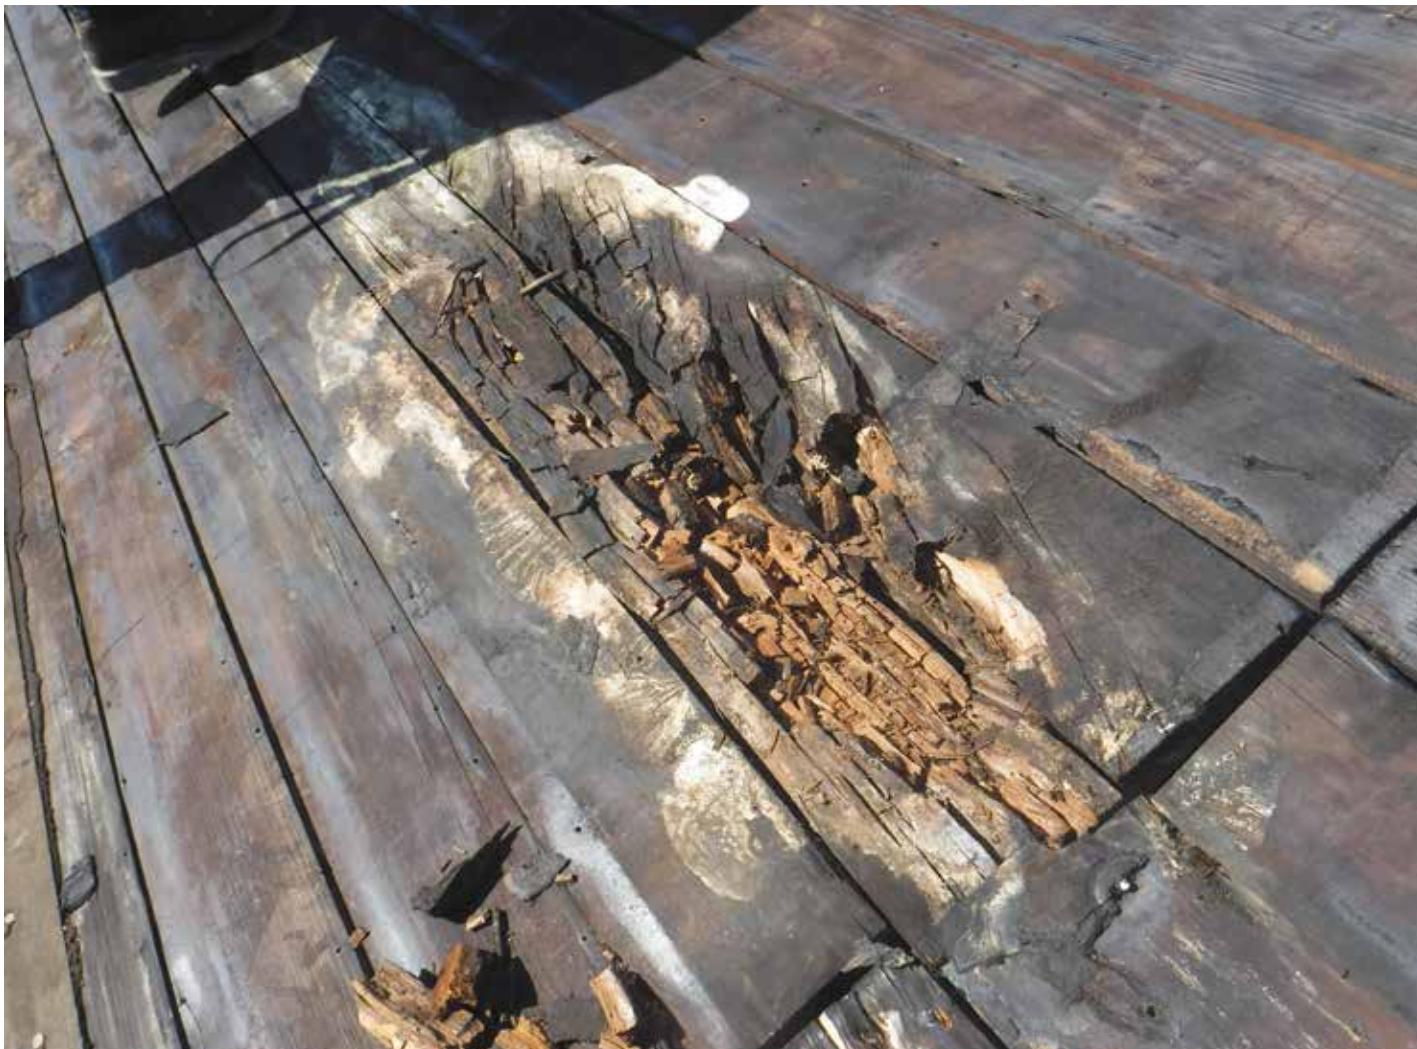
The inspection of the wood beams, purlins, and decking was undertaken topside as the existing roof cover was removed (**Fig. 13**).

Figure 13. Inspection and identification of bad decking (2.5 in. thick and 5.5 in. wide tongue and groove) was performed topside after the removal of the existing standing-seam roof, insulation, and underlayment.

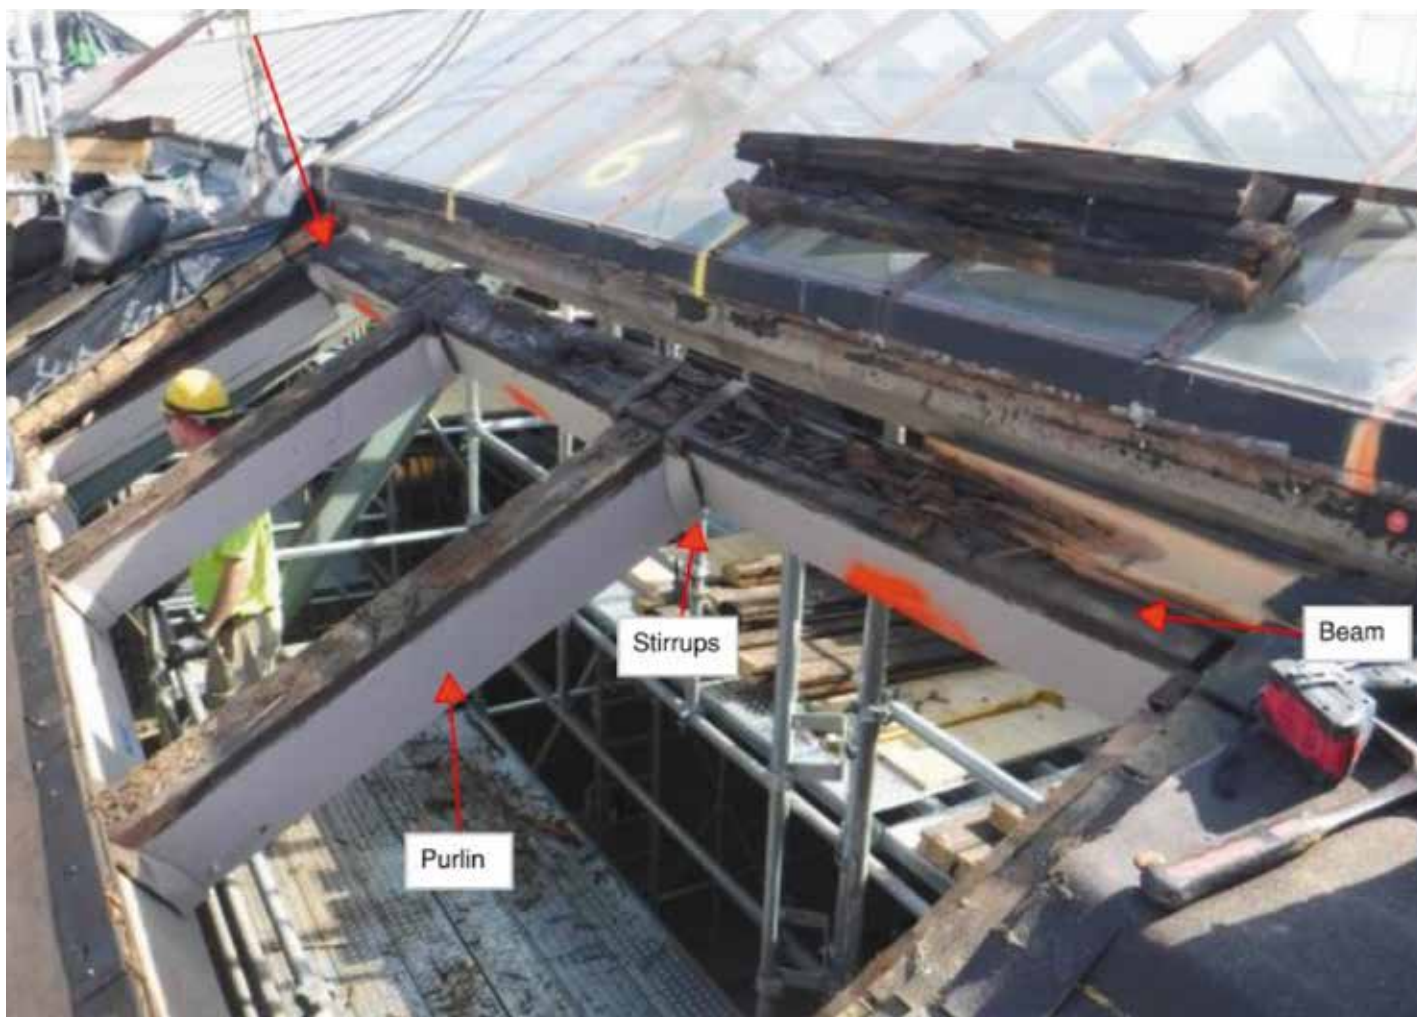
work platforms established just below the bottom chords of the steel trusses. About one dozen north-south wood beams and purlins were removed and replaced due to water damage (**Fig. 14**).

Figure 14. Decking removed, exposing water-damaged timber beam framing at base of original skylight curb. The beams ran north-south, intersecting with east-west purlin at regular intervals between the steel trusses. The purlin had to be removed to facilitate the replacement of the north-south beam.
