BUILDING ENVELOPE TECHNOLOGY SYMPOSIUM

REDINTEGRATION OF SANCTORUM – MULTIDISCIPLINARY HISTORIC REHABILITATION OF ROCKEFELLER MEMORIAL CHAPEL

DONALD KILPATRICK

INSPEC, Inc. • MILWAUKEE, WI

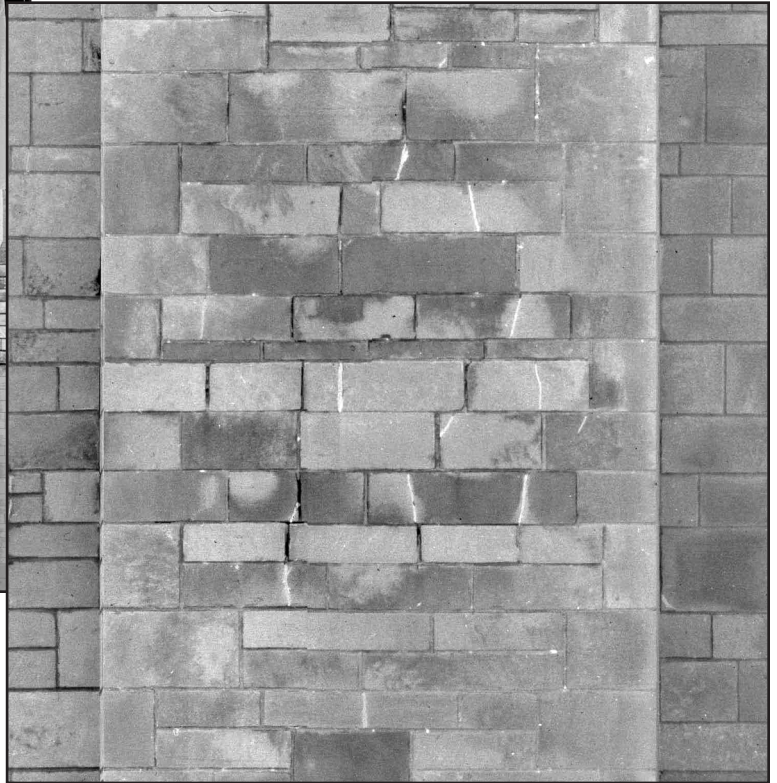
Photo 7 – Enlarged area of localized distress below tower balcony roof with failed drain leader.

repairs ranging from wholesale replacement to injection and patching (Photo 7).

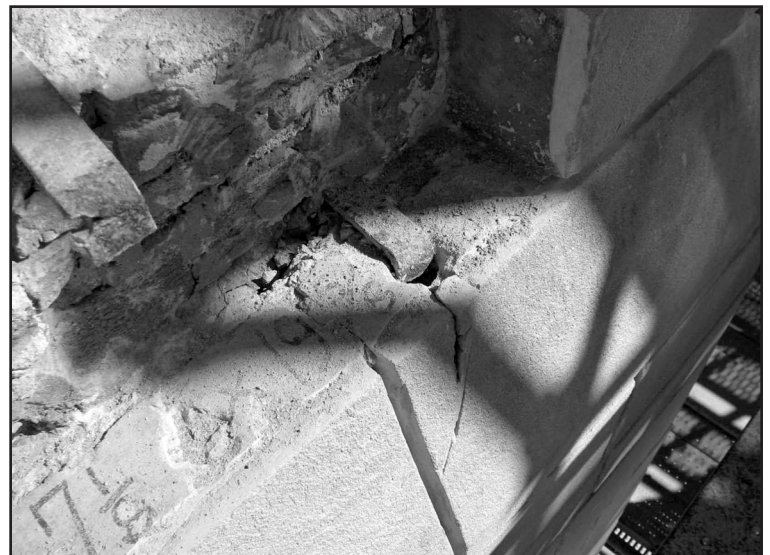
With corrodible metal within 2 in of the outer wall, cyclical exposure to moisture had resulted in rusting and volumetric expansion of the steel and cracking of the

Photo 8 – Typical stone distress resulting from corroded steel strap and/or the open cell (receiver) in the stone subjected to freeze/thaw damages.

stone (Photo 8). At the stone mullions of the major window openings, similar conditions exist, with the corrosion causing cracking that radiates from the centrally located steel pins. All replacement anchors, pins, and straps required for setting and repairing

stone are stainless steel. The tower turrets and pinnacle features above the nave roof will be completely torn down and rebuilt using stainless steel pins with provisions for new, galvanized tension rings.

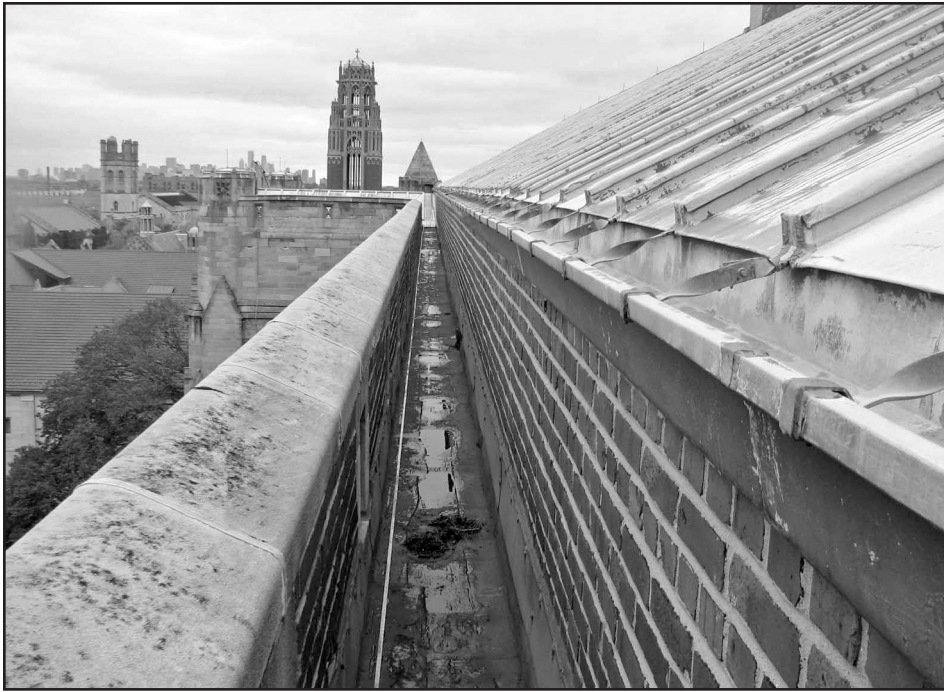
Photo 9 - Typical integral gallery at the east and west sides of the nave.

and adjacent parapet wall condition (Photo 9). These roof areas are serviced by wall-mounted exterior/interior drain heads that are routed to the attic, where they are combined with attached downspouts from the nave roof above. The revisions to the building drainage will require select demolition and reconstruction of the parapet wall features to accommodate new drain head elevations at a level that will ensure the required 1/8-in-per-ft slope on the new laterals on the attic interior from the south end of the building to the north end.

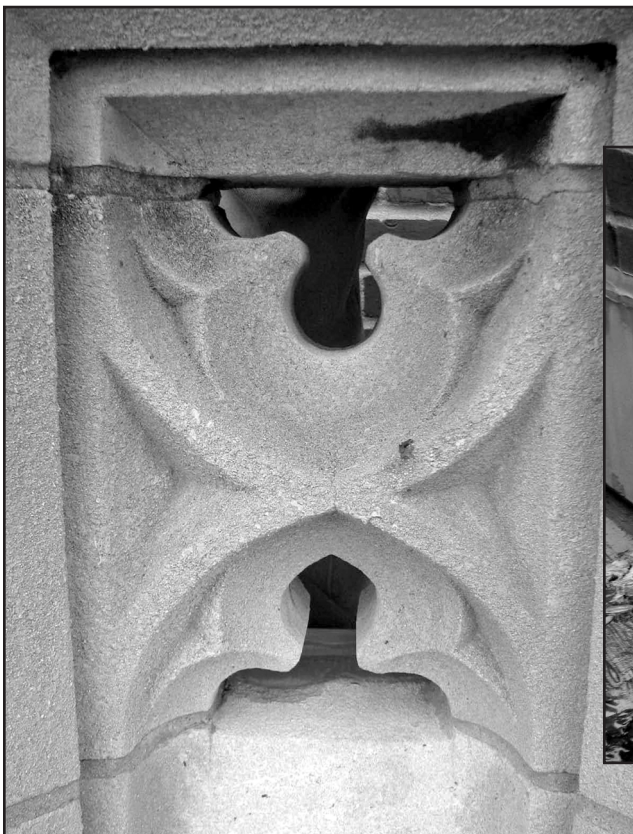
Photo 10 - Carved stone central to the three-stone set establishing the portal openings.

center stone will be removed and saw cut, salvaging the stone surround of the opening, and new pieces of similar ornamentation (less the opening through the wall) will be carved and set as in-fill. This will accommodate the final revised height of the finished integral gutter assembly, assuring positive slope to drain (Photos 10 and 11).

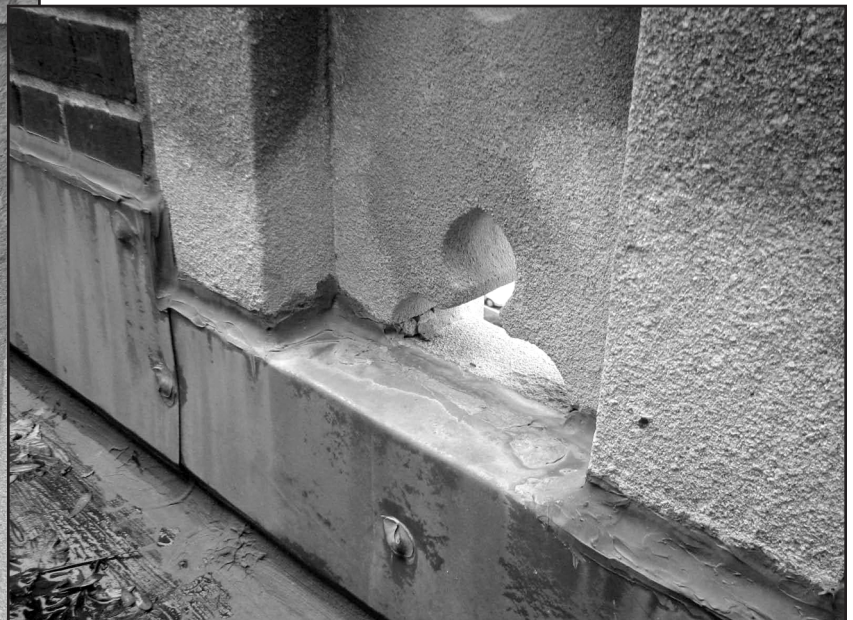
Photo 11 - Area of stone infill on roof side of parapet wall required to accommodate revised height of finished gallery roof.

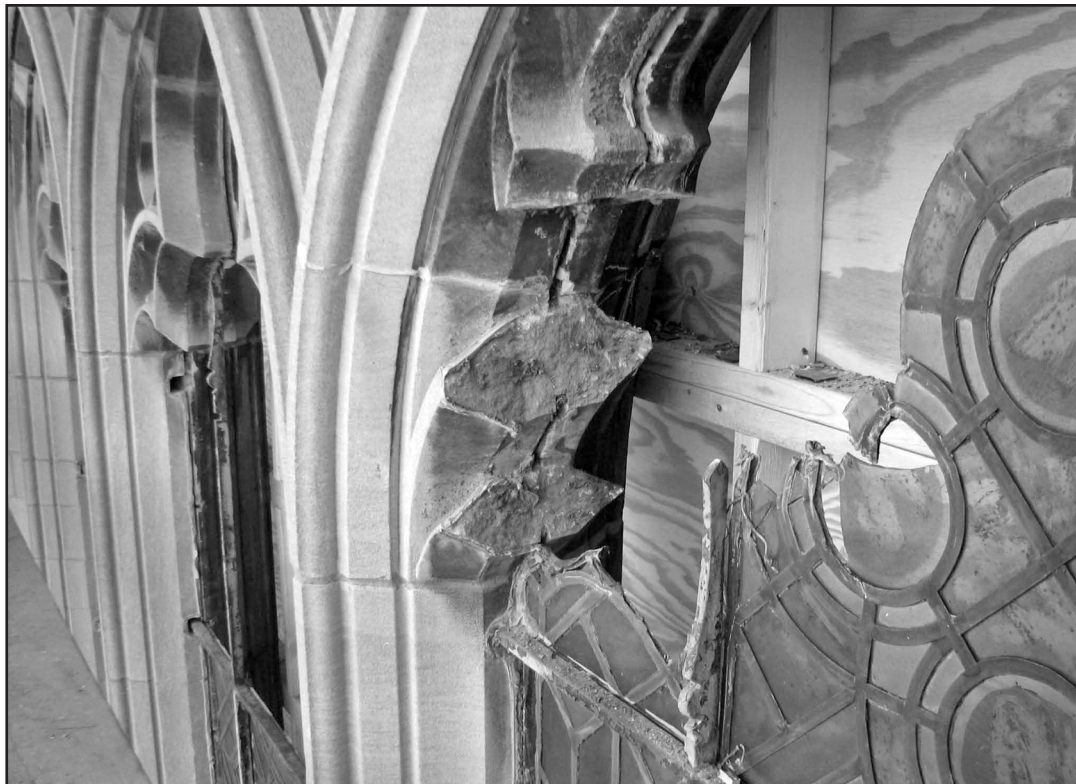
Photo 12 – At some locations, the stained glass and exterior support framing provided supplemental support to damaged stone tracery.

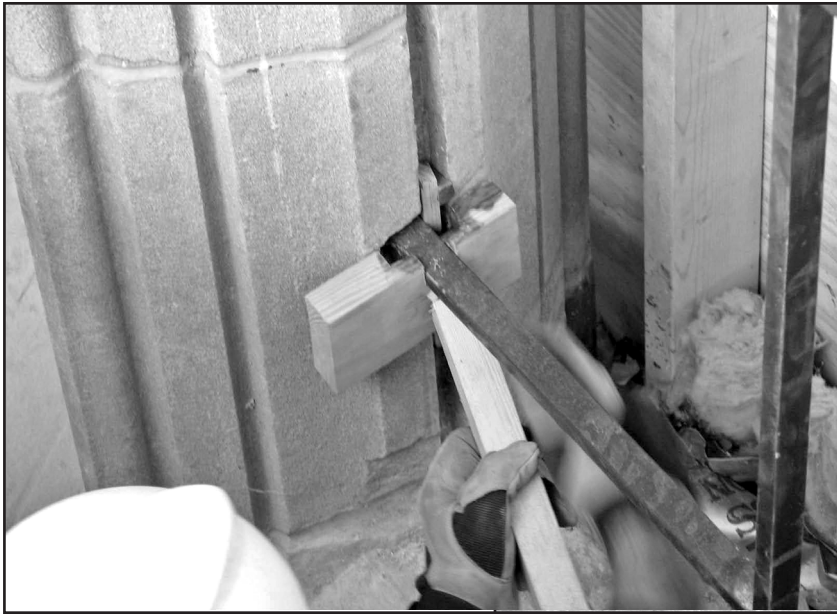
Photo 13 – Wood forms set in advance of pouring molten lead to fill the pocket in the stone surround.

the installation of molten lead in the pockets. Crucibles were used to heat the lead, which was poured around each of the bars interfaced with the stone. Wood forms were used to contain the molten lead in the pockets (*Photos 13 and 14*).

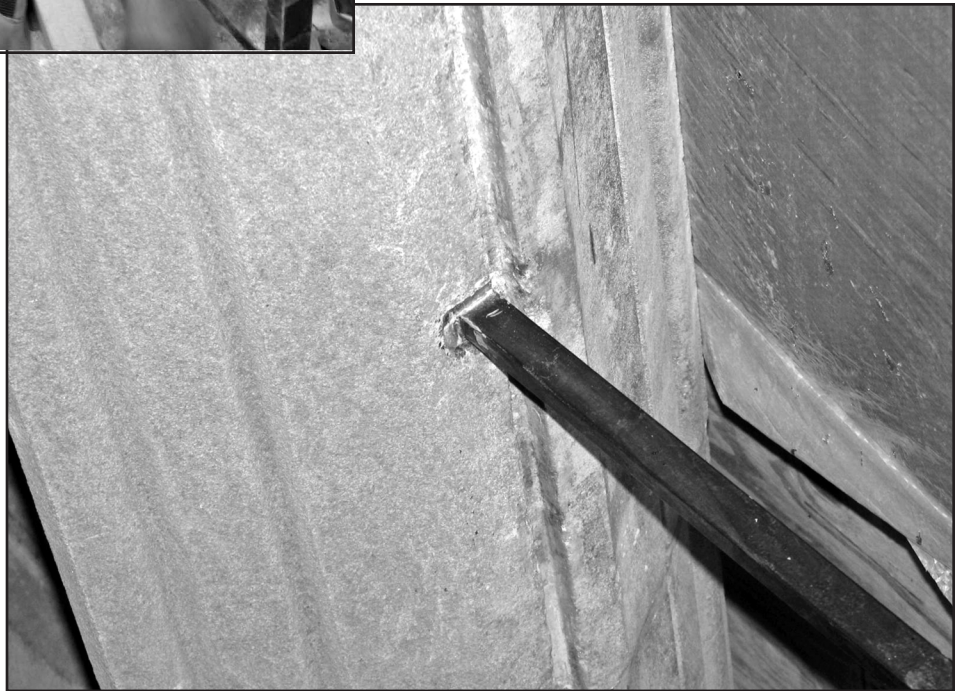
Photo 14 – Finished interface of exterior support bar framing and stone surround.

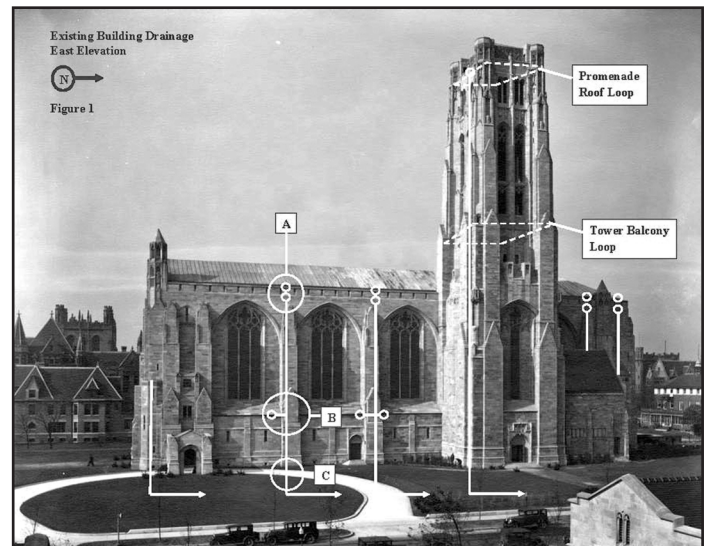
Figure 1 – Existing building drainage, east elevation.

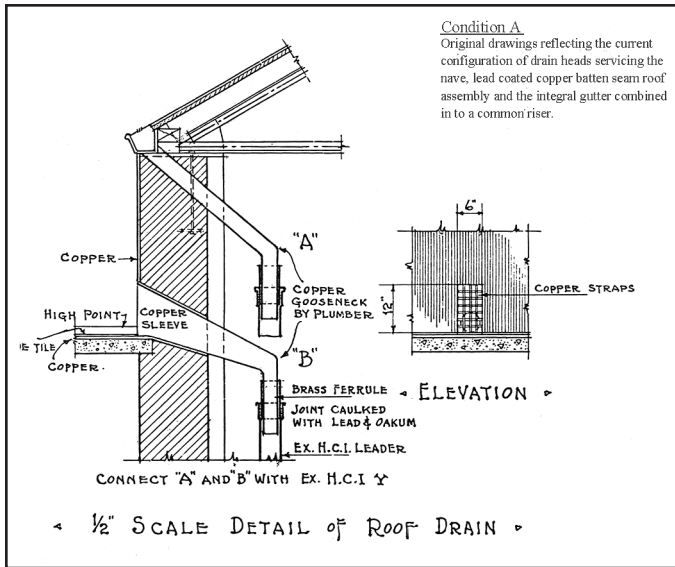
Figure 1, Condition A – Original drawings reflecting the current configuration of drain heads servicing the nave, lead-coated copper batten-seam roof assembly, and the integral gutter combined into a common riser.

This condition left the assembly susceptible to moisture damage, most notably in the form of corrosion of the steel beams, resulting in volumetric expansion and loss of concrete cover (fire protection). (See Photo 15.) Additional distress specific to this condition was noted in the outside face of the limestone cladding at and below the roofline. The drains, as small triangular roofs, are completely restricted, to the extent that water builds to level, exceeding the height of the membrane and accessory flashings. As a result, a significant volume of water has been essentially pumped into the high-mass walls, driving accelerated corrosion of mild steel straps anchoring the 4-in ashlar stones to the multiple-wythe masonry backup.

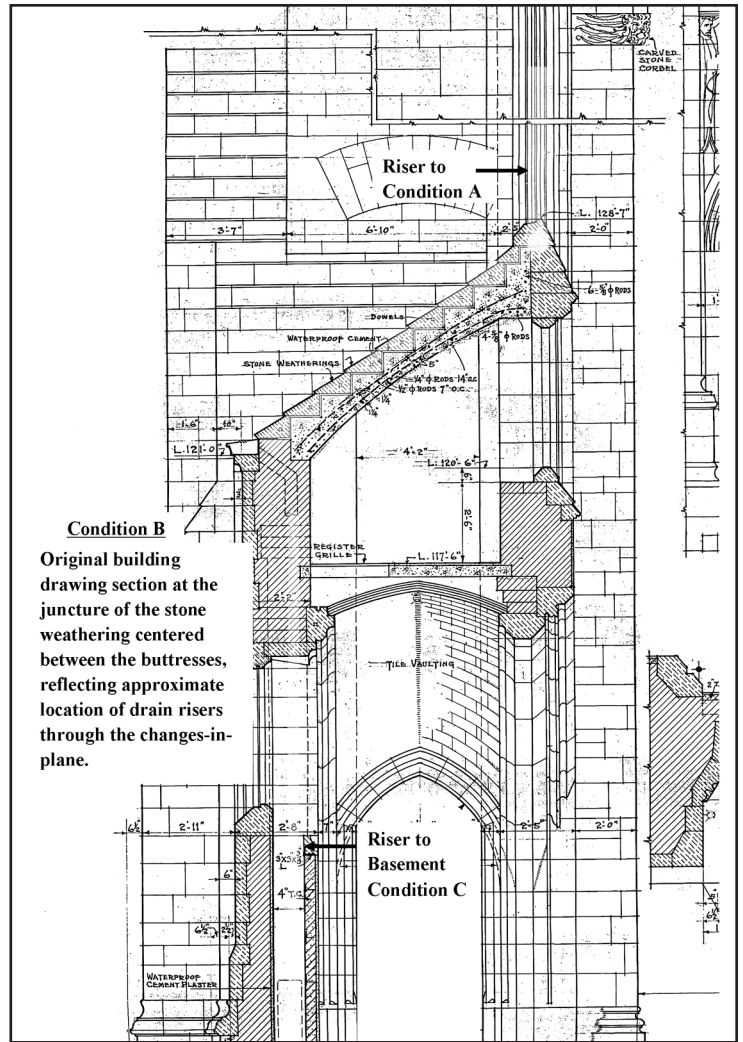
Figure 1, Condition B – Original building drawing section at the juncture of the stone weathering centered between the buttresses, reflecting approximate location of drain risers through the changes-in-plane.

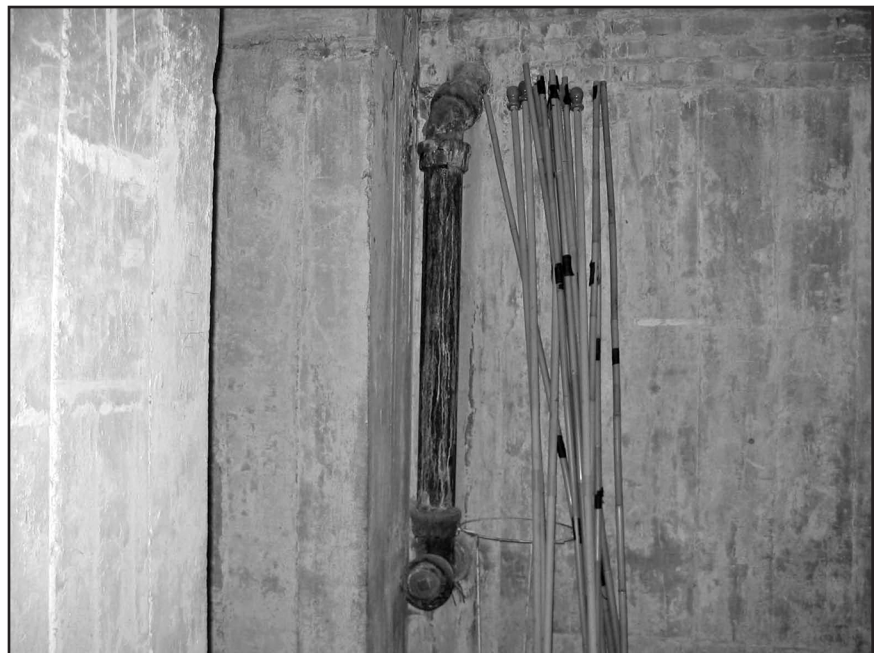
or side of the buttress and turn towards the building exterior, where the piping follows the contours established by the steel-reinforced, poured concrete deck for the stone weathering. The stone weathering roof areas are serviced by lead-coated copper gutters with one drain per segment on each side of the buttress as presented on the building exterior (Figure 1, Condition B). These drains are combined with the single riser dedicated to the nave drains and again are presented, with cleanouts, at regular intervals in the basement (Figure 1, Condition C).

Figure 1, Condition C – Typical drain leader exiting the confines of the buttress as presented in the basement.

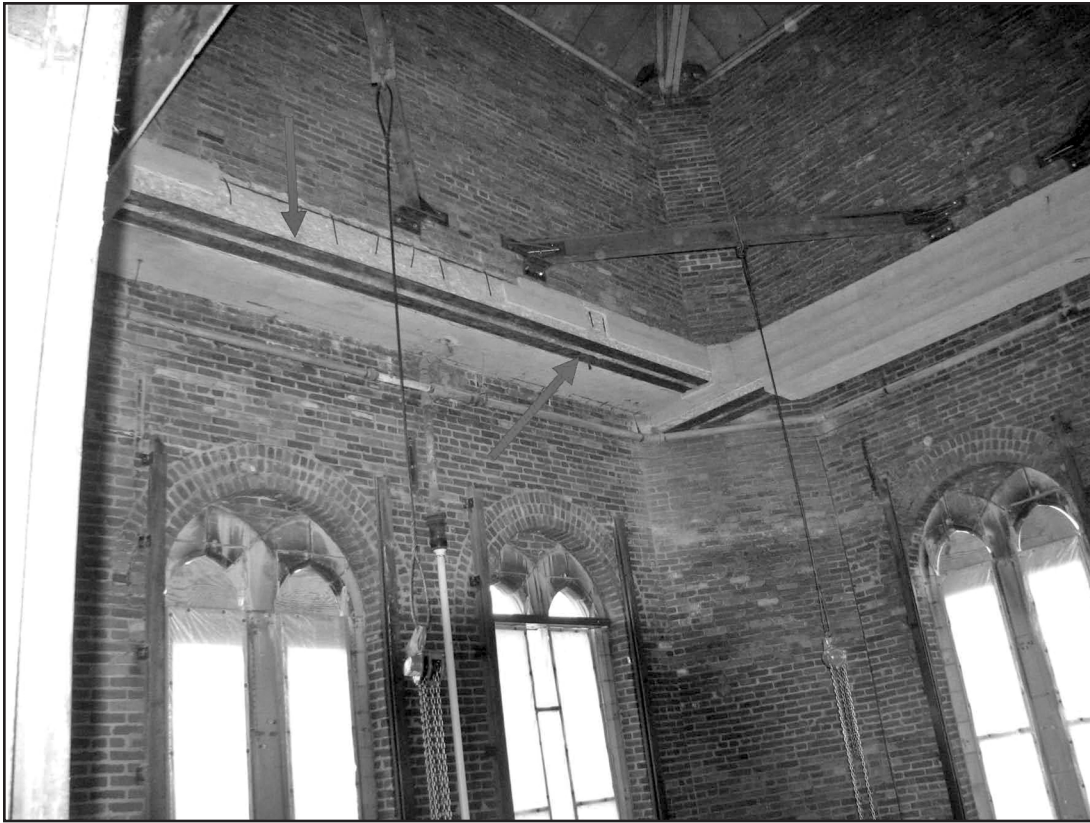
Photo 15 – Loss of concrete cover (fireproofing) at upper tower limits resulting in recurring water entry.

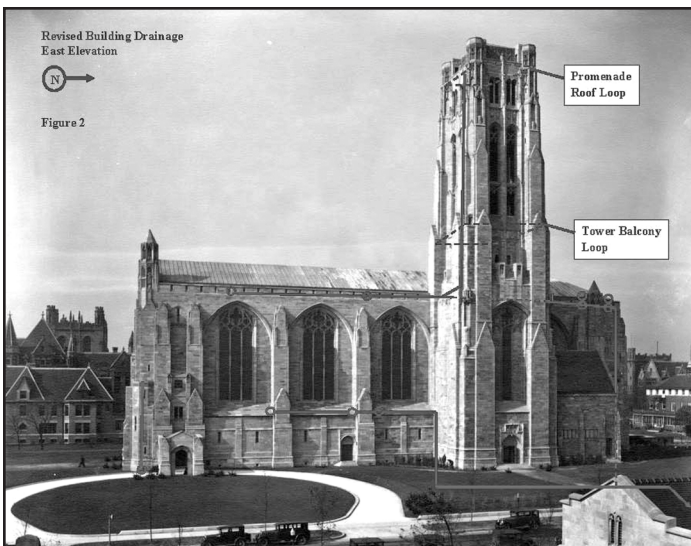
Figure 2 – Revised building drainage, east elevation.

replaced in kind, the new design focused on provisions that would accommodate the installation of a new system that would not require disruption of interior finishes. Design parameters must also acknowledge ease of installation and end use with respect to future maintenance and servicing. The resultant design maximizes the opportunity presented in the attic of the nave combined with available chase locations for risers on the north end of the

(attic laterals) new drain lines will be chased by a drip pan equipped with alarms. This redundancy in the design will provide reasonable assurance that leaks, should they occur as the new system is placed in service, will be contained. The drip pans will be connected to the primary risers on the east and west sides of the north end of the building. The new tower drainage will largely

be replaced in kind with respect to drain head and riser locations, with the noted exception found in its connection to the new east lateral above the vaulted ceiling as described above. The apparent lack of positive slope and relatively small pipe size as originally installed are believed to have been contributing factors to the time-weighted demise of the tower drainage systems. The new pipe size will be increased from 1½ to 2 in at the drain head and 4 inches in the closed loop, servicing the four tower-promenade roof drains in conjunction with increased slope to the primary riser on all drain leader laterals.

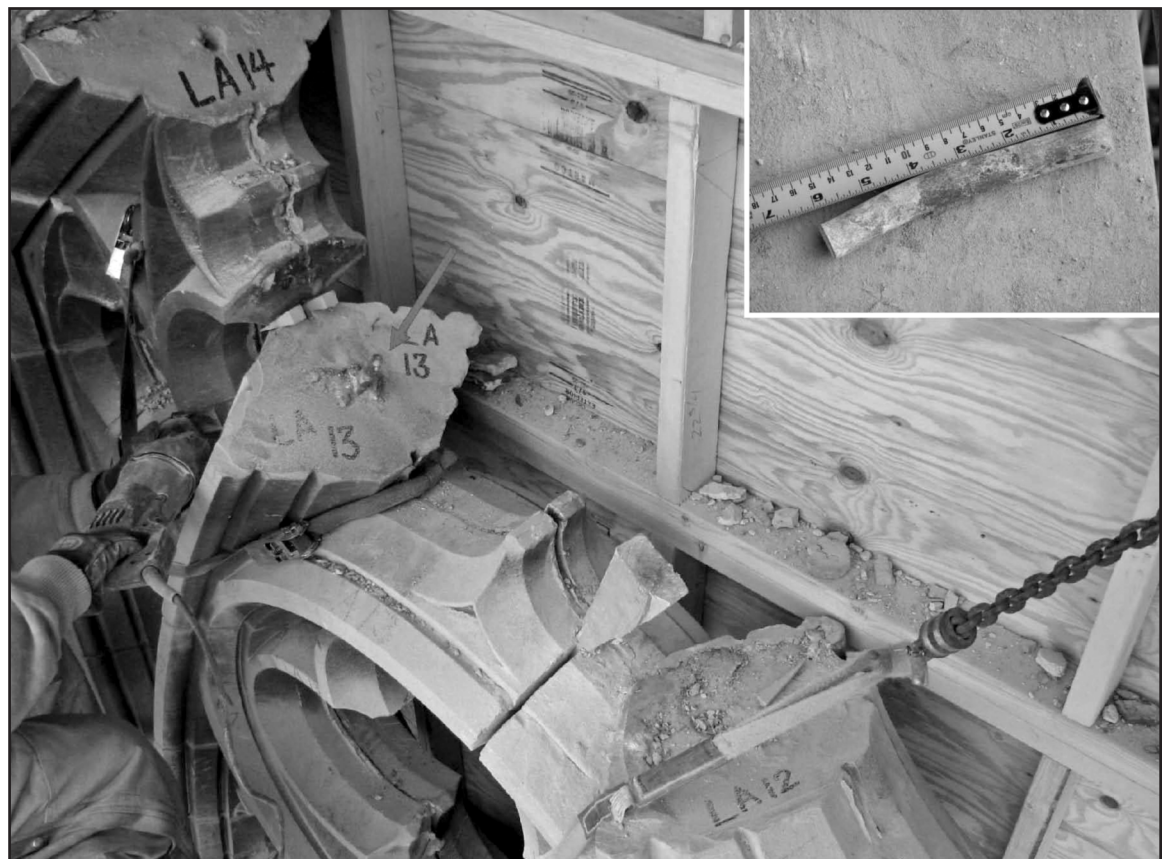
Photo 17 – Overall condition of steel pins at stone cusps from the organ loft window location.

dence to suggest that the processes of corrosion were contributory in whole or part to stones exhibiting distress conditions such as cracking and spall. This work was in part considered a large-scale inspection opening, while at the same time providing assurance that the restored Skinner organ would not be subjected to damages resulting from leaking windows.

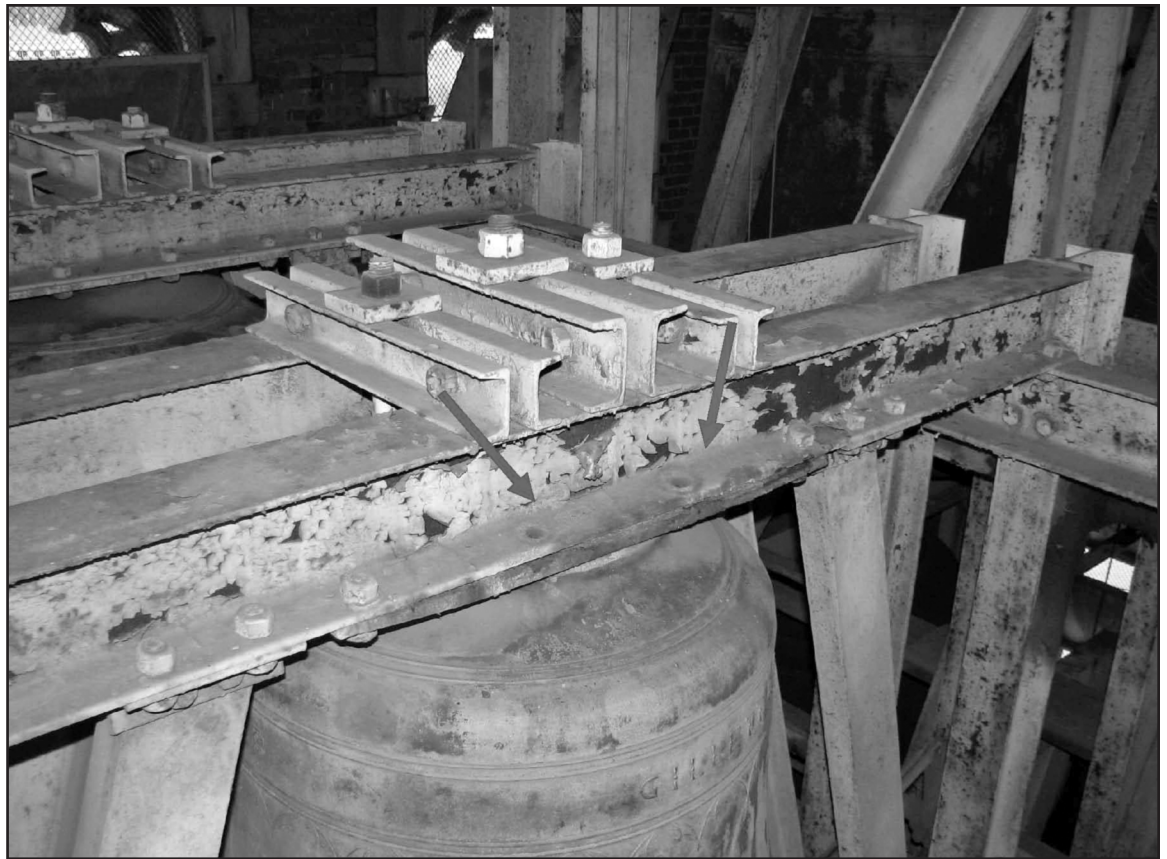
This increased work scope was deemed appropriate and necessary, based on present-day conditions affecting the structural steel framing, which was exhibiting severe areas of localized corrosion and measurable deflection, most notably in the floor slab of the playing cabin. It was also noted that mounting plates of the upper bells below the cabin had been subjected to damage from corrosion, with significant deflection, and in some instances, 3 to 4 bolts of an 8-bolt pattern had sheared, due to the volumetric expansion of the plate steel (Photo 19). The cause of the corrosion was determined to be stone tracery at the upper limits of the large louver openings, accepting water during periods of heavy, wind-driven rains. The revised louver design includes provisions for a custom louver assembly of minimal depth that will be installed behind the tracery to minimize the volume of wind-driven rain that enters the tower interior.

Photo 19 - Wind-driven rains entering the tower interior, resulting in heavy corrosion of steel plates and failure of bolted connections.
