INNOVATIVE WINDOW INJECTION TECHNIQUE SAVES OWNER \$500,000

BY DAVID CAMPBELL, RWC, AIA

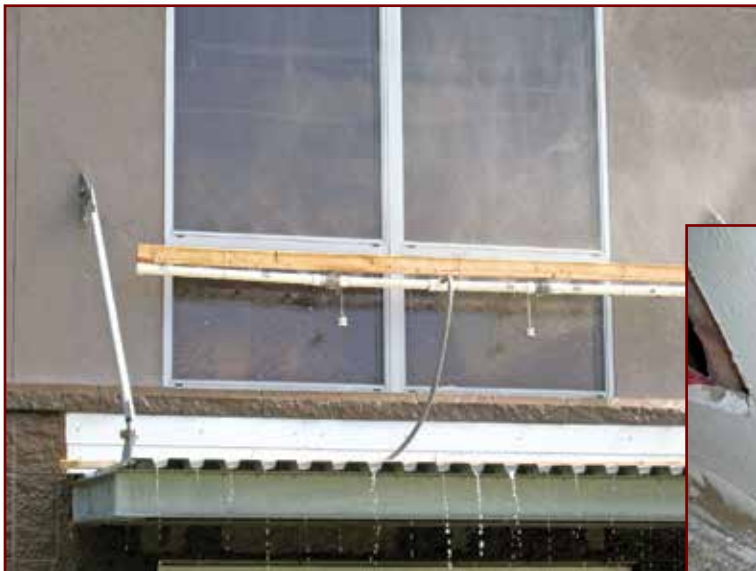
Inspec was hired to investigate the problem, determine the cause(s), and make remedial recommendations. Our investigation started with a systematic progression of spray-bar water testing at various suspect windows (Photo 1). The interior finishes were removed to better observe the infiltration into the wall system. By process of elimination, it was determined that the primary source of the infiltration was isolated to the windowsills. This was confirmed by flooding the window-sill tracks with water, which re-created the

Photo 1 – Spray-bar water testing.

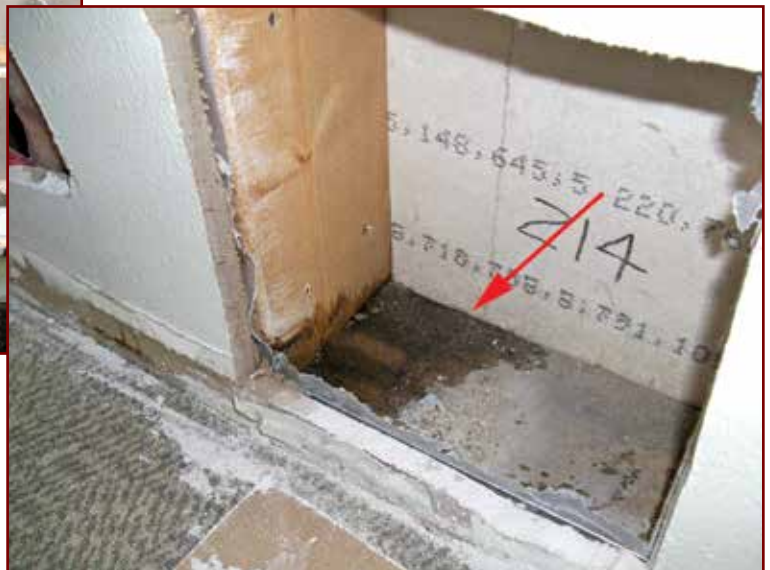
infiltration into the wall system between the window unit and the framed rough opening (Photo 2).

Photo 2 – Re-created water intrusion into wall system.

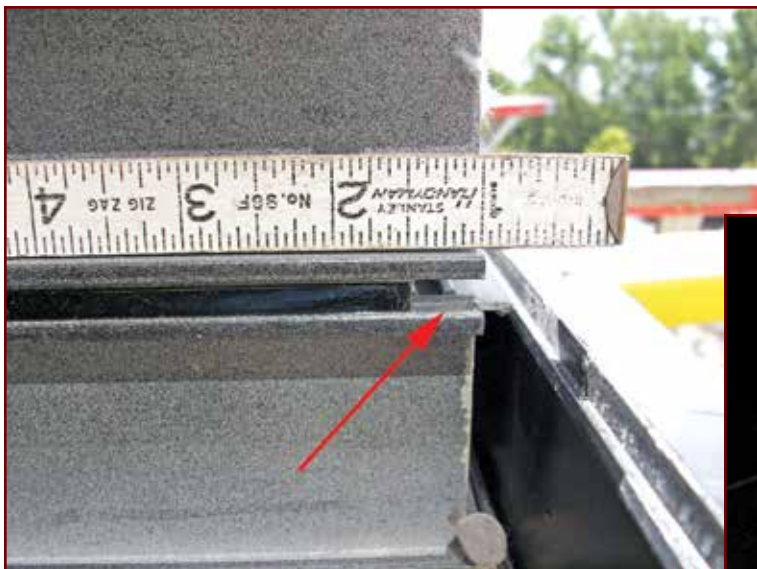
Photo 3 – The window thermal break had shrunk ½ in.

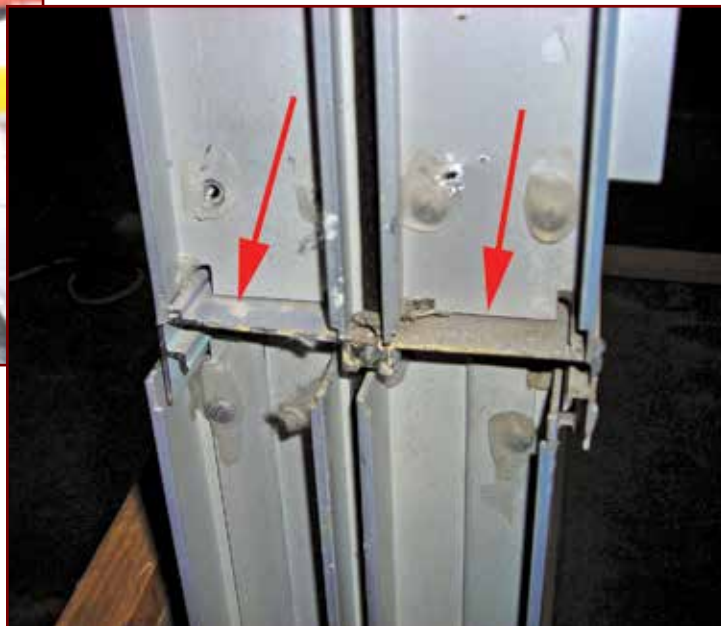
In addition, the exterior finish materials were removed around the window in order to examine installed flashings and weather-resistant barriers (WRB). Next, one window unit was completely removed and more closely examined for installation and/or design defects. It was discovered that some of the factory-installed gaskets, which provide a thermal break between the exterior and interior window components, had shrunk as much as one-half inch over time (Photo 3). It was also discovered that silicone sealant had not been installed at the base of the aluminum jamb plates (Photo 4).

Photo 4 – Silicone sealant missing.

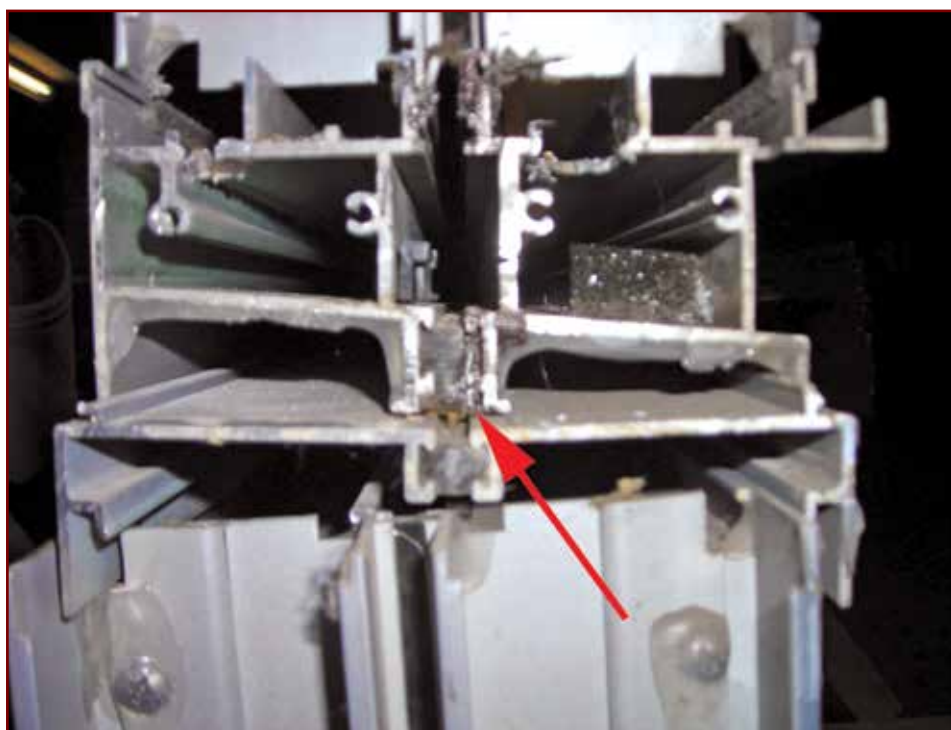
By removing the aluminum jamb plate, it is revealed that, in section, the operable windowsills are composed of two main chambers with a smaller chamber between them created by the thermal gasketing (Photo 5). The windowsill tracks are designed to drain through holes down into the corresponding chamber below, where the water then passes from chamber to chamber toward the exterior, following the chamber floor slope. Once in the exterior chamber, the water discharges through weep holes to the exterior of the window. Since the silicone sealant was not installed at the bottom of the jamb plate, the water that accumulates within the two main chambers also drains out the chamber ends at the jamb and enters the wall system between the window unit and the framed rough opening. In addition, the water in the middle gasket chamber enters the wall system in the same way, only through the opening created by the shrinking gasket at each jamb.

Photo 5 – Section through windowsill shows chamber created by thermal gasketing.
