# LOW-SLOPE ROOFS ARE ROTTING

BY  
**DWIGHT D. BENOY, P.E. AND  
PAMELA JERGENSEN CCS CCCA**

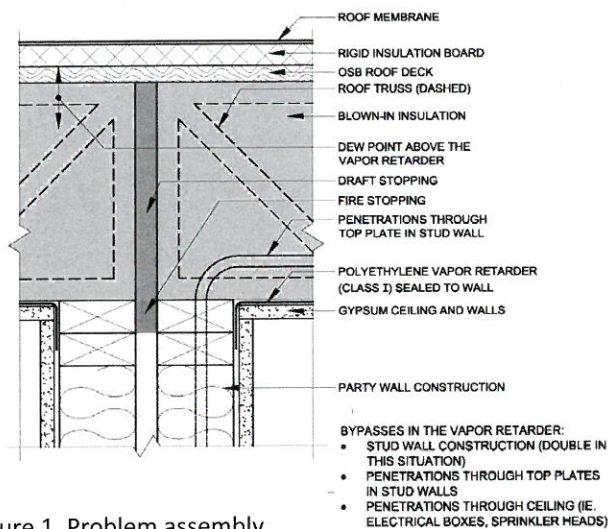
Figure 1. Problem assembly

The investigations found many bypasses in the vapor retarder that would allow the warm, moist interior air to migrate into the truss space (Figure 1). The party walls between apartment units, which were a double-stud wall construction, interrupted the continuity of the vapor retarder. Likewise, any interior partition walls resulted in a discontinuity in the vapor retarder at the ceiling. This was exacerbated by the penetrations through the top plate of the wall by plumbing stacks and wiring. Penetrations through the ceiling, such as sprinkler heads and electrical boxes for light fixtures, were also found not to be sealed to the vapor retarder.

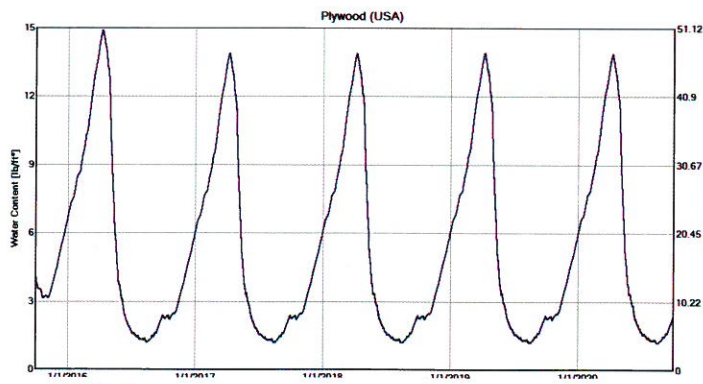
Figure 2.

Figure 2 is the hygrothermal model graph of the roof deck in the roof assembly shown in Figure 1, assuming the presence of vapor retarder bypasses, over a five-year period. The water content of the roof deck exceeds 19% for about 40% of the year, peaking in April. Calculating the dew point using traditional methods by selecting temperature and humidity conditions in January may not have shown the potential problem of excessive moisture in the system that peaks in April. The moisture damage to the roof deck, as observed in the field, strongly correlates to the hygrothermal model results.

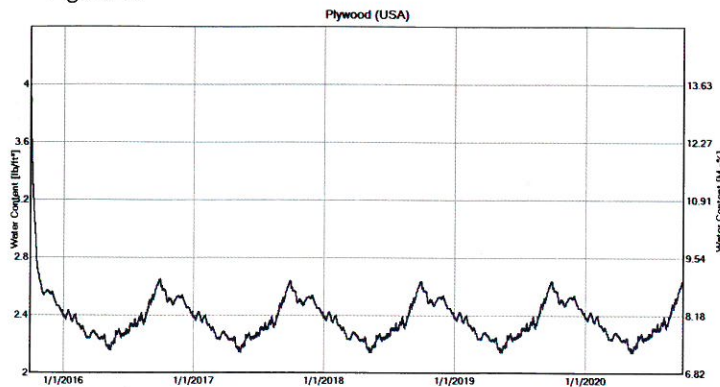
Figure 4.

Figure 4 is the hygrothermal model graph of the plywood roof deck in the roof assembly shown in Figure 3. This shows the moisture content of the plywood roof deck staying below 19% and actually drying out over time from its initial peak moisture content at the time of construction. Anecdotal observations of roofs similar to this design in place for 20 years or more substantiate the hygrothermal model results.

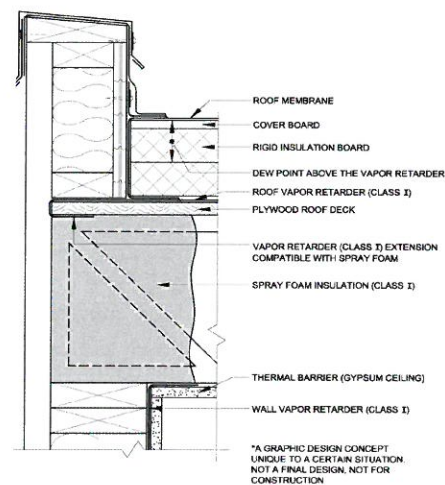
Figure 3. A general recommendation for a roof system and parapet detail

A more constructible approach would be to install a vapor retarder on the roof deck level (Figure 3). Some insulation could be installed in the truss space, but most of the insulation would need to be installed above the vapor retarder so that the dew point occurs above the vapor retarder. Insulating above the roof deck with rigid board insulation would be more expensive than insulating with blown-in insulation in the truss space. However, eliminating condensation is less expensive than costly repairs after the fact.

Installing the vapor retarder at the roof deck level affords a much better opportunity for achieving a complete vapor retarder. This would be a relatively easy way to provide continuity across party walls and to seal penetrations. The vapor retarder must also be continuous from the roof to the exterior walls. This might be accomplished by using spray foam insulation within the truss space at the exterior walls.

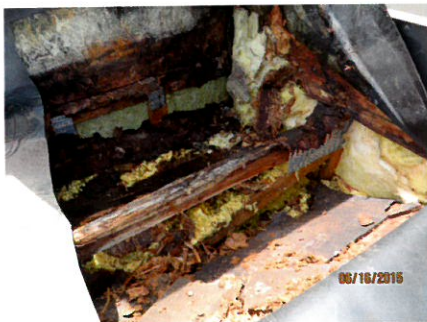
Invasive inspection openings made into the roof assembly revealed the OSB decking was severely deteriorated in many areas, such that it

could not support the roofing materials above. The top portion of the top cord of the wood trusses was also wet and rotted in some cases. The steel tie plates of the trusses were corroded. Framing lumber at the exterior walls in the truss space was also wet.

Photo #1 – Rotted deck

Recent investigations of three buildings in a northern climate clearly demonstrated the well-intended cost-saving measure to insulate within the truss space resulted in premature roof failure and expensive repairs. Those repairs included complete replacement of the roof covering and roof deck, along with repairs to the structural trusses and installation of new insulation. This was an expensive lesson from which we should all learn.

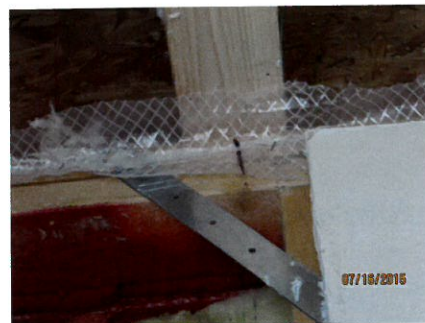
The polyethylene vapor retarder was turned down the vertical face of the exterior walls and lapped with the polyethylene vapor retarder of the wall, with the overlap sealed with plastic tape. At partition walls, the vapor retarder was attached to the vertical face of the top plate of the wall with a thin bead of adhesive. Overlaps in the ceiling vapor retarder were also sealed with plastic tape.

Photo #2 – Vapor retarder

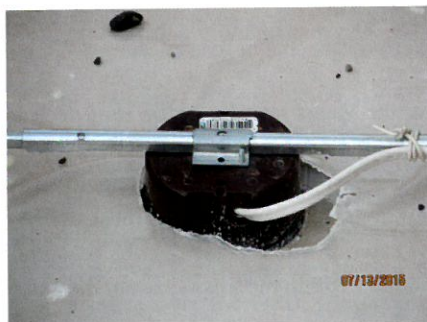
Photo #3 – Vapor retarder bypass at ceiling light electrical box.

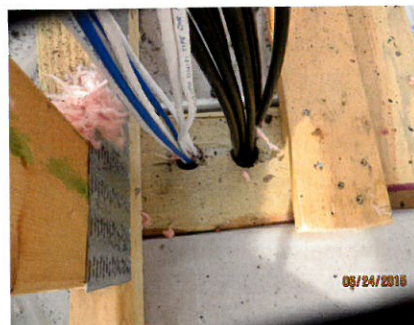
Photo #4 – Vapor retarder bypass through top plate of partition wall.

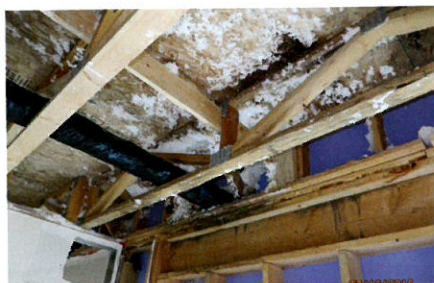
Two of the buildings had ducts from bathroom and dryer vents running through the truss space. Some of these ducts were not well-sealed at the joints, which introduced very moist air directly into the space where condensation was most likely to occur.

Photo #5 – Leaky dryer and bathroom vent ducts in truss space.
