## Optimized Design of Combined Disciplines:

# STEEP-SLOPE ROOFING AND EXTERIOR-WALL CLADDING

By Don Kilpatrick

### Project Profile — Phased Steep-Slope Roof/Exterior Wall Rehabilitation

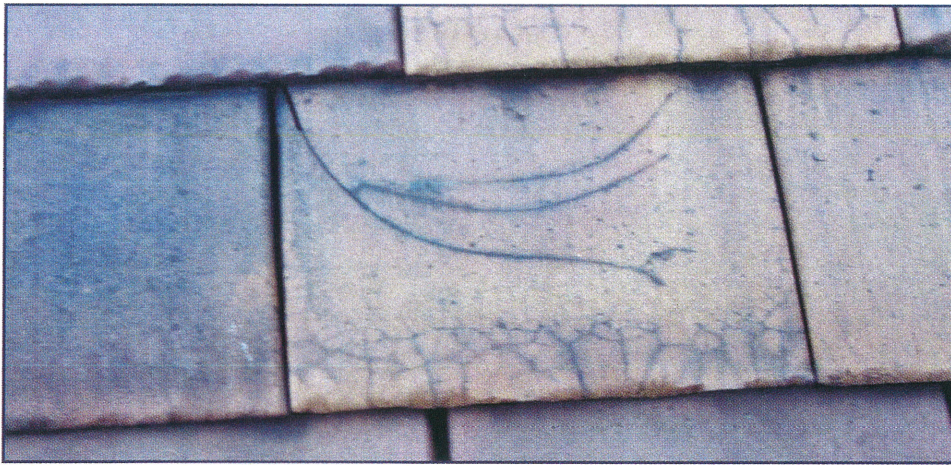
*Photo 5 – Typical condition of the tile in the field of the roof.*

exhibiting distress. Through a visual examination, it became apparent that the tiles were exhibiting severe cracking in sections, across the full dimension or thickness of the tiles (*Photo 5*). There was no apparent pattern to the cracking or evidence to suggest that it was induced by any impact.

Tiles were removed, and an initial rate-of-absorption test was performed. Interestingly, the results, when compared and contrasted to tile from other buildings in excess of 100 years of age, indicated the absorption rate for the failing tiles was, by volume, 30 to 40 times greater than that of the older materials that were not exhibiting distress or cracking. The findings supported the theory that the performance issues related to the tile were the result of water retention and subsequent freeze/thaw cycles. Understanding that the continued free-fall of fragmented clay tile to pedestrian areas below presented an unacceptable risk, the owner opted to install nets to catch the projectiles over the short term until funding for design and construction could be secured (*Photo 6*).

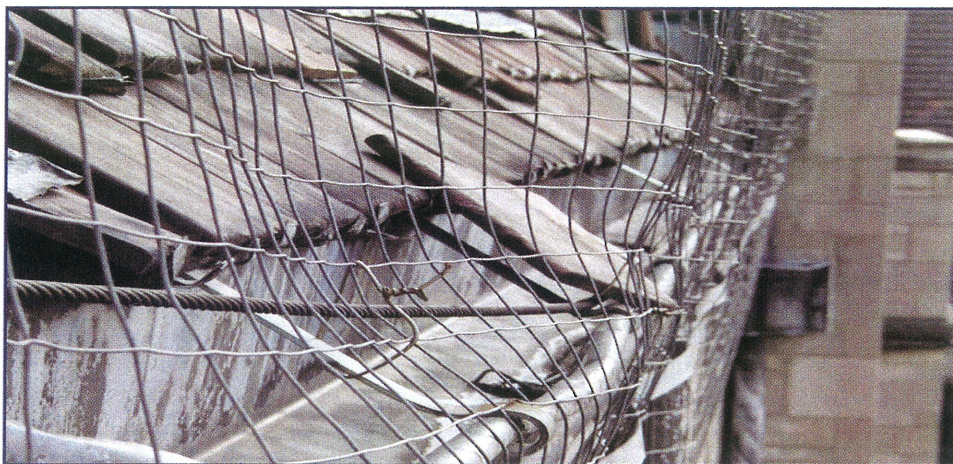
*Photo 6 – Netting installed as emergency response to falling tile.*

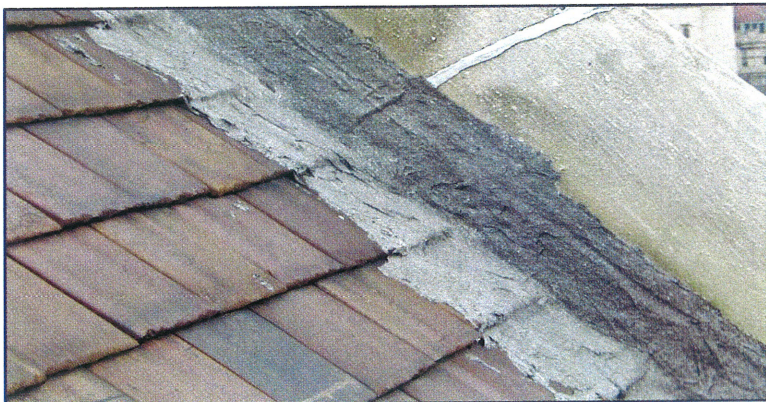
included a cursory inspection of the building's exterior walls, in part due to the readily discernable wall distress conditions in exterior-wall features (parapets) adjacent to and extending above rooflines. The roof side of the parapet and stone copings had been subjected to liberal applications of mastic-based repairs over the 75-year life cycle of the installation (*Photo 7*). Removed from the above-roofline features, it was noted that much of the stone cladding in close proximity to window heads was exhibiting out-of-plane movement and localized distress in the form of cracked, spalled stone.

*Photo 7 – Repeated applications of cold-process repairs at rakes with adjacent stone coping.*

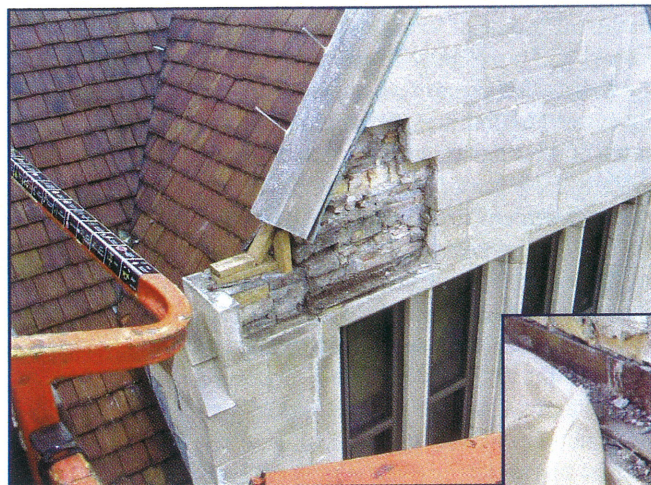
The aforementioned wall distress conditions were serious enough to warrant further review through selective removals in areas of interest to develop an improved understanding of the as-built conditions, most notably at the gabled roof features present at regular intervals across the primary N/S- and E/W-orientated wings of the facility. As suspected, concealed steel imbeds (loose steel lintels at the window heads) had been subjected to moisture, resulting in corrosion (*Photos 8 and 9*). The

*Photo 8 – Inspection opening at area of localized distress at gables.*

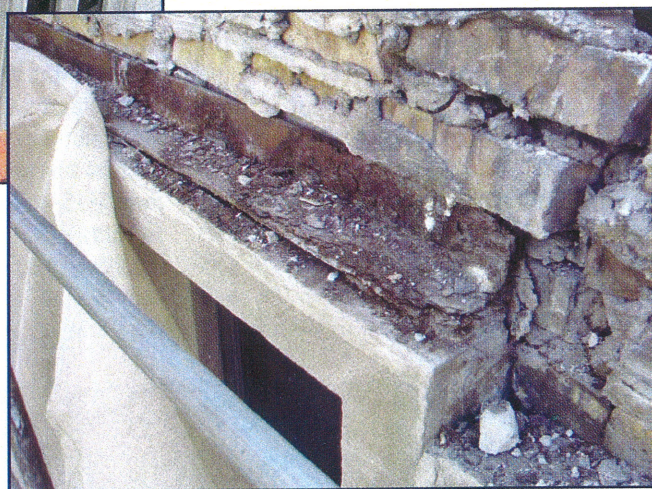
volumetric expansion of the steel had shifted the surrounding stone from its original setting. The above-described rust jacking (expansion of steel in sections due to corrosion) of the loose-set steel lintels established conditions warranting a complete rebuild of the backup materials with new steel and concrete-reinforced CMU wall sections. At several locations, it was noted that the overall length of the loose steel lintels fell short of the full span established by the window opening, with the ends not bearing of the jamb stones as would be prescribed by current engineering conventions (*Photo 10*). The presence of corrosion and the questionable integrity of the condition established by the incorrectly sized lintels provided justification for the complete rebuild of the stone-clad gables.

Further study showed cyclical exposure to moisture as the catalyst for the accelerated corrosion of the concealed steel imbeds (loose lintels) at this location. As originally constructed, a through-wall flashing was installed as a supplement to the stone cop-

*Photo 9 – Typical corrosion of loose steel lintels at window head of gable features.*

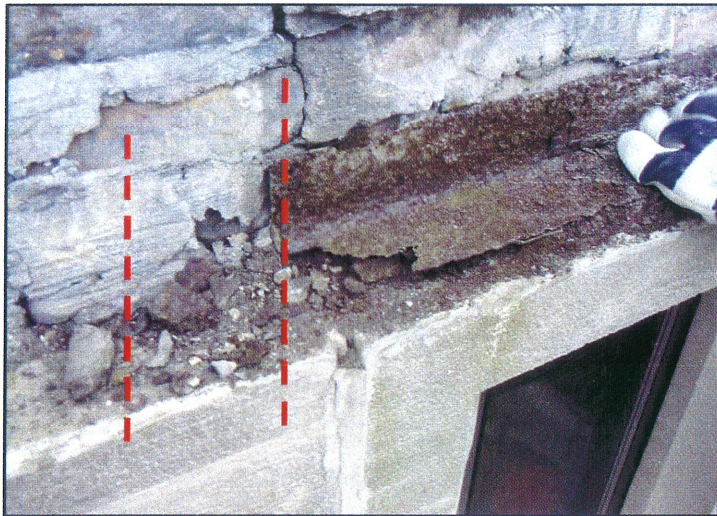
*Photo 10 – Loose steel lintels did not provide adequate span across the full dimension of the window opening. The area between the lines indicates approximate revised bearing limits of new steel window head lintel.*

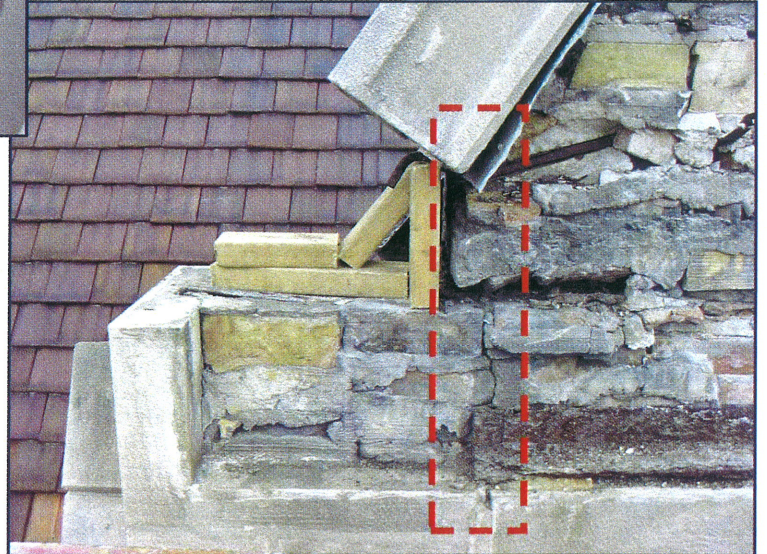
mined that the through-wall flashing was not continuous through the complex geometry of differing planes as established by the stone coping assemblies (*Photo 11*). The ultimate demise of wall cladding at this location can be attributed to this “disconnect” of the drainage plane as witnessed in the through-wall flashings below the stone coping.

*Photo 11 – Lack of continuity in through-wall flashing resulting in corrosion of loose steel lintel below.*

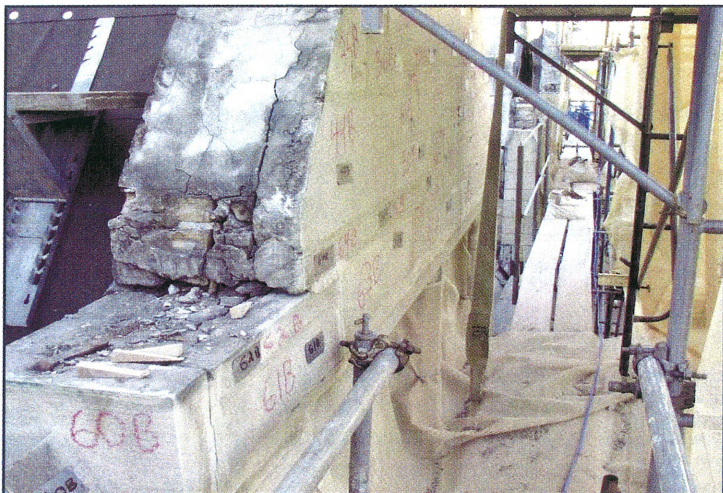
*Photo 12 – Cataloguing of stone cladding ahead of required selective removals for the gable, backup wall rebuild.*

The required selective removals of wall cladding materials to facilitate the removal and replacement of the damaged loose steel lintels typically stopped at the window heads (*Photo 12*). All stone copings and masonry backup materials were removed, exposing the timber framing of the roof deck (*Photo 13*). This accommodated the necessary modifications to the wood roof deck (cutting back flush with the timber frame) and the installation of “J” hooks that would be integrated with the new steel-reinforced CMU back-up wall as it was built up (*Photo 14*).

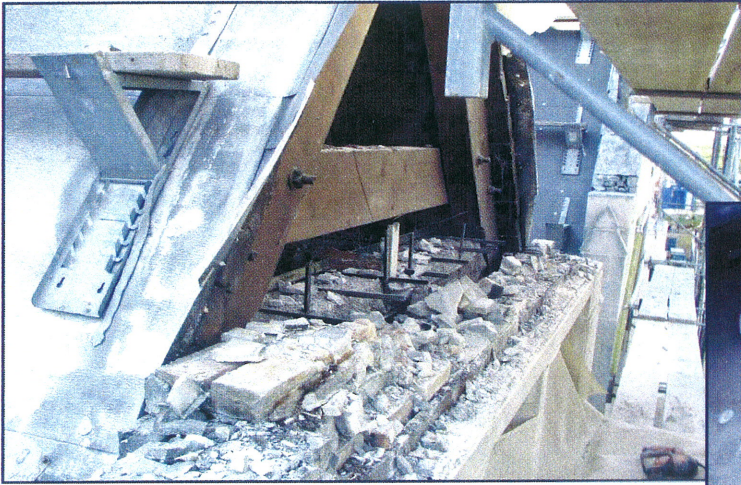
Photo 13 – General limits of demolition at gables with temporary roof covering established.

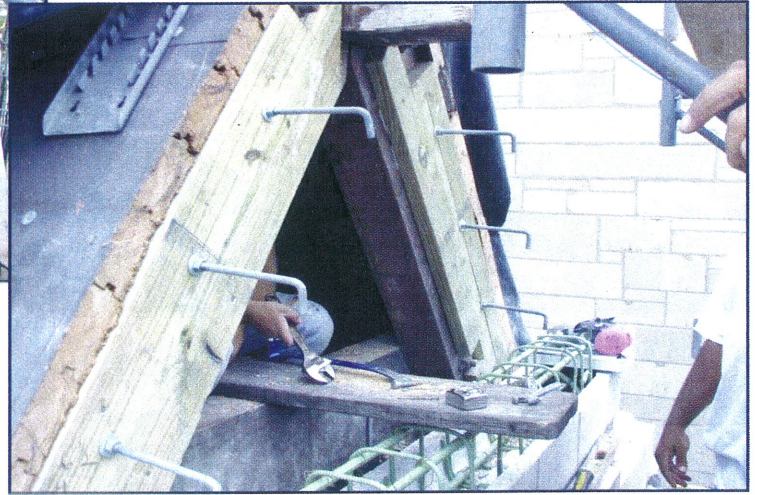
Photo 14 – Gable end rebuild with new bond beam and “J” hooks that will interface with fully grouted, steel-reinforced CMU backup wall.

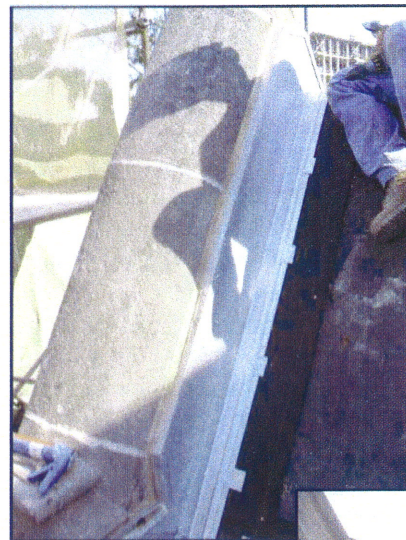
Photo 15 – Completely reinstalled stone coping with integrated through-wall and accessory counterflashing assembly ready for the installation of clay tile.

backup wall. Final roof system accessory flashings were integrated with the new through-wall flashing below the stone copings (Photo 15). With all masonry and new through-wall flashing components in place, the work area was turned over to the roofing contractor, and tile installation began (Photo 16).

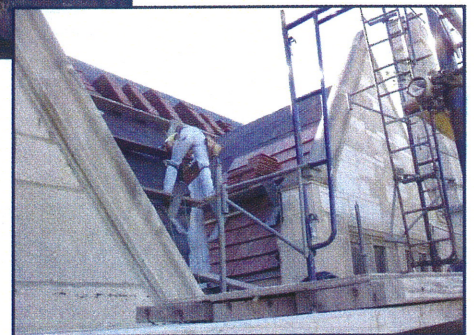
Photo 16 – Installation of clay tile subsequent to the completion of adjacent cladding repairs.
