Optimized Design of Combined Disciplines:

STEEP-SLOPE ROOFING AND EXTERIOR-WALL CLADDING

By Don Kilpatrick

Project Profile — Phased Steep-Slope Roof/Exterior Wall Rehabilitation

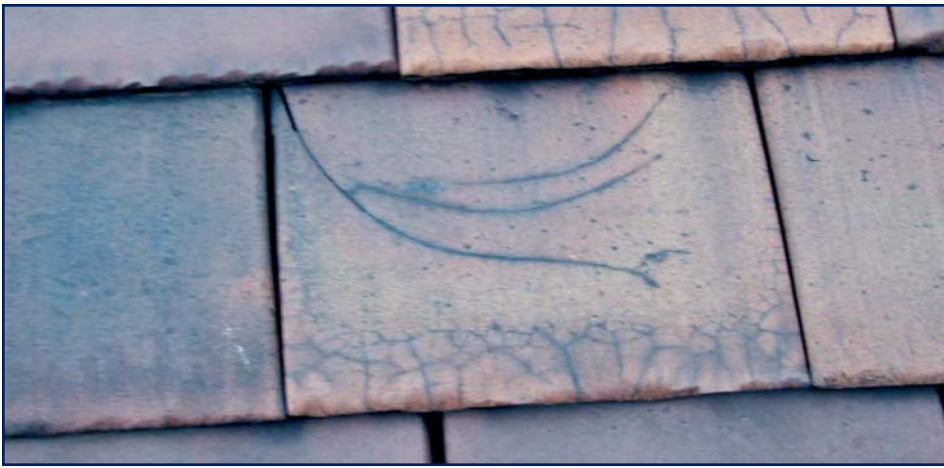
Photo 5 – Typical condition of the tile in the field of the roof.

exhibiting distress. Through a visual examination, it became apparent that the tiles were exhibiting severe cracking in sections, across the full dimension or thickness of the tiles (Photo 5). There was no apparent pattern to the cracking or evidence to suggest that it was induced by any impact.

Tiles were removed, and an initial rate-of-absorption test was performed. Interestingly, the results, when compared and contrasted to tile from other buildings in excess of 100 years of age, indicated the absorption rate for the failing tiles was, by volume, 30 to 40 times greater than that of the older materials that were not exhibiting distress or cracking. The findings supported the theory that the performance issues related to the tile were the result of water retention and subsequent freeze/thaw cycles. Understanding that the continued free-fall of fragmented clay tile to pedestrian areas below presented an unacceptable risk, the owner opted to install nets to catch the projectiles over the short term until funding for design and construction could be secured (Photo 6).

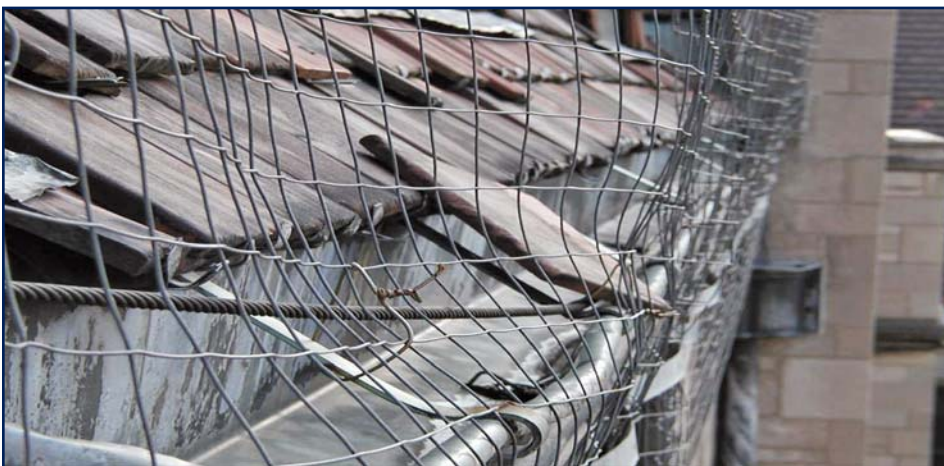
Photo 6 – Netting installed as emergency response to falling tile.

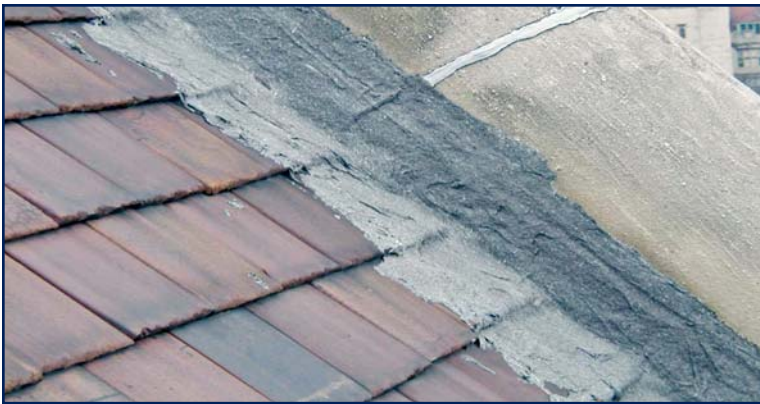
included a cursory inspection of the building's exterior walls, in part due to the readily discernable wall distress conditions in exterior-wall features (parapets) adjacent to and extending above rooflines. The roof side of the parapet and stone copings had been subjected to liberal applications of mastic-based repairs over the 75-year life cycle of the installation (Photo 7). Removed from the above-roofline features, it was noted that much of the stone cladding in close proximity to window heads was exhibiting out-of-plane movement and localized distress in the form of cracked, spalled stone.

Photo 7 – Repeated applications of cold-process repairs at rakes with adjacent stone coping.

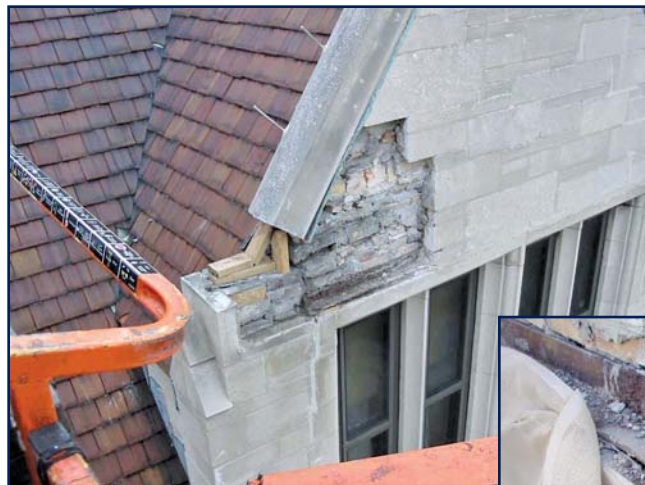
The aforementioned wall distress conditions were serious enough to warrant further review through selective removals in areas of interest to develop an improved understanding of the as-built conditions, most notably at the gabled roof features present at regular intervals across the primary N/S- and E/W-orientated wings of the facility. As suspected, concealed steel imbeds (loose steel lintels at the window heads) had been subjected to moisture, resulting in corrosion (Photos 8 and 9). The

Photo 8 – Inspection opening at area of localized distress at gables.

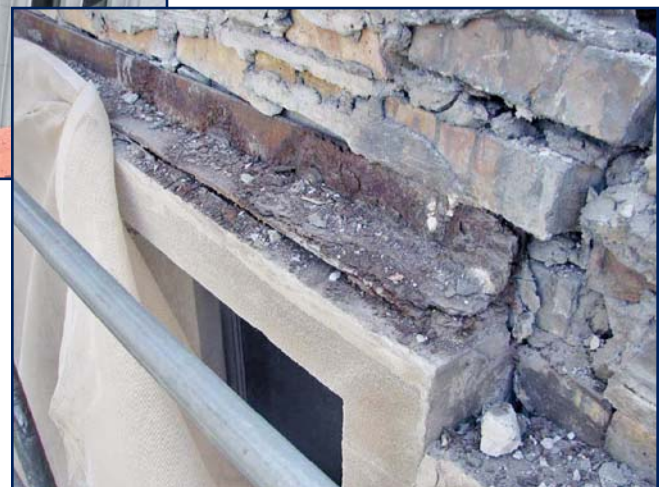
volumetric expansion of the steel had shifted the surrounding stone from its original setting. The above-described rust jacking (expansion of steel in sections due to corrosion) of the loose-set steel lintels established conditions warranting a complete rebuild of the backup materials with new steel and concrete-reinforced CMU wall sections. At several locations, it was noted that the overall length of the loose steel lintels fell short of the full span established by the window opening, with the ends not bearing of the jamb stones as would be prescribed by current engineering conventions (*Photo 10*). The presence of corrosion and the questionable integrity of the condition established by the incorrectly sized lintels provided justification for the complete rebuild of the stone-clad gables.

Photo 9 – Typical corrosion of loose steel lintels at window head of gable features.

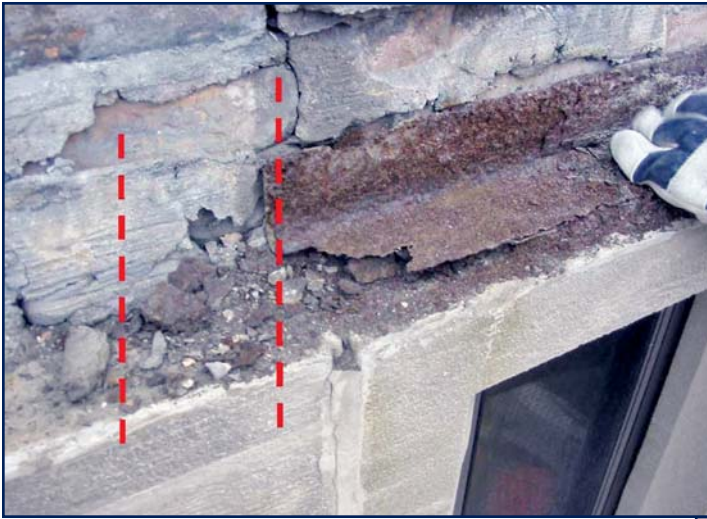
Photo 10 – Loose steel lintels did not provide adequate span across the full dimension of the window opening. The area between the lines indicates approximate revised bearing limits of new steel window head lintel.

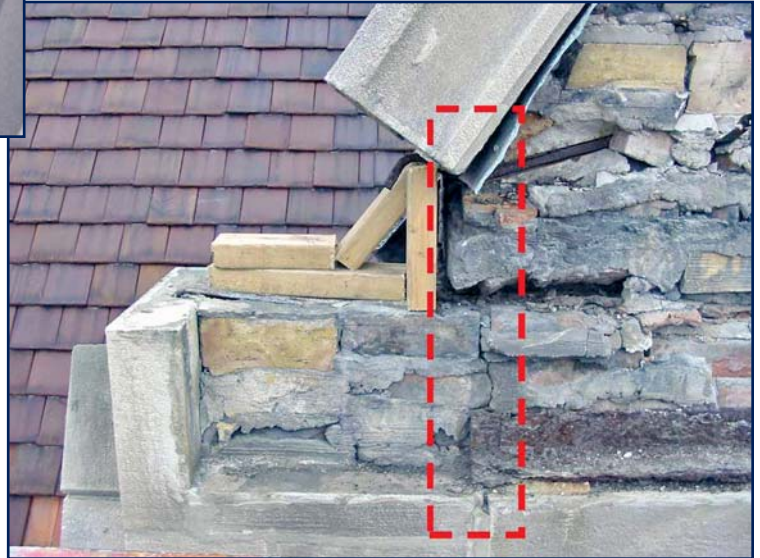
Further study showed cyclical exposure to moisture as the catalyst for the accelerated corrosion of the concealed steel imbeds (loose lintels) at this location. As originally constructed, a through-wall flashing was installed as a supplement to the stone cop-

ing, replete with an extended downward or vertical break on the roof side to provide coverage for the accessory flashings for the tile roof assembly. As previously stated, liberal applications of mastic were present through this change in plane from the roof to the stone copings. Removal of the stone coping at the transition of the sloped-rake roof edge to the short, horizontally oriented coping at the base of the gables was very instructive. At this location, it was deter-

mined that the through-wall flashing was not continuous through the complex geometry of differing planes as established by the stone coping assemblies (*Photo 11*). The ultimate demise of wall cladding at this location can be attributed to this “disconnect” of the drainage plane as witnessed in the through-wall flashings below the stone coping.

Photo 11 – Lack of continuity in through-wall flashing resulting in corrosion of loose steel lintel below.

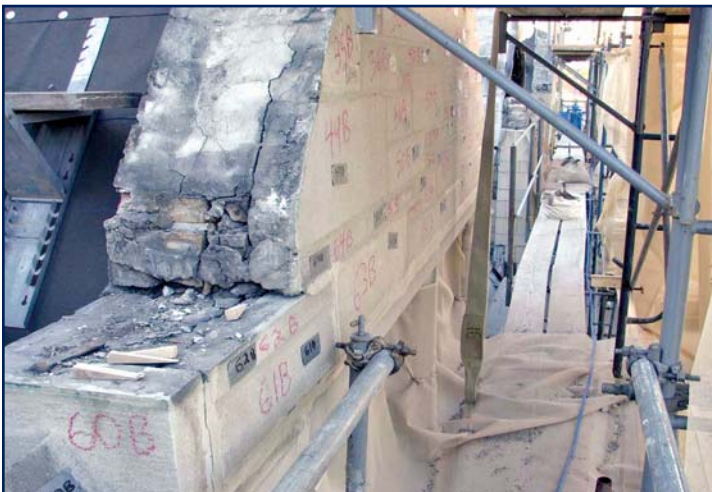
Photo 12 – Cataloguing of stone cladding ahead of required selective removals for the gable, backup wall rebuild.

The required selective removals of wall cladding materials to facilitate the removal and replacement of the damaged loose steel lintels typically stopped at the window heads (*Photo 12*). All stone copings and masonry backup materials were removed, exposing the timber framing of the roof deck (*Photo 13*). This accommodated the necessary modifications to the wood roof deck (cutting back flush with the timber frame) and the installation of “J” hooks that would be integrated with the new steel-reinforced CMU back-up wall as it was built up (*Photo 14*).

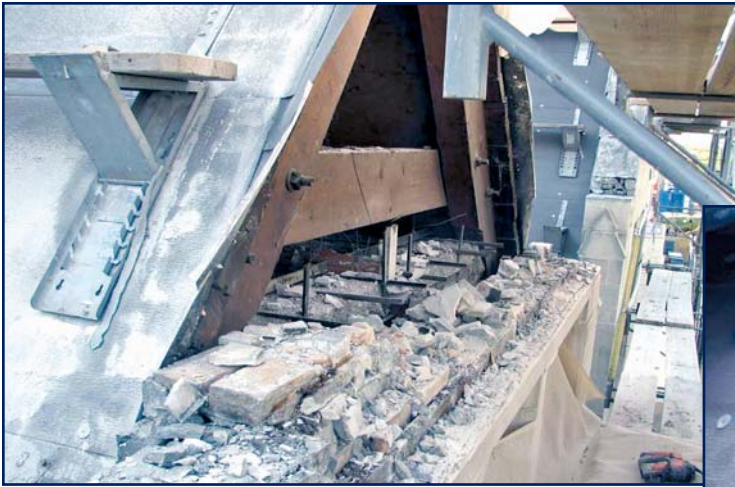
Photo 13 – General limits of demolition at gables with temporary roof covering established.
