WINDOW RECEPTORS

Notes From the Field

By Don Kilpatrick

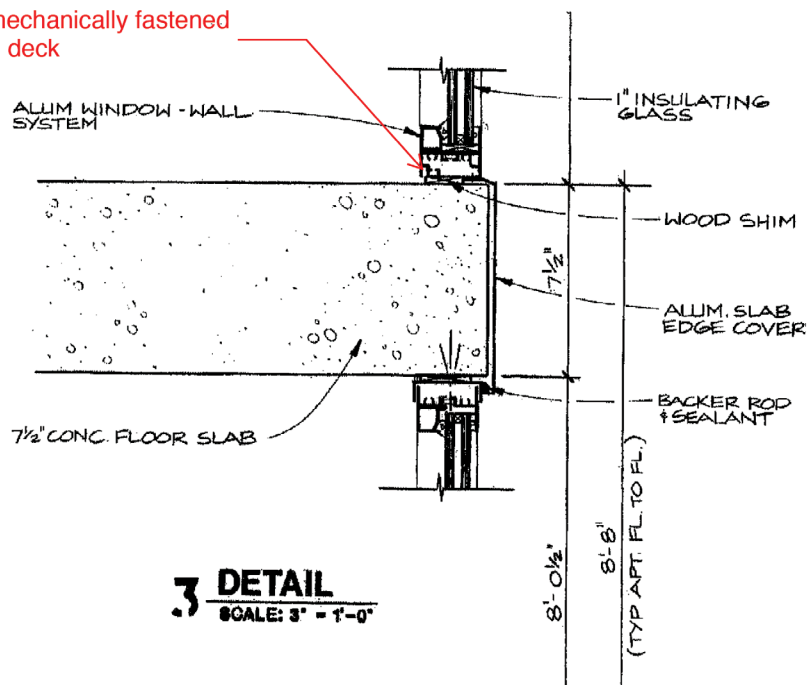
Figure 1 – Typical section at floor/ceiling line.

There are hundreds of buildings across the United States with the signature characteristics of a steel-reinforced concrete frame with floor-to-ceiling windows (columns and floor slabs integrated with a window system). If the designer of record were so moved, the leading edge of the floor line might even be covered with sheet metal panning and some insulation. The nose of the floor slab breaks the plane of the exterior wall at regular intervals; one man's ceiling is another man's floor (Figure 1). Architecturally, it can be a

Receptor mechanically fastened to concrete deck

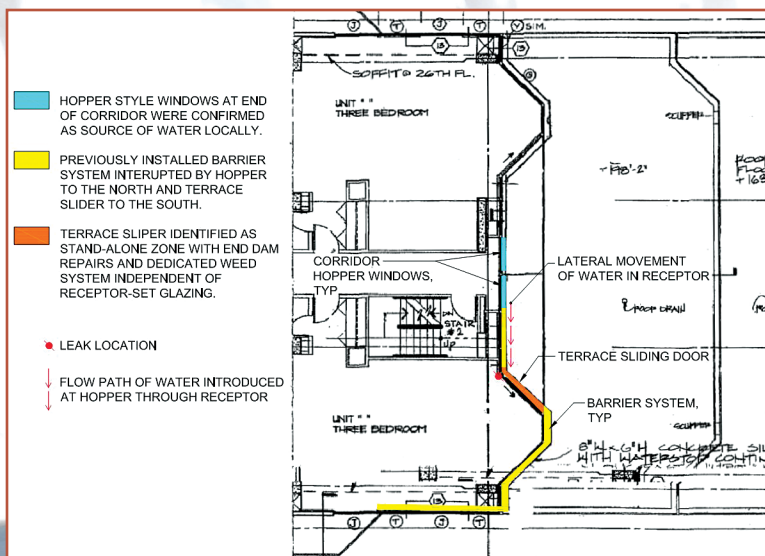
Figure 2 - Plan view.

A pair of hopper windows overlook a narrow terrace at the end of the corridor (Figure 2). Leakage to the building interior at the hopper was previously reported. Here again, the window system is set in sill receptors that run continually along the floor line through window mullions and parting walls. The sill receptor below the hopper window at this location continues south some 12 feet, through a series of fixed IG spandrels and mullions, ending at a change-in-plane or direction of the sill receptor at the jamb of the terrace sliding door.

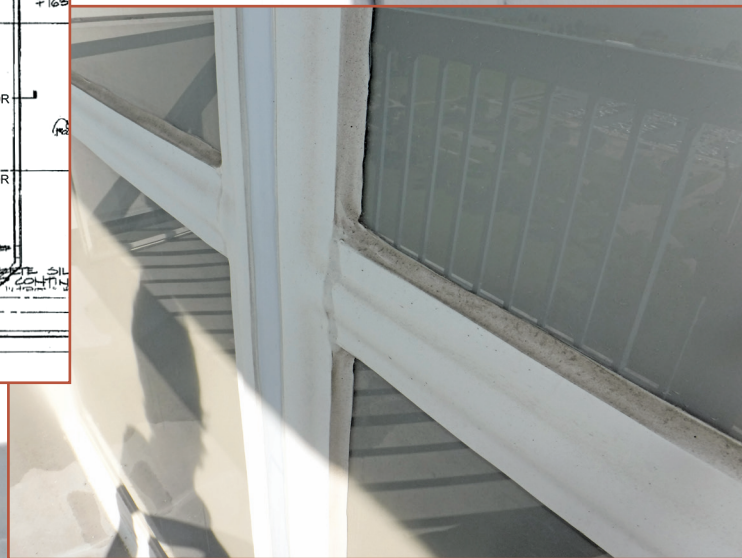
Figure 3 - The more aggressive barrier system compromised the overall aesthetics and was not well-received by unit owners.

In response to leakage at the corridor hopper windows, workers had previously installed an extension on the vertical leg of the sill frame and sill receptor. Concurrently, an effort was made to convert the exterior of the spandrel glass to a barrier system via the introduction of cured silicone membrane (Figure 3). The work scope, however, may be described as overly aggressive, using far more material than required, which resulted in a compromised aesthetic. Installing reticulated foam in the weep ports of the terrace sliding glass doors that were to remain open was additionally recommended. All weeps at the sill conditions of

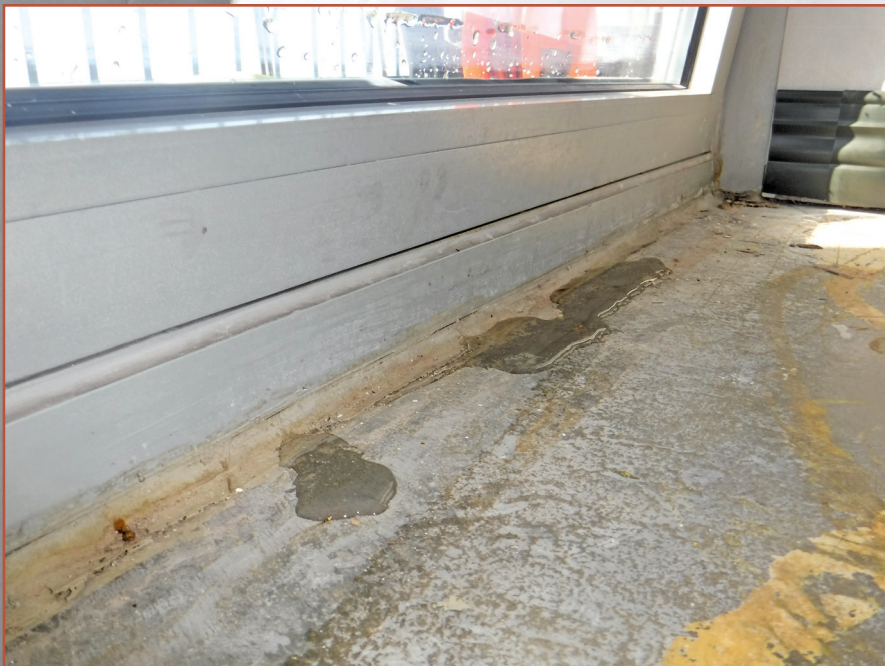
Figure 4 – The installation of vertical leg extensions needs to acknowledge the ever-present potential for lack of continuity at mullions and parting walls.

One-Minute Interval – Water was observed at the supplemental vertical leg extension at the sill/mullion interface (Figure 4). The water wasn't overtopping the increased vertical leg height, but rather observed as rolling out of the lower corner of the window frame from below the extender. Behind was the sealant bead that perhaps was once bonded to and provided closure/transition from the concrete deck to the sill receptor.

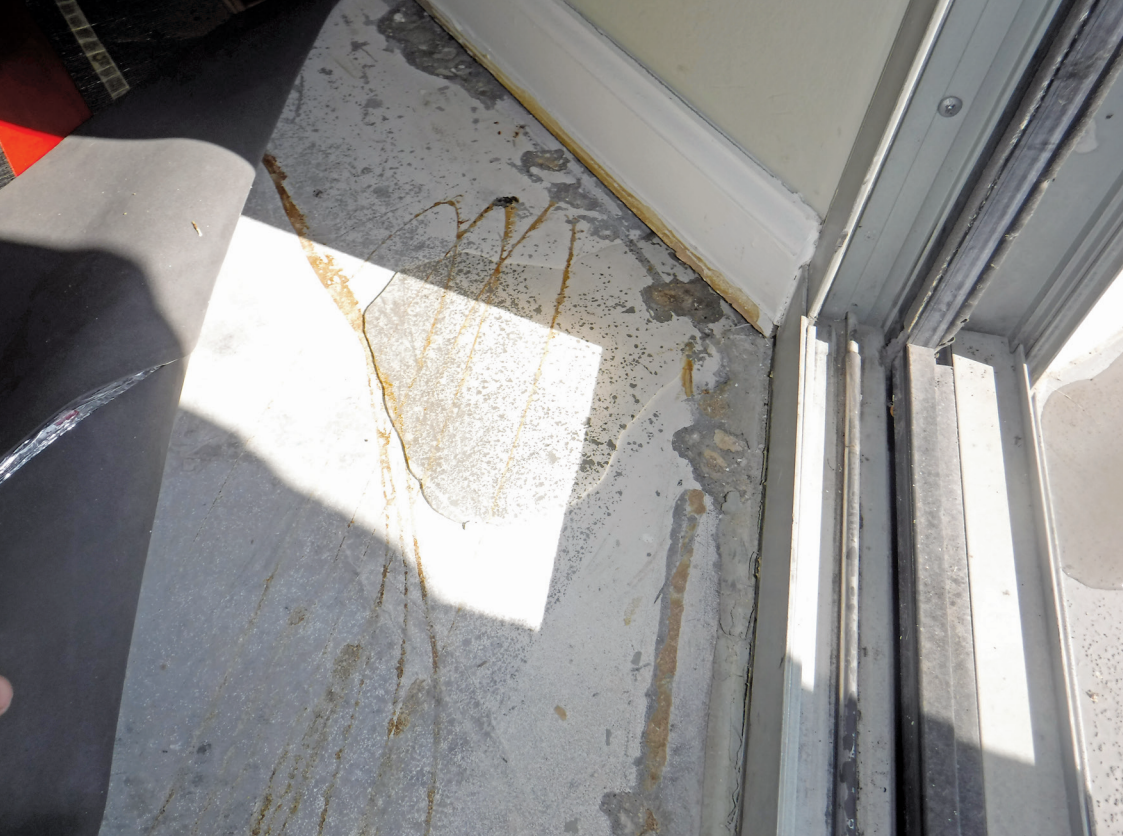
Figure 6 – Free moisture pooling on the interior of the occupancy adjacent to terrace sliding door. The source was confirmed as water that was introduced to the sill receptor via the weep structure of the hopper window, some 12 feet removed from this location.

Four- to Five-Minute Interval – Water appeared at the floor line below the corner of the terrace sliding glass door (Figure 6). After four to five minutes, free moisture was observed pooling on the floor at the jamb of the terrace slider. Runoff from the water test across the terrace was ruled out as a source, as was the spandrel glass between the hopper and terrace doors. The spandrel glass portion of the glazing assembly had already been converted to a barrier system. The hopper window remained unchecked at this point. A second, more aggressive test was scheduled for the next week.

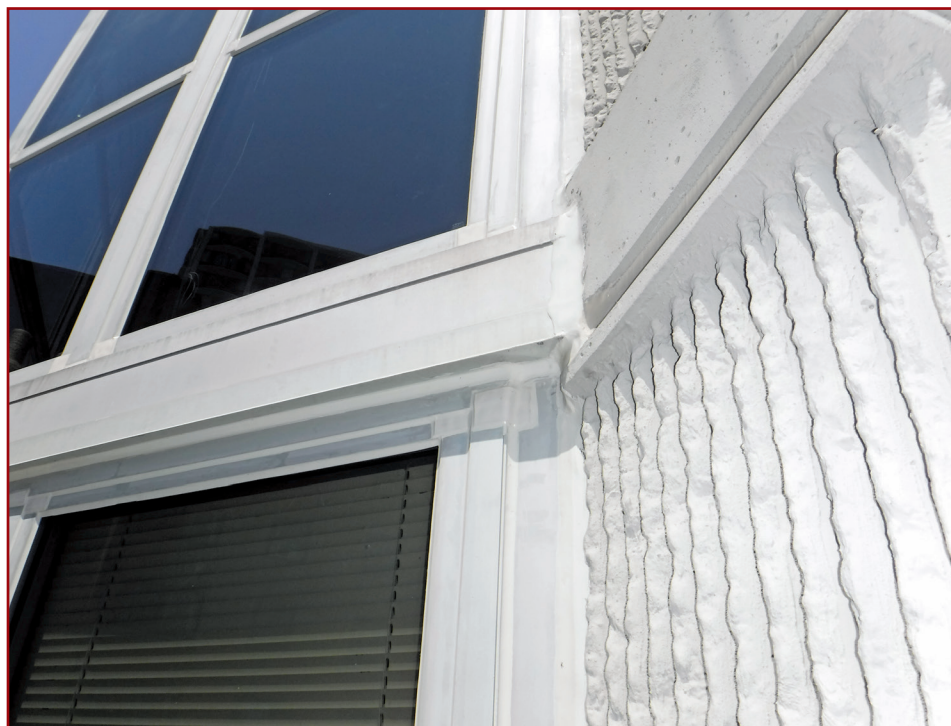
Figure 7 – Revised barrier system that places emphasis on a more targeted approach, resulting in a more aesthetically pleasing finished installation (cap beads, fillet beads, target patches).

sitions from frame to concrete are additionally treated (Figure 7). Prior to fully executing this type of repair, it is recommended that an exhaustive process of due diligence

The weep system is typically closed at the most outboard portion of the frame, sash, and glazing. All remaining potential sources for water entry are sealed, including weep system(s), butt joints at joinery of extrusions, frame-to-glazing cap beads, slip/snap joints at mullions, etc. Sealant joints through the transi-

be undertaken such that the mechanics of the failure are fully understood. Sealant compatibility must be confirmed, and adhesion tests are highly recommended prior to releasing the work for full production.

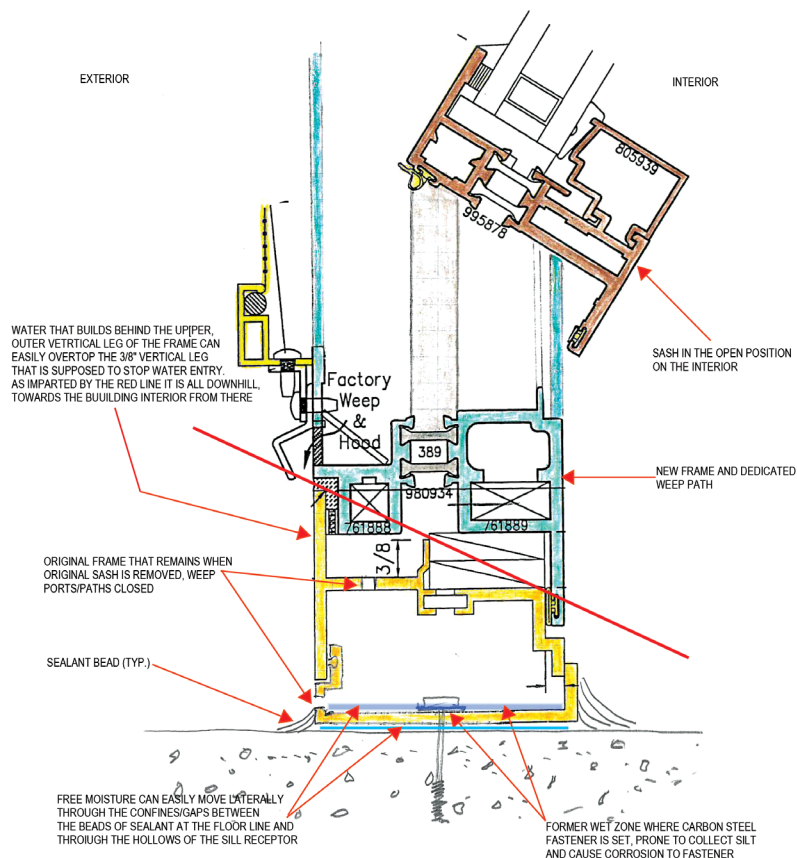
Figure 8 – Window section.

The operable sashes tilt inward. The geometry of the sill extrusion is the opposite of what might be characterized as practical for the application. At the sill condition in section, the outboard vertical leg has the highest profile (a uniform 1-in. leg that additionally carries through the jambs and head), with the overall profile from there (at the sill section) essentially stair-stepping downward (beyond the 3/8-in. vertical leg), towards the building interior (Figure 8). Of all the seated joints in the hopper assembly in the closed position, the sill condition would be characterized as highly vulnerable to leakage during periods of sustained rain.

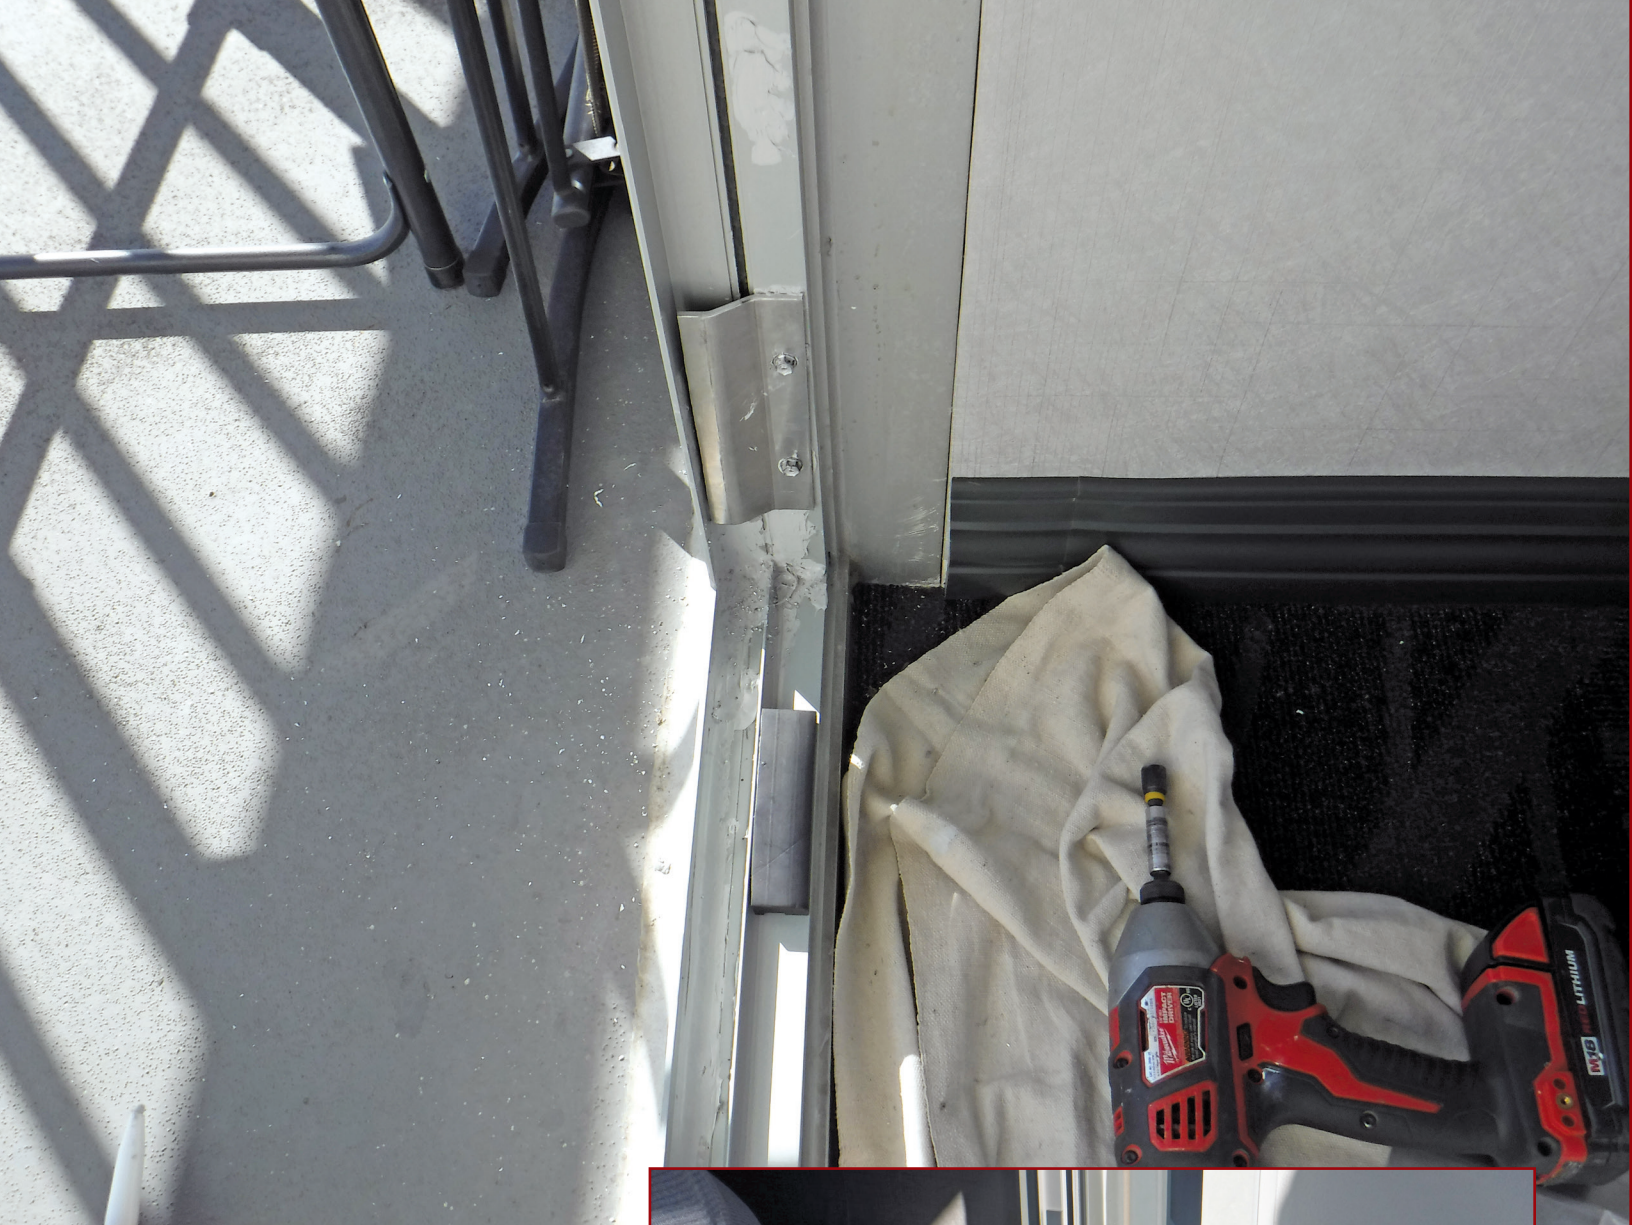
Figure 9 – During the dry fit process, shims in the sill are adjusted, and clips are installed in the jambs.

The uniformity of the opening, or pocket of the frame that remains with the operable sash removed, lends itself to the introduction of a new window as an insert. The plug-and-play aspect of the installation is centered on the introduction of a new self-contained window frame and operable sash that would be independent of the frame surround that will remain. This new window would bring with it a compartmentalized zone for water management, with the existing window frame

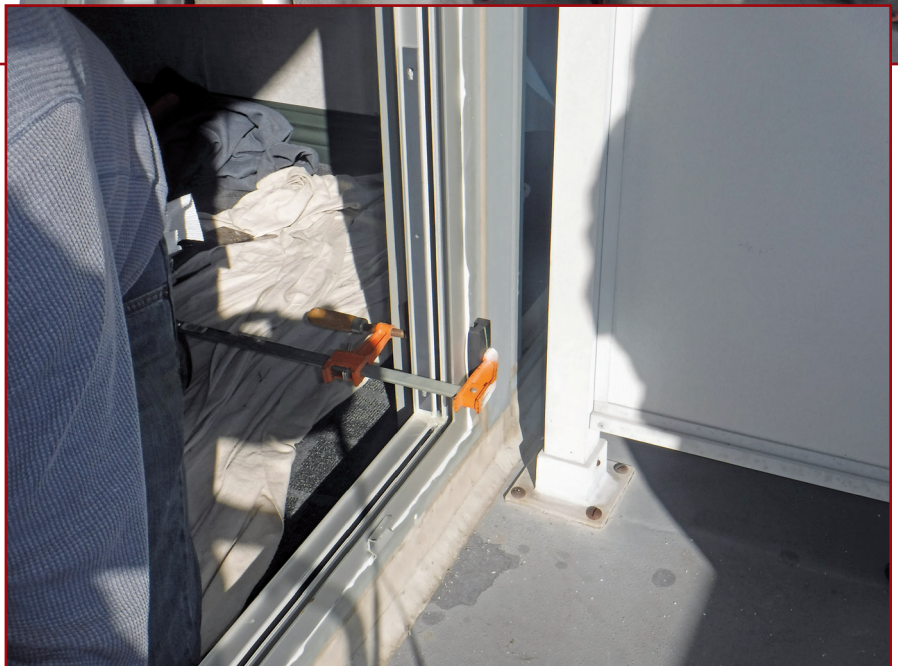
Figure 10 – New insert set in position being drawn down with clamps. The inner flange of the opening/existing frame is dressed with a bead of wet sealant prior to nesting the new window in place. The excess sealant on the exterior is struck with a knife, providing clean/crisp lines.

First the accessory hardware from the original hopper window was stripped from the opening, including fixed points for hinges and catches for latch mechanisms. Weep ports on the horizontal plane of the sill extrusion were plugged, and the joinery of the extrusions at the inside corners through the transition to the jamb were locally treated with an appropriate gun-grade sealant. The insert was dry-set, and adjustments were made to the shims at the sill condition. Heavy clips were mechanically fastened to the jamb and back side of the 1-in. reveal in the pocket, and dressed in a bead of silicone sealant (Figure 9). The insert was subsequently set in the opening and drawn down with clamps. The tolerances were such that when the clamps were drawn down, the previously installed wet sealant (setting bead) was observed extruding from the joint (Figure 10). With offsets measured and approved as consistent, and the window securely nested in the opening, fasteners were set at the jamb. The sealant bead on the exterior was struck smooth with a knife, and the installation was given a seven-day cure prior to testing.

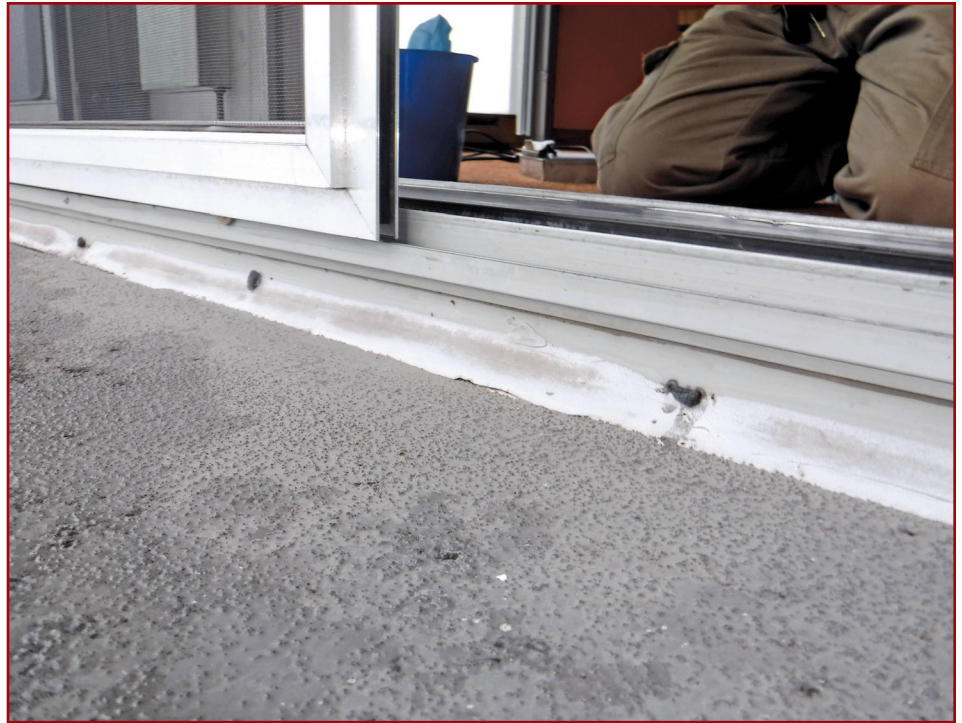
Figure 12 – Reticulated foam stuffed into weep ports of the terrace slider do more harm than good. Any porosity the material had is compromised by 1) forcing the material in a hole smaller than the piece of material that is intended to fill it and 2) the material fulfills the role of a clogged filter due to the abundance of silt in the subframe.
