## **MOTHER NATURE**

## offers alternative to TRADITIONAL NDT ROOF MOISTURE SURVEYS

BY DONALD KILPATRICK

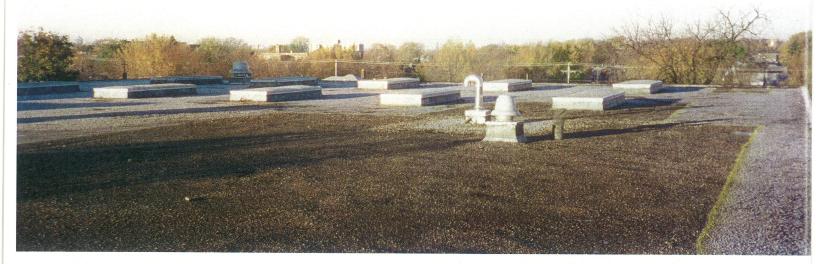
Overall of a fairly large anomaly in a built-up roof assembly.

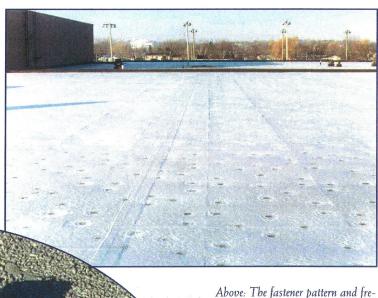
quency are demonstrated by heat loss in the frost on this adhered EPDM.

Left: Test opening made at the transition from wet to dry materials

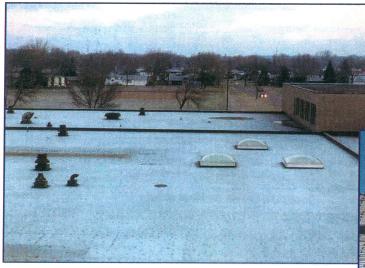
Above: A small anomaly in the foreground, drain sump, and larger anomaly in the upper right corner were found on these roof areas.

Below: Frost patterns here clearly demonstrate the problems related to an unvented, single layer of insulation in a sloped roof configuration.
