The Journal of RCI

WATERPROOFING IS *NOT* BELOW-GRADE ROOFING

By David Campbell, RWC, AIA

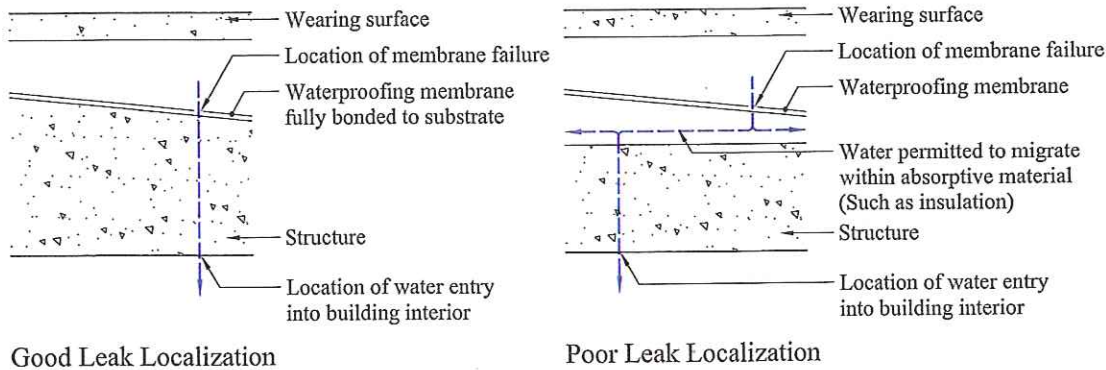
Diagram C: Importance of Waterproofing Leak Localization

Leak localization is achieved when the system assembly maintains a relationship between the location of the membrane failure and the location of the water entry into the interior space below. This relationship allows a localized repair of the membrane directly above the point of

water entry through the structure, thereby avoiding having to replace the entire system.

Since a roofing membrane is rarely subjected to the type of hydrostatic pressure that would “drive” water through a failure and since roofing membranes are easily accessible, allowing relatively inexpensive repairs, such leak localization is not a critical characteristic of roofing assemblies. However, this is not the case with waterproofing. If a waterproofing membrane should develop a failure and the substrate is such that water is allowed to migrate laterally below the membrane, water could travel a considerable distance before it shows up in the interior space below, due to hydrostatic pressure. Without being able to identify the exact location of the membrane failure, the owner would have no recourse but to replace the entire waterproofing assembly.

Diagram C illustrates this concept, and Photo 2 shows how one waterproofing failure can result in multiple leaks through otherwise innocent shrinkage cracks when water is allowed to migrate below the membrane.

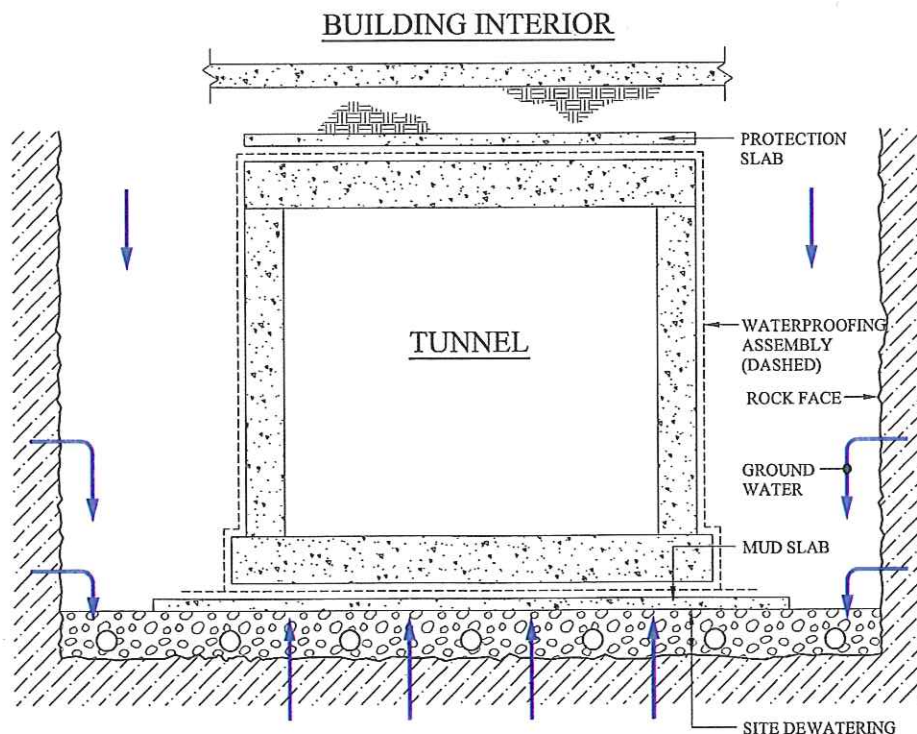
Diagram D: Permanent and/or Temporary Subdrainage Dewatering

Sometimes waterproofing design must take existing conditions into account such as geology, groundwater, and even groundwater contaminants, which are obviously not a concern in roofing design. Diagram D illustrates the elaborate measures that sometimes must be taken in order to properly manage existing groundwater in a particular geological condition, both during and after waterproofing installation. The volume of groundwater that was expected to enter the excavation through cracks and fissures in the bedrock at this airport site was such that full-time site dewatering, as shown in the diagram, had to be maintained. In addition, tests revealed that the groundwater was contaminated with hydrocarbons and ethylene glycol, which are capable of chemically "melting" most waterproofing-related products over time. Consequently, special care was taken in specifying products that were compatible with this witch's brew of contaminants.

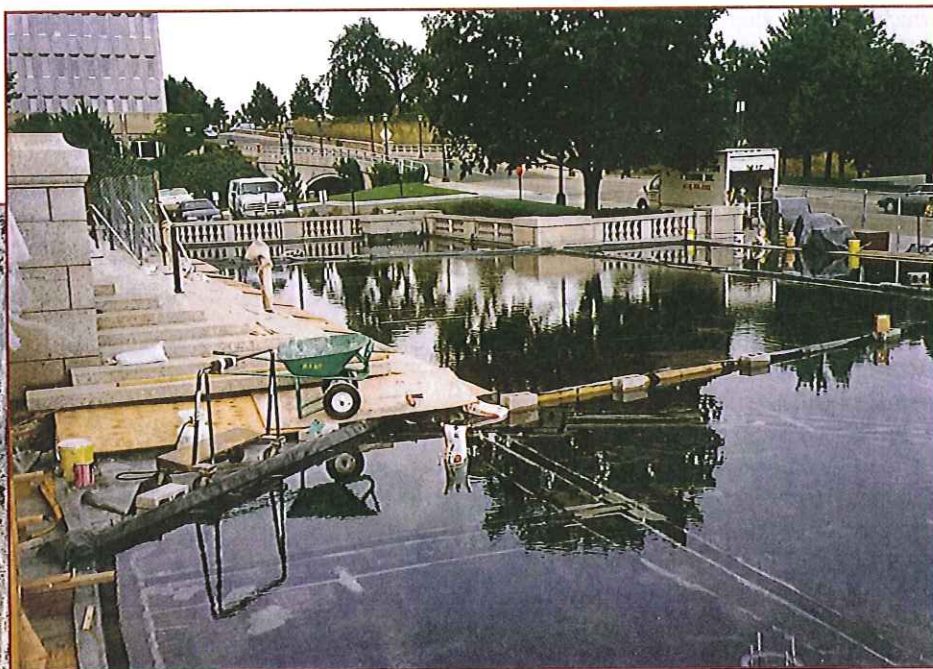
Photo 8

As shown in *Photo 8*, flood testing is accomplished by simply exposing an installed waterproofing membrane to standing water (usually two to four inches) for a specified period of time (usually 24 to 48 hours) prior to the installation of any protection course or other overburden materials. One exception to this would be hot rubberized asphalt,

which requires that the protection course be installed and bonded to the membrane prior to the flooding. At the end of the specified period of time, the interior is inspected for moisture infiltration, the water is drained away, and any membrane failures that were discovered are repaired.

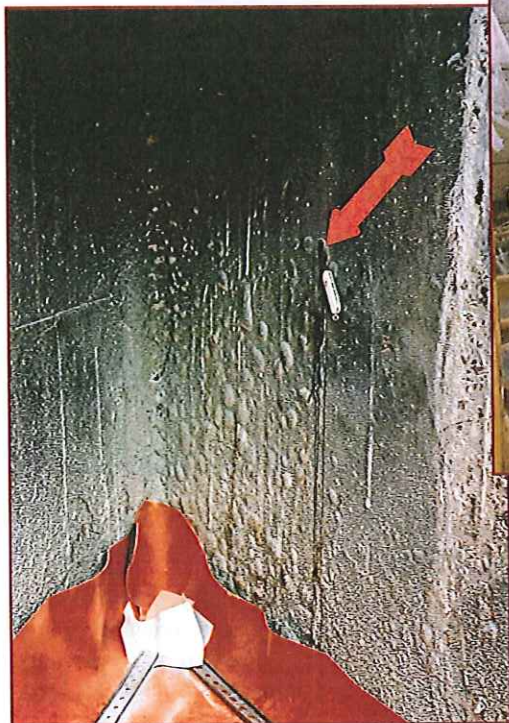
Photo 7

Testing the substrate for moisture content is also critical. *Photo 7* shows what can happen when hot rubberized asphalt is applied to a concrete substrate that has too high a moisture content. The moisture in the concrete vaporizes when the hot, 375-degree material hits it, creating water-filled blisters, which can break open and cause membrane failure.

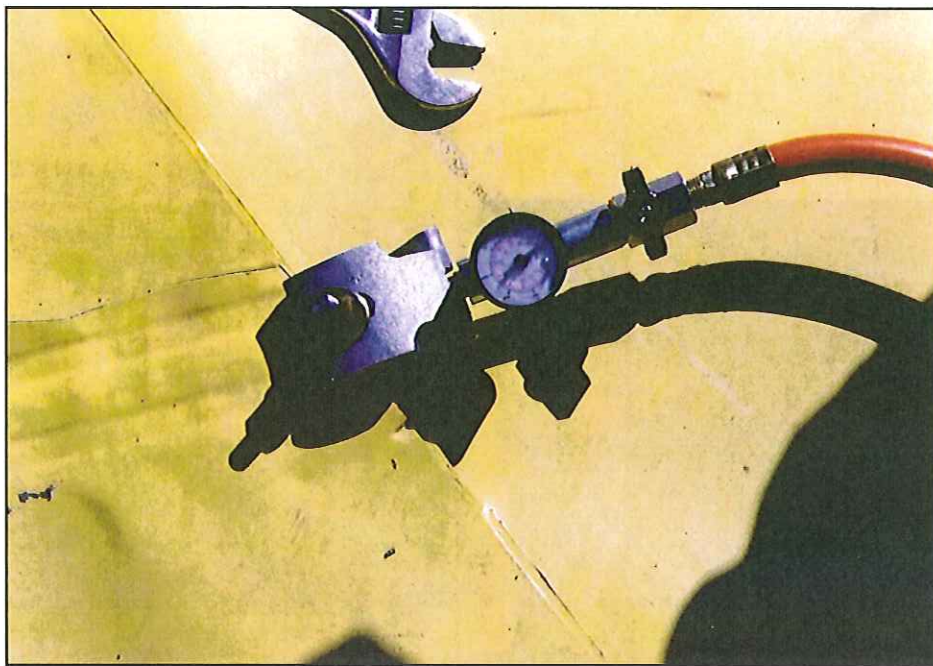
Photo 9

Since vertical waterproofing installations cannot be flood tested, at least one manufacturer has developed a way of "pocket seaming" its PVC membrane, which enables testing of the seams by pressurizing them with air and then watching for a pressure drop on a gauge attached to one end of the seam (Photo 9). This method does not test the entire vertical field membrane, but it does at least test the seam, which is the most susceptible to failure.
