High-Quality Waterproofing is Cost-Effective

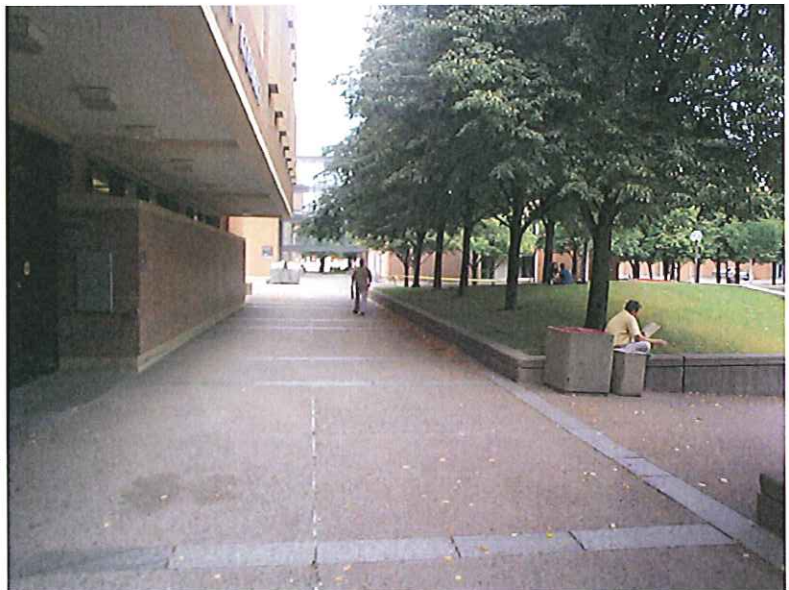
Photo A: Existing site features above a waterproofed foundation wall.

Such site features can include plant materials, wearing slabs, pavements, lighting, retaining walls, stairs ways and ramps, curbs, bollards, signage, etc. If the waterproofing that needs repair or replacement is on a foundation wall then, depending on the foundation depth, the excavation "angle of repose" can affect a very large surface area and thereby also affect a great many existing site features as well. Photo A is a good example of this. If the foundation of this building had to be rewaterproofed, the excavation would affect retaining walls, mature trees, wearing pavement with granite feature strips and many other amenities unrelated to the waterproofing itself.
