REPAIR OF ABOVE-ROOFLINE PARAPET WALLS ON VINTAGE STRUCTURES

By Don Kilpatrick and Michael Wiscons, SE, PE

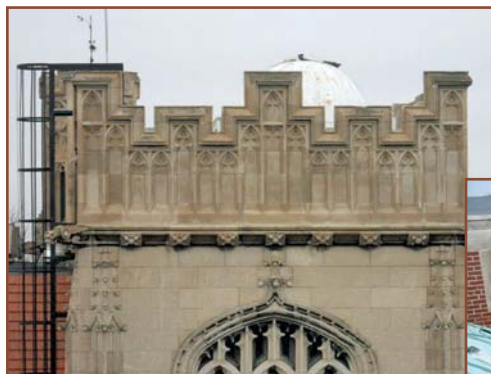
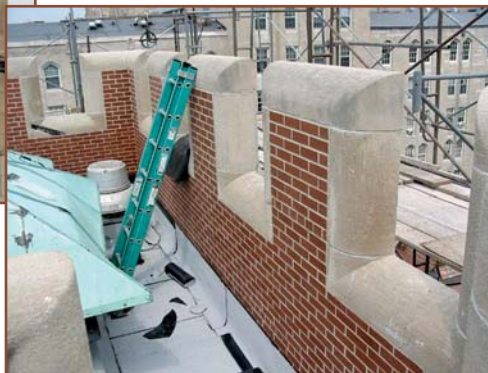
Photos 1A and 1B – Examples of a "crenellated" parapet wall or battlement as identified by the alternating high (merlon) and low (crenel) points of the feature.

Our nation's inventory of vintage structures has evolved to include a broad range of signature features. Many vintage structures have crenellated above-roofline parapet walls with heights ranging from 12 in. up to 10 ft. above the roofline, with the latter commonly referred to as battlements. Historically, the regular intervals of projected high (merlons) and low (crenels) points provided cover and openings from which combatants could exchange fire with the enemy. Architects of the 19th and 20th centuries included these features, focusing on

the form as an architectural embellishment rather than the original function, which went the way of moats, drawbridges, and dungeons. This type of construction features a geometric, symmetrical-toothed appearance at the top of the parapet wall, commonly as in-fill between projected buttresses and neighboring outcroppings of even higher towers and turrets.

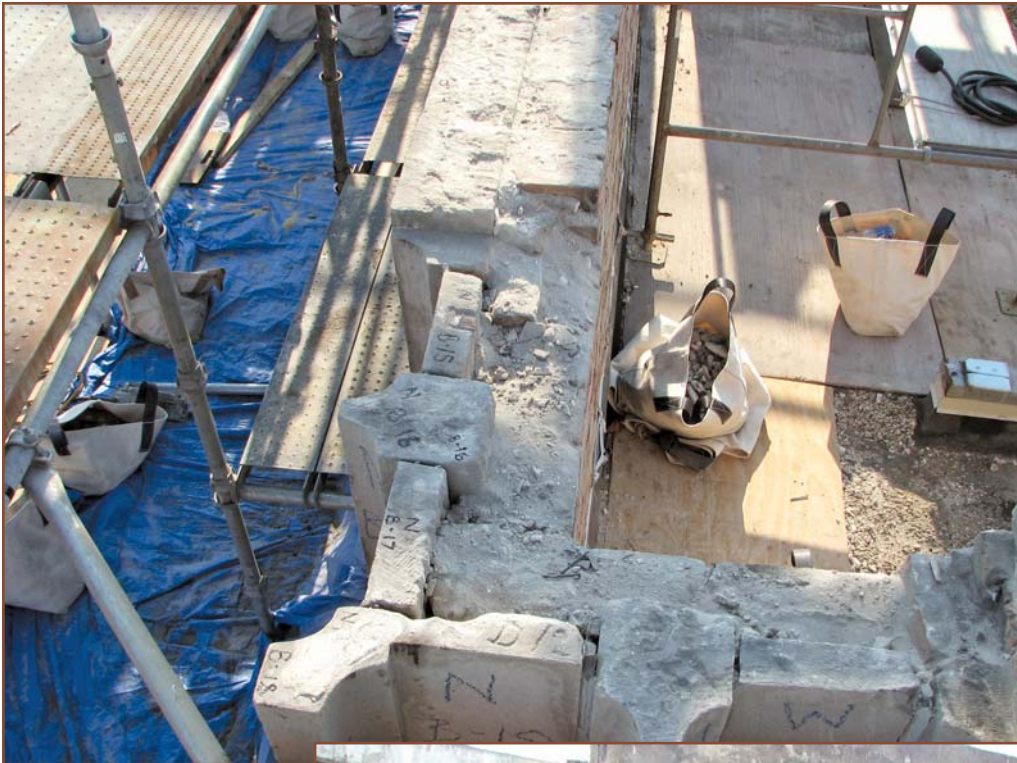
Photo 2 – Cut/carved stones labeled for correct spotting during reconstruction.

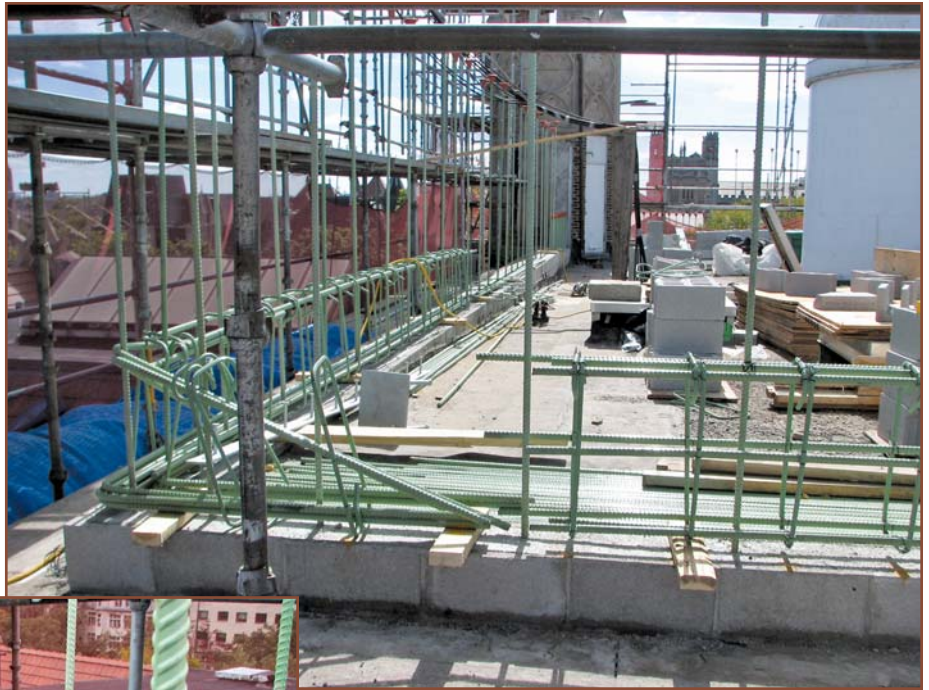
Photo 4 – Rebar set for forming and pouring of a new concrete beam above existing roofline.

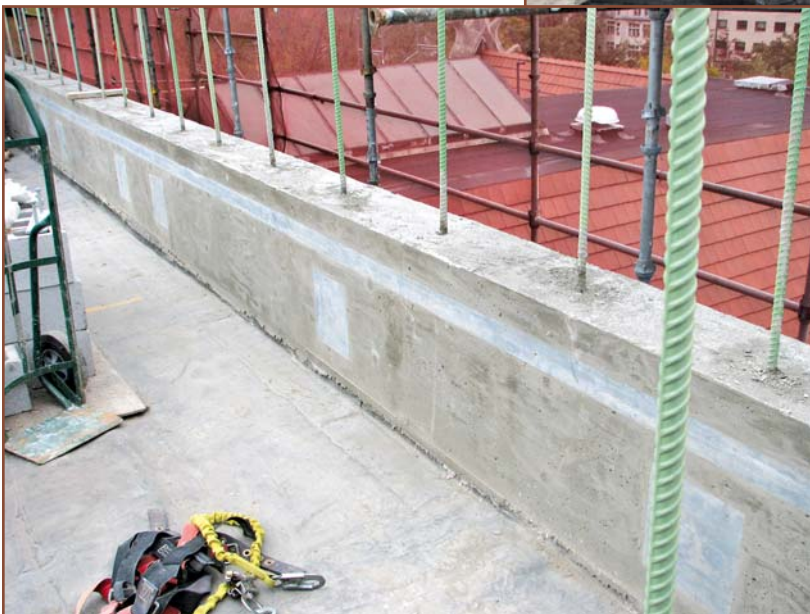
Photo 5 – Forms stripped, exposing interior face of new concrete beam fitted with embedded weldments.

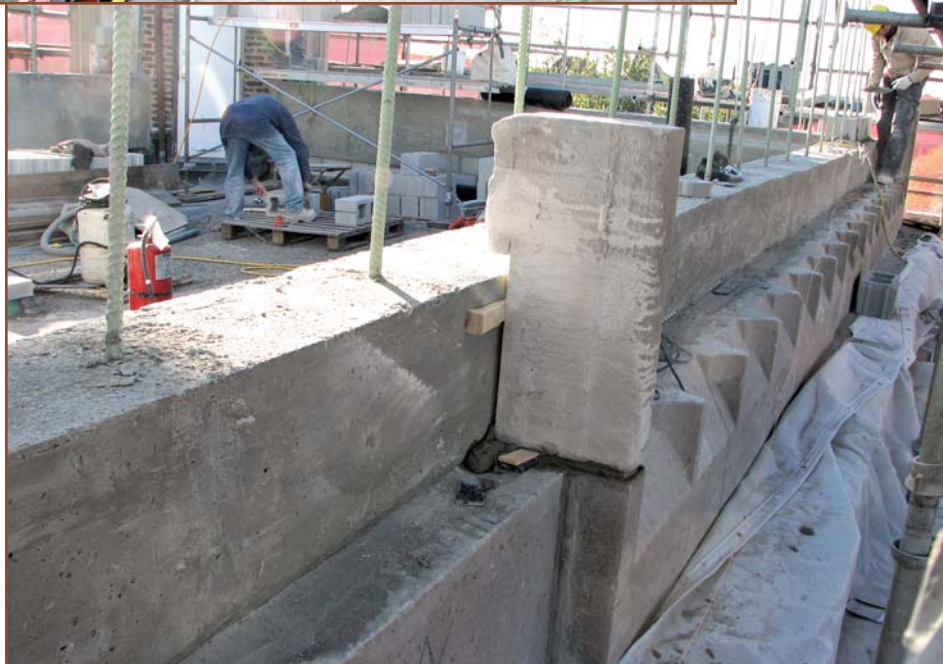
Photo 6 – Stone requiring field cut to accommodate new tolerances established by the concrete beam.

On projects in which the scope includes the complete reconstruction of the brick masonry backup wall—utilizing a steel-reinforced, fully grouted CMU wall section—the 8-in. bond stones may need to be field cut to 4-in. thickness so as not to interfere with the continuity of a bond beam and/or reinforcing steel set in the fully grouted cells of the new backup. Any new steel (generally limited to anchors for resetting of the stone, in the form of pins and clips) should be of stainless steel.

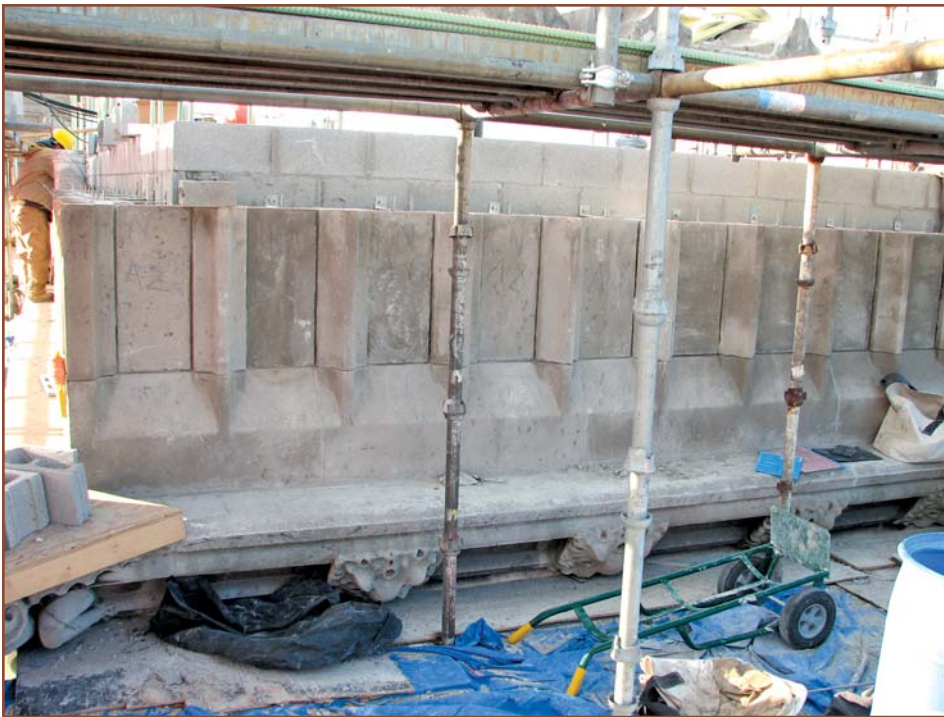
Photo 7 – Reinstallation of cut/carved limestone cladding with stainless steel anchors.

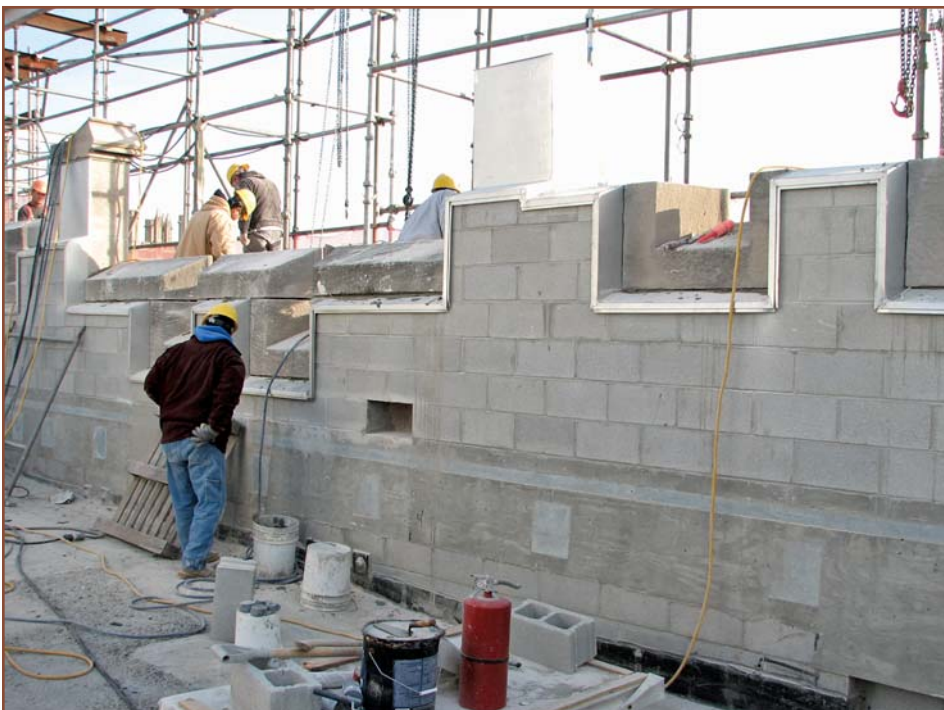
Photo 8 – Fully integrated zinc- and tin-coated copper receiver flashings below stone copings.

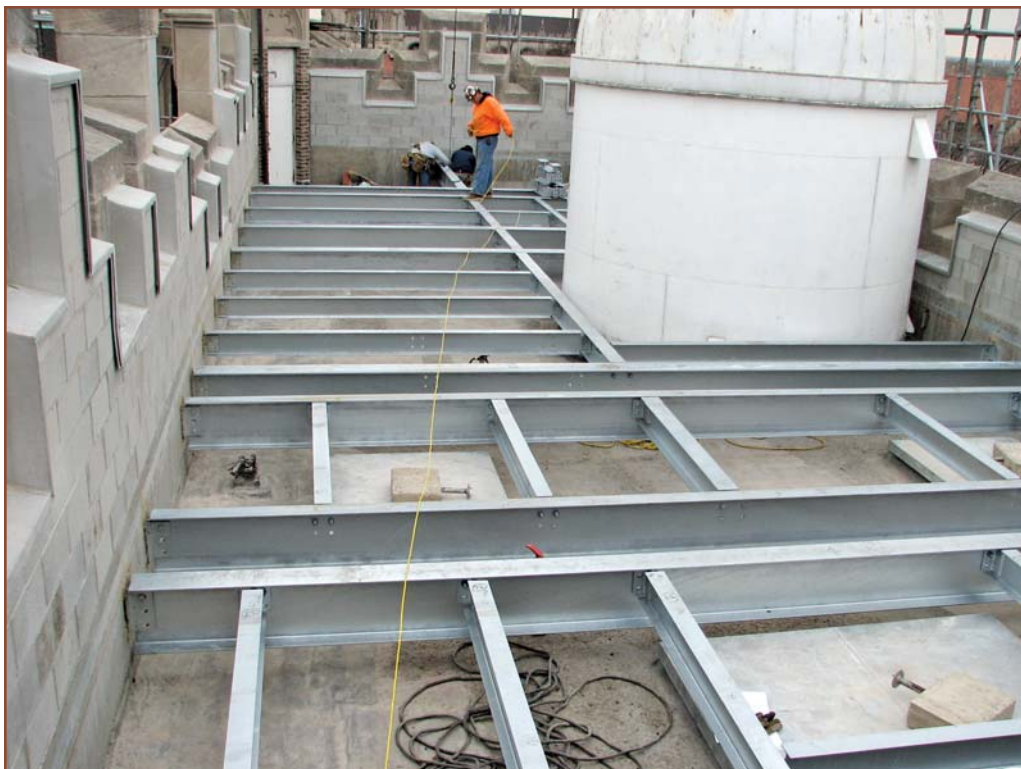
Photo 9 – The introduction of new, galvanized structural framing elements above the original roofline.

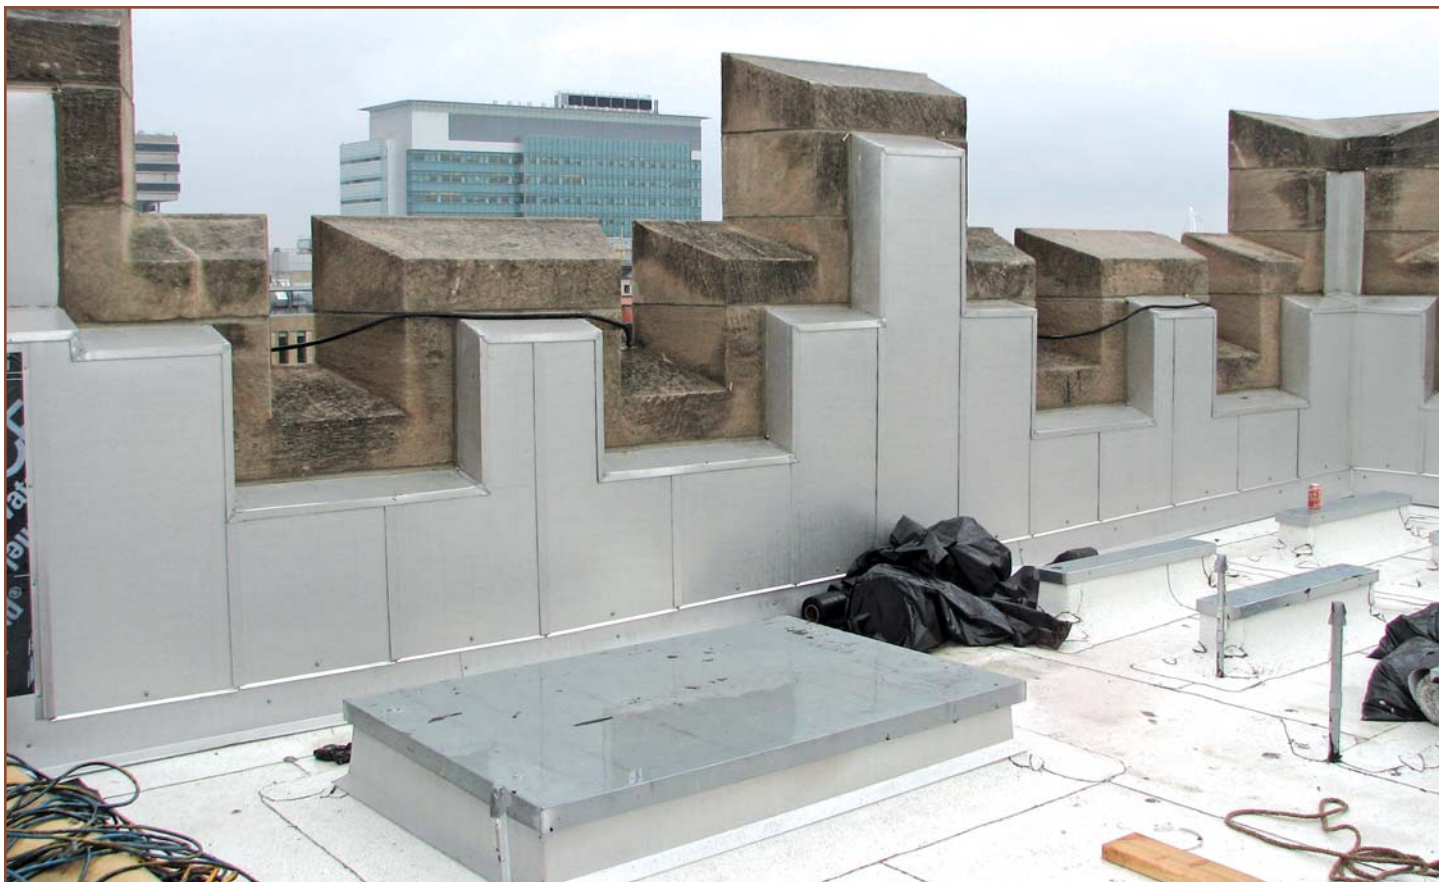
Photo 10 – Fully completed parapet and new roof assembly.
