Vintage Structure With Hybrid Decking and Low-Rise Foam

By Donald Kilpatrick

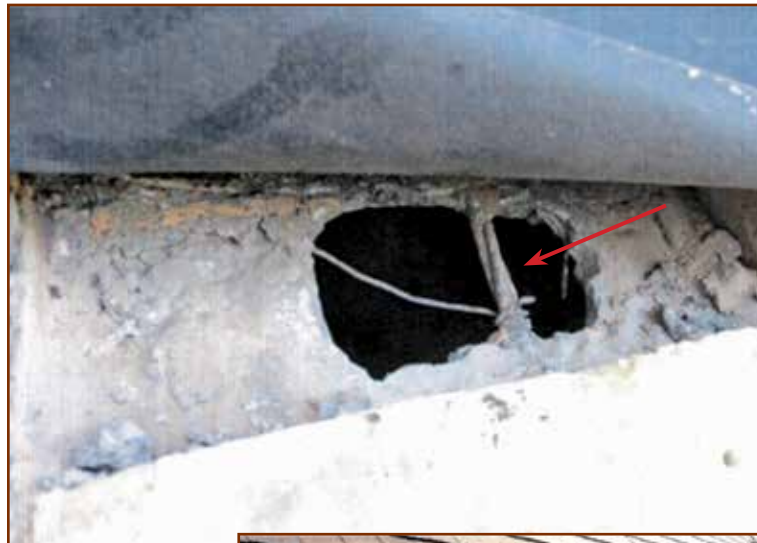
Photo 1 – Spiral-wound steel reinforcement of concrete deck.

were originally set on top of the concrete deck in a bed of mortar with joints infilled and struck flush. The reinforcement that was encountered at 3-in. centers was composed of three $\frac{3}{16}$ -in. wires wound in a spiral. Mechanically fastening to the concrete deck was no longer considered a viable option (*Photo 1*).

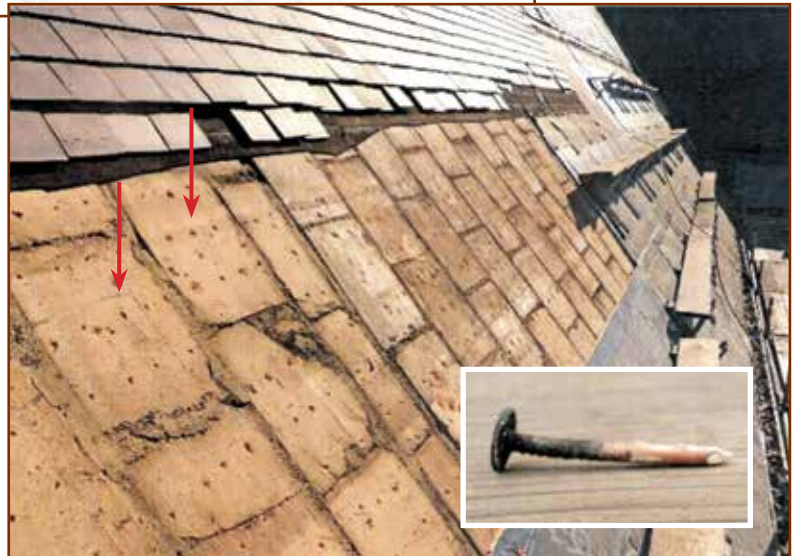
Photo 2 – Overall condition of structural clay tile roof deck with uniformly spaced rows of pockmarks from the original nailed installation of flat-slab clay tile.

Removal of the tile and organic underlay yielded a substrate that, aside from the pockmarks from the original installation of clay tile, was fairly pristine (*Photo 2*). The initial response was to explore all options related to mechanically fastening to the book tile. A series of varied fasteners were tested for pullout resistance in the book tile substrate. While some fasteners demonstrated promise at one location, another of like kind at an adjacent location would

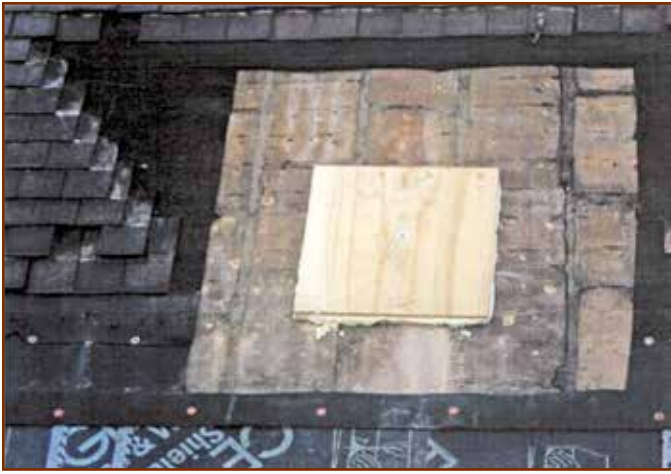
Photo 3 – Initial test panel set in adhesive to structural clay tile substrate under controlled conditions.

Mechanical Uplift Resistance of Insulation Adhesives over Varied Substrates. The initial 2- x 2-ft. panel was set in the field of the roof area and allowed to cure for a period of 20 minutes (Photo 3). Pull test results for this panel were in excess of 110 lbs. per sq. ft. (Photos 4 and 5). A second 2-foot-square test panel was cut from the center of a full sheet of $\frac{3}{4}$ -in. plywood after a cure period

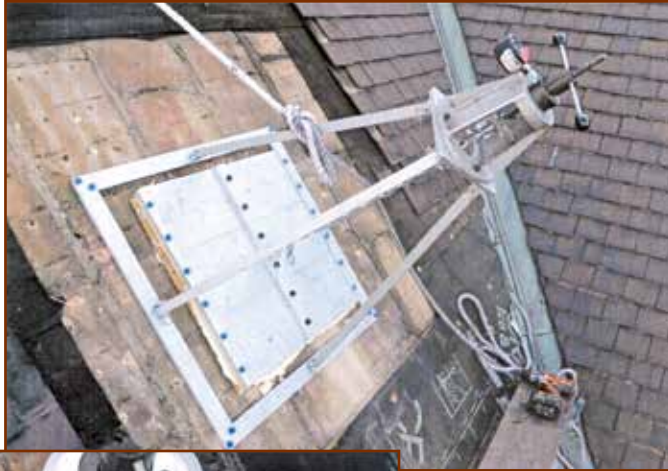
Photo 4 – Test apparatus set up for the pull test of the 2-ft. square panel fixed to the deck with low-rise foam adhesive under controlled conditions.

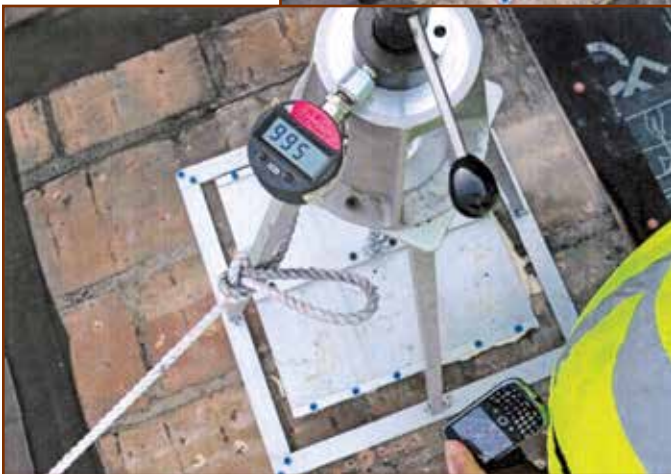
Photo 5 – Pull test values in excess of 140 lbs. per square foot derived under controlled conditions.

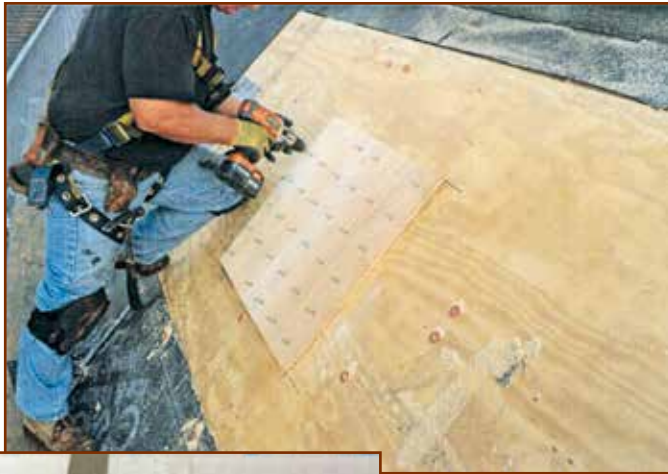
Photo 6 – Contractor preparing test panel for pull test under field conditions.

of 15-20 minutes. Uplift values in excess of 180 lbs. per sq. ft. were derived at that test location (Photos 6 and 7).

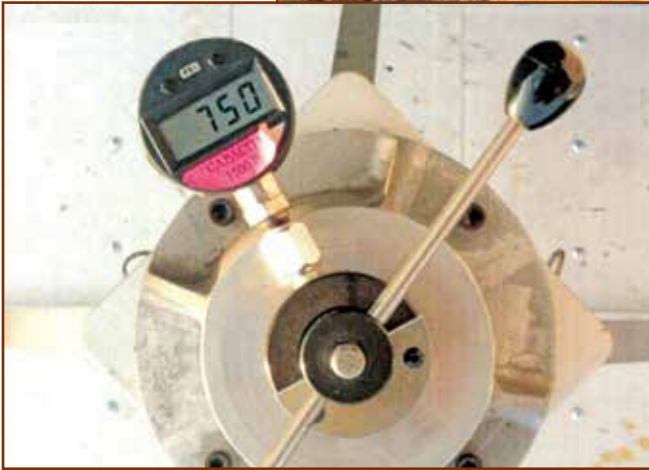
Photo 7 – Test result under field conditions yields pull test values in excess of 180 lbs. per square foot.
