The Art of Replicating and Sourcing Leaks to the Interior of Buildings;

Engineered Doctrine or Applied Fundamentals?

BY DON KILPATRICK

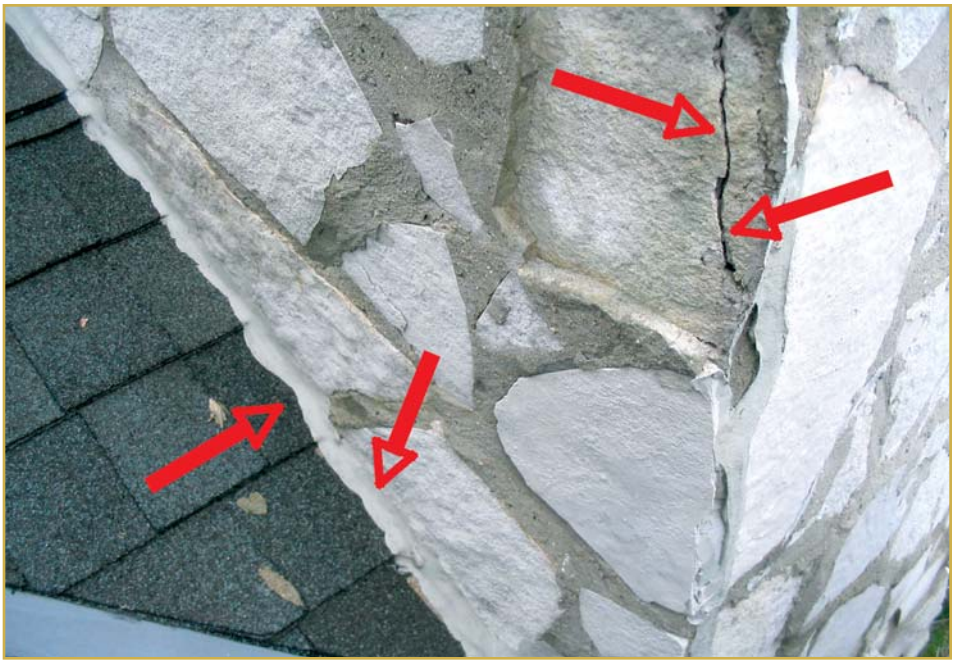
Photo 4 – Removal of loose stone cladding revealed openings in mortar bed. The shingle covering the interface with the stone cladding is sealed with caulking, restricting the harmless discharge of water from the above-roofline features.

At this location (much as described by the long-term resident handyman), it was noted that the shingle roof covering had been sealed with a liberal application of caulking directly to the stone cladding (*Photo 4*). As the open stone-to-stone joinery above the roof line was accepting water, the handyman's efforts with the strategically placed sealant bead had effectively closed the only opportunity for the moisture to harmlessly exit the wall section. In summary, on this day, our hoses never saw the bib. The water test (more importantly, the dry-

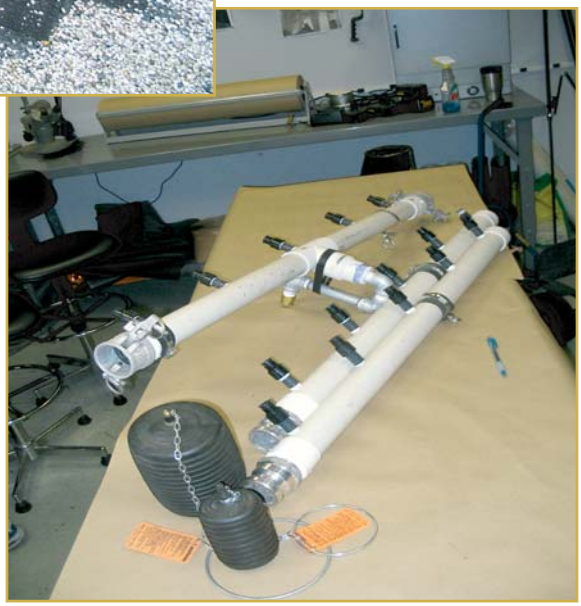
Photo 10 – Tools of the trade: shop-made spray bar and pneumatic drain plugs.
