Journal of the Roof Consultants Institute

Phenolic Insulation and the Building Envelope

By Don Kilpatrick and Michael G. Taylor, Esq.

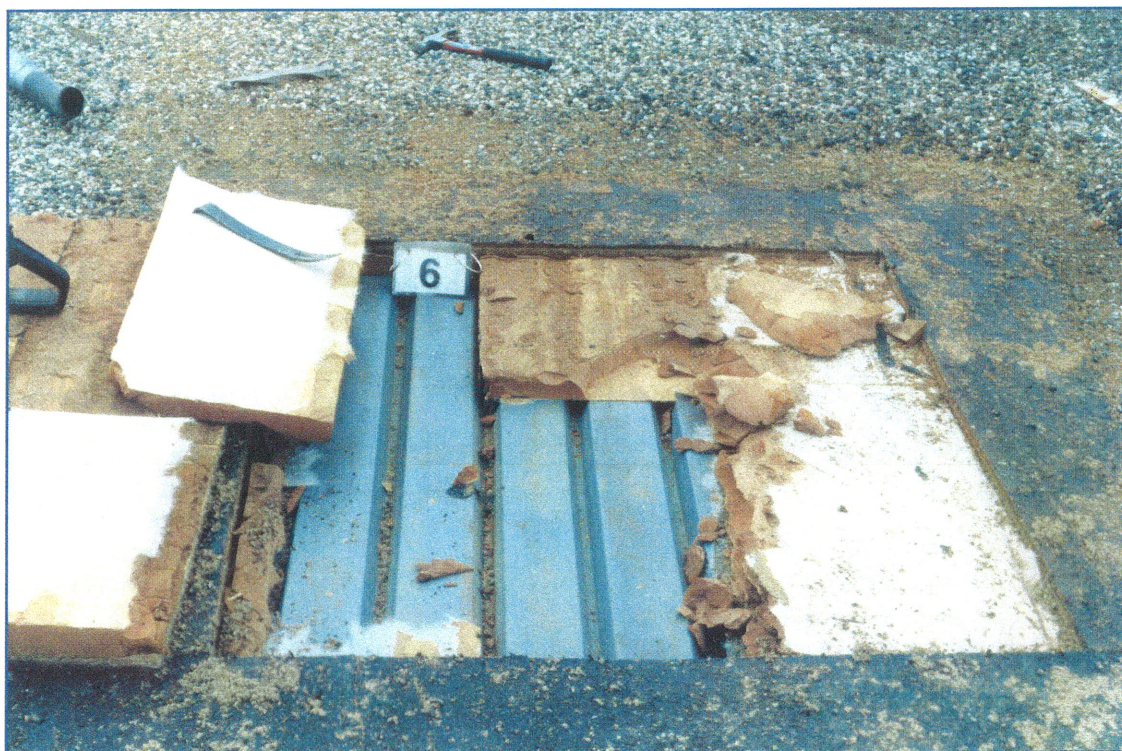
Figure 1

The expansion joint wood blockings ran perpendicular to the direction of the steel deck, centered over a 3/4-in. gap in the deck. The sheet metal cap and counterflashing covering the expansion joint were rusting. At the inspection opening, a wash of warm air came out of the building, and condensation was noted on the vinyl draped over the top of the wood blocking. The insulation adjacent

metal cap (Figure 1). Severe corrosion was observed on the underside of the sheet metal cap (Photo 4). Condensation was also noted at these locations. The insulation around the curb was essentially dry.

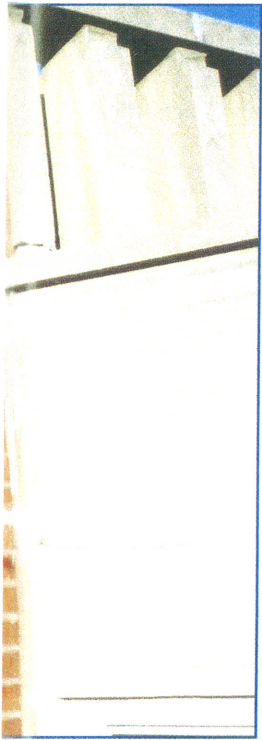
It could be argued that the vapor retarder, installed over a concrete deck, would provide adequate protection for any steel that might be in close proximity to phenolic insulation, wet or dry. However, on this project it was determined that the portion of the vapor retarder that continued through the transition from the horizontal plane of the roof deck up the vertical surface established by the interior of the parapet was largely void of mopping asphalt.

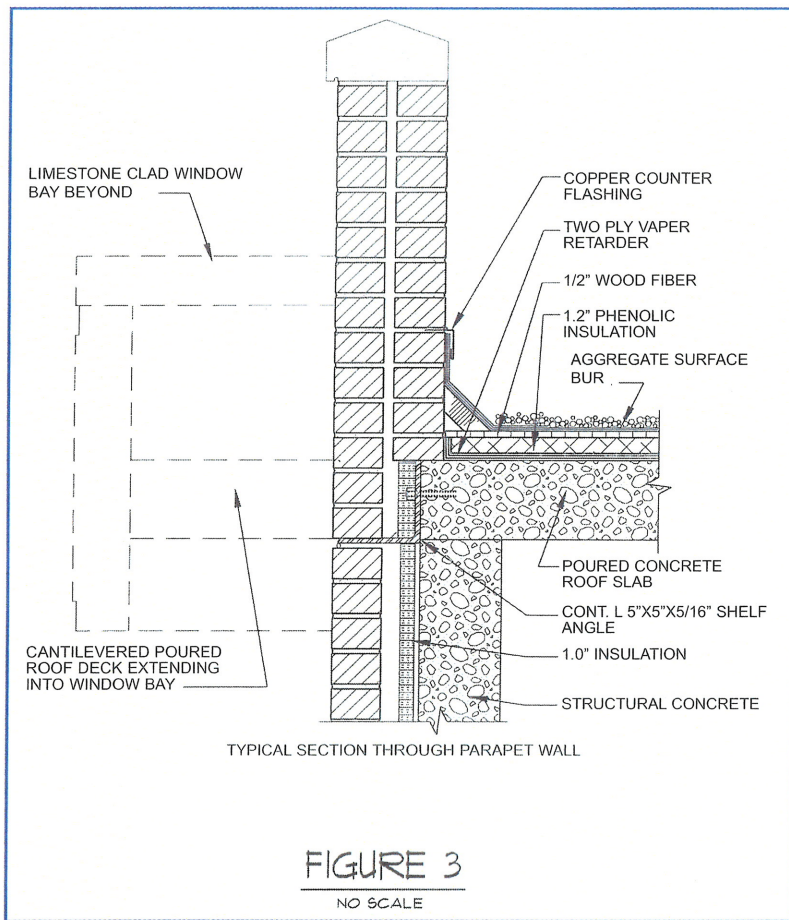
Figure 3

A series of inspection openings in areas of localized distress confirmed significant corrosion of the shelf angles (Photos 9 and 10). The conditions were most prominent at the tenth-floor roof slab and parapet interface, with conditions improving at the juncture of the eighth-floor slab and brick veneer (Figure 3). On the remaining similar floor slab interfaces with the brick veneer, the deflection was present but not as pronounced as that of the tenth floor. The subsequent shift of loads from the upper limits of floors 10-8 was distributed to the remainder of the shelf angles mechanically fastened to the outside face of the floor slabs on floors 7-3. As a result, the integrity of the anchorage mechanisms was compromised. It was determined that replacement of the shelf angles and brick veneer would be required on floors 3-10.
