# REINTEGRATION

## OF SANCTORUM:

### Multidisciplinary Historic Rehabilitation of Rockefeller Memorial Chapel

By Donald Kilpatrick and Barry O'Quinn

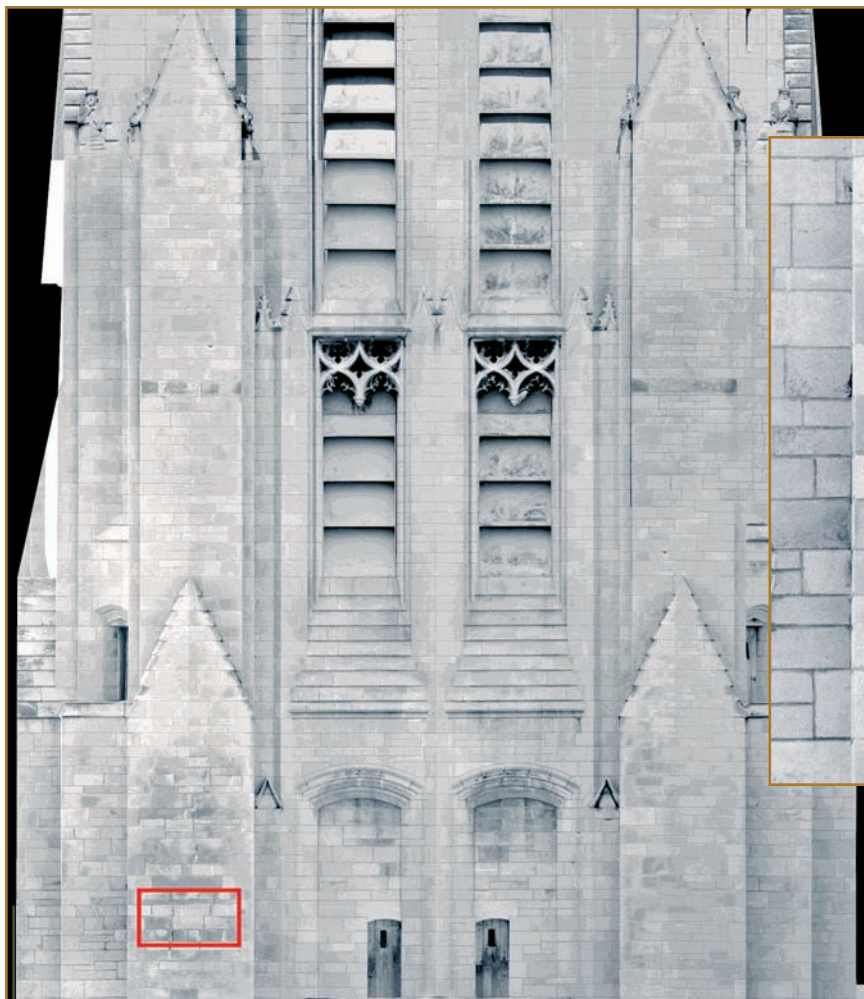
*Photo 6 – Digital photogrammetry of partial east tower elevation.*

In the absence of a full complement of original building drawings, digital photogrammetry was selected as a means to record present-day condition indices and was subsequently utilized as the primary method to graphically impart site-specific work scope locations and limits to the bidders (*Photo 6*). The high-resolution photography delivers a permanent record of building and can be integrated with AutoCAD, accommodating manipulation of the images in full and partial elevations. The graphic representation derived from the photogrammetry yielded a significant reduction in cost over traditional methods of delivery (line drawings) while achieving unsurpassed interpretive quality of the building's varied features. Using the images, the engineering staff was able to view the building stone-by-stone, locating and cataloging over 4,000 individual units requiring varied repairs ranging from wholesale replacement to injection and patching (*Photo 7*). [Editor's note: See "Digital Close-Range Stereophotogrammetry for Heritage Recording: The Impact of Responsible Measurement," by Peter Belden Trieb and Don Kilpatrick, *Interface*, November/December 2004.]

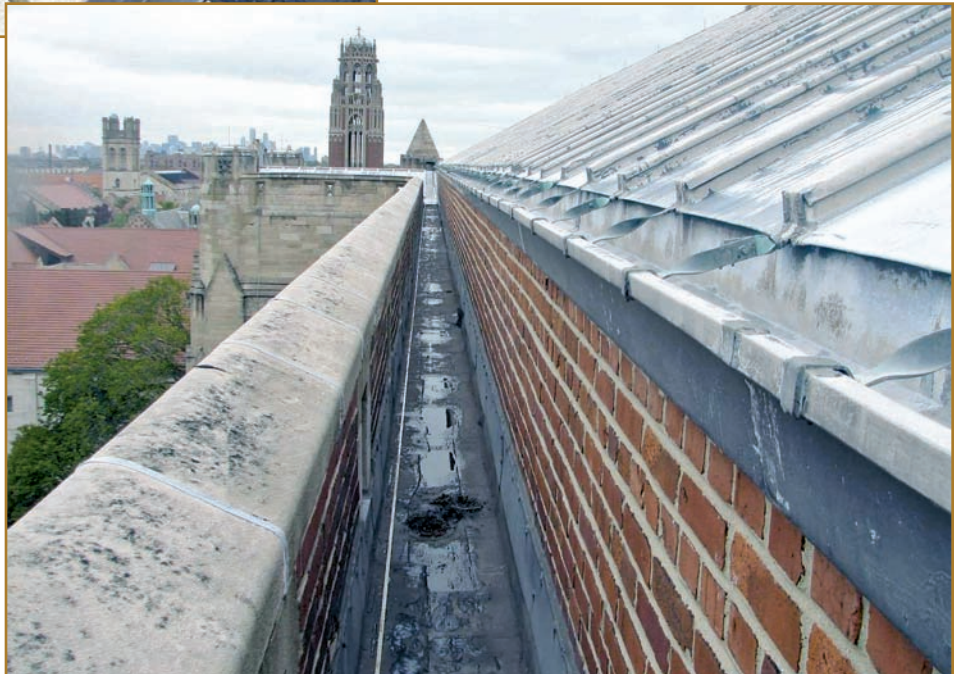
*Photo 9 – Typical integral gallery at the east and west sides of the nave (below).*

Integral gutters or long, narrow gallery roofs are present between the lead-coated, copper batten-seam roof of the nave and visible from grade parapet wall condition (*Photo 9*). These roof areas are served by wall-mounted exterior/interior drain heads that are routed to the attic, where they are combined with attached downspouts from the nave roof above. Revisions to the building drainage will require select demolition and reconstruction of the parapet wall features to accommodate new drain-head elevations at a level that will ensure the required 1/8-in-per-ft slope on new laterals on the attic interior from the south end of

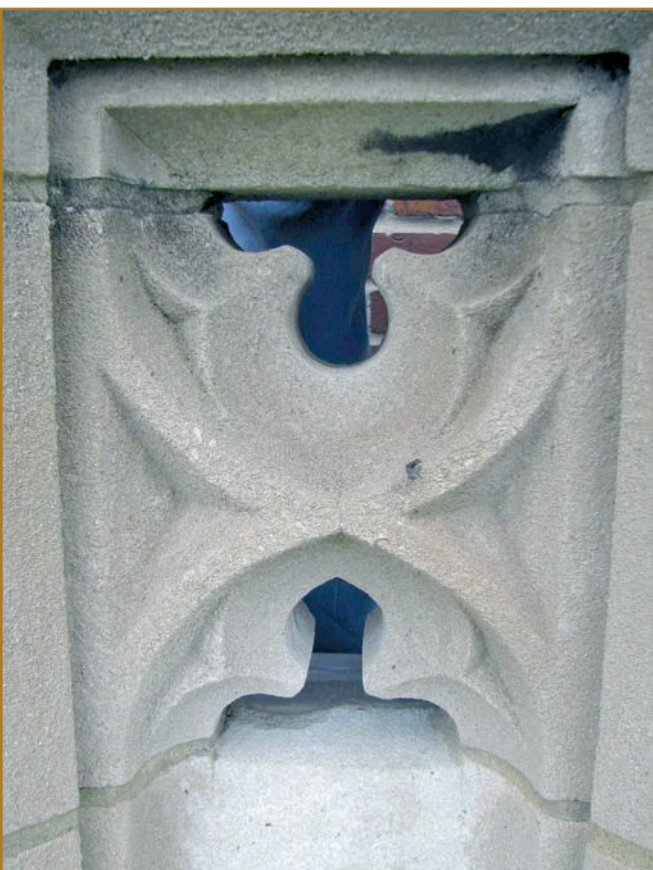
*Photo 10 – Carved stone central to the three-stone set establishing the portal openings.*

*Photo 11 – Area of stone infill on roof side of parapet wall required to accommodate revised height of finished gallery roof.*

set establishing the portal openings. The center stone will be removed and saw cut, salvaging the stone surrounding the opening, and new pieces of similar ornamentation (less the opening through the wall) will be carved and set as infill. This will accommodate the final revised height of the finished integral gutter assembly, assuring positive slope to drain (*Photos 10 and 11*).

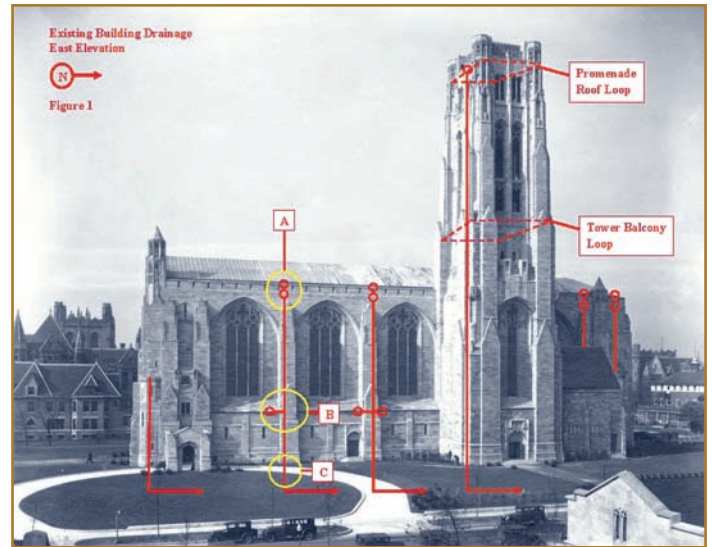
Figure 1 – Existing building drainage, east elevation.

high parapet walls (*Figure 1, Condition A*). Both drain heads are routed to the nave attic interior, where accessory lead-coated copper piping is interfaced with the cast-iron risers, continuing into the masonry walls at the base of the vaulted ceilings. The risers continue down the interior side of the buttress and turn toward the building exterior, where the piping follows the contours established by the steel-reinforced, poured concrete deck for the stone weathering. The stone weathering roof areas are served by lead-coated copper gutters with one drain per segment on each side of the buttress as presented on the building exterior (*Figure 1, Condition B*). These drains are combined with the single riser dedicated to the nave drains, and again are presented, with cleanouts, at regular intervals in the basement (*Figure 1, Condition C*).

Figure 1, Condition A – Original drawings reflecting the current configuration of drain heads servicing the nave, lead-coated copper batten-seam roof assembly, and the integral gutter combined into a common riser.

*Figure 1, Condition C – Typical drain leader exiting the buttress as presented in the basement.*

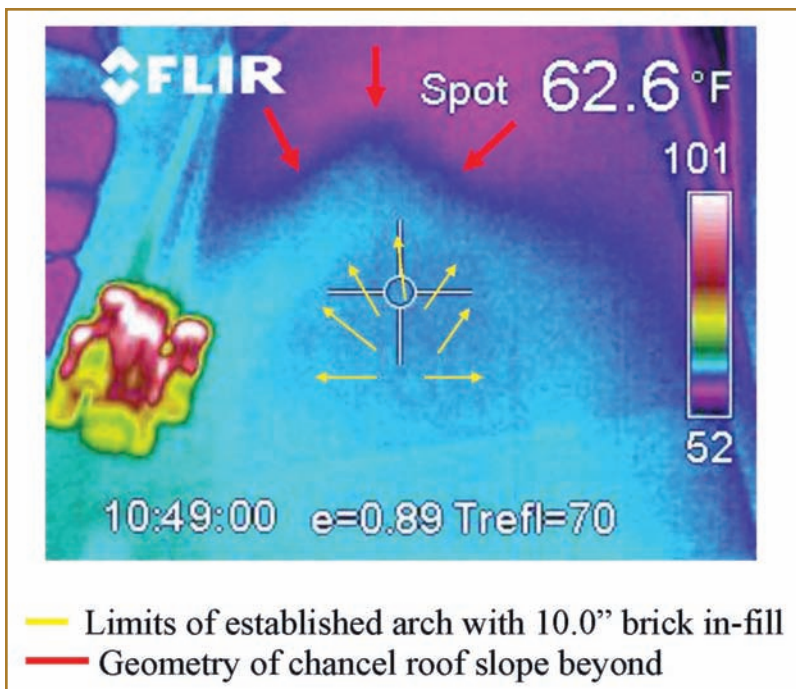
Interestingly, the geometry of the wall section above the floor line of the organ loft suggested that similar considerations for a tonal opening may have been included in the original construction (*Photo 16*). Inspection openings through plaster interior finishes were made on the organ-loft side of the wall to confirm the presence of a rowlock arch above the spring line. Infrared equipment was used to visualize the relative

*Photo 16 – Photogrammetry shows considerations for a tonal opening may have been included in the original construction.*

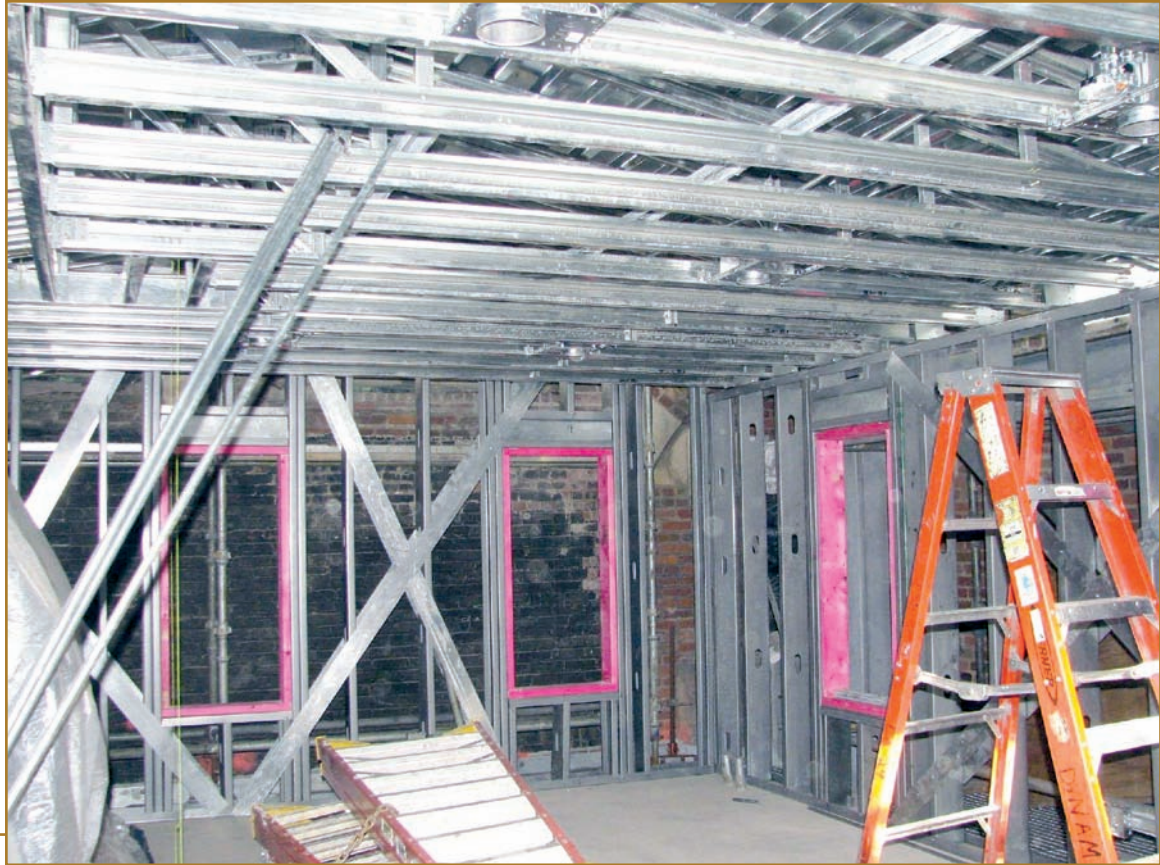
*Photo 22 – New wall framing and truss assembly for the playing cabin.*

Careful coordination of disciplines was required to achieve the owner-mandated soft issues specific to the new playing cabin, equipped amenities, and, most notably, the established deadline for a gala celebrating the restored instrument scheduled for the first weekend of June 2008 (Photos 21 and 22). A matrix of cabin as-built conditions was established and distributed to all involved parties for review and comment.

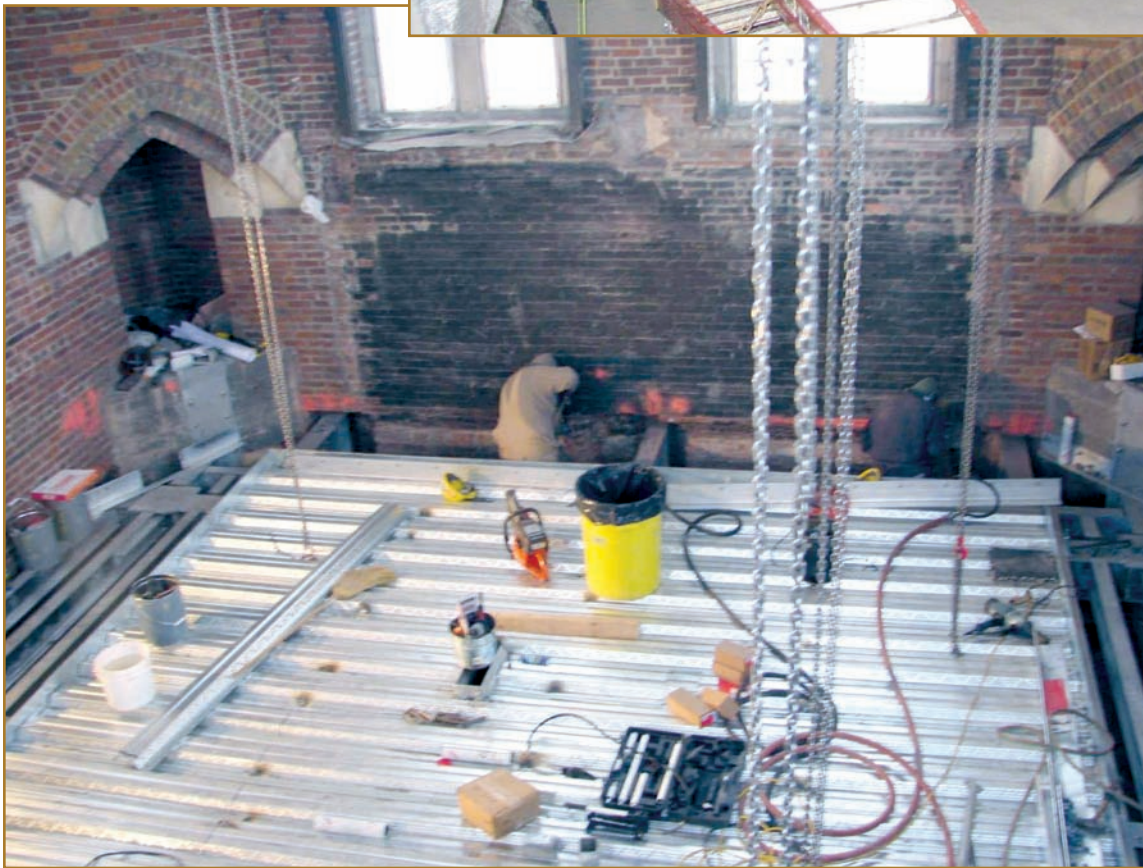
*Photo 21 – Ironworkers set new steel framing and decking for the playing cabin at the 160-ft level of the tower interior.*
