BUILDING ENVELOPE TECHNOLOGY SYMPOSIUM

REDINTEGRATION OF SANCTORUM – MULTIDISCIPLINARY HISTORIC REHABILITATION OF ROCKEFELLER MEMORIAL CHAPEL

DONALD KILPATRICK

INSPEC, Inc. • MILWAUKEE, WI

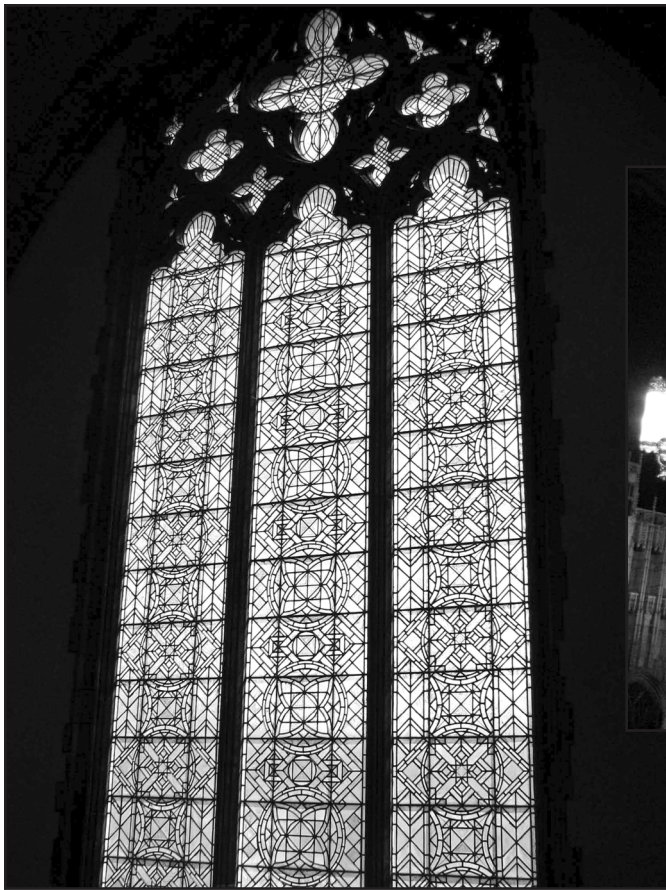
Photo 3 – Typical lancet window as seen from nave interior.

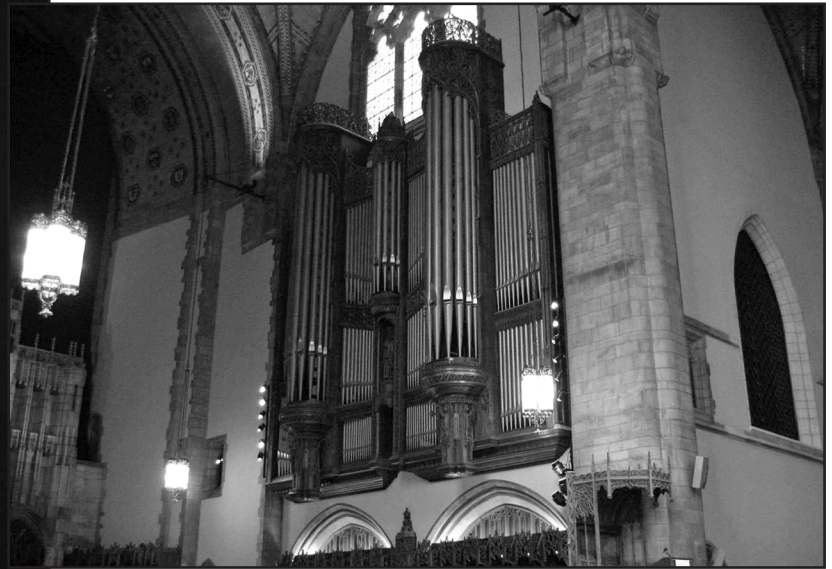
Photo 4 – Restored façade pipes of the E.M. Skinner organ.

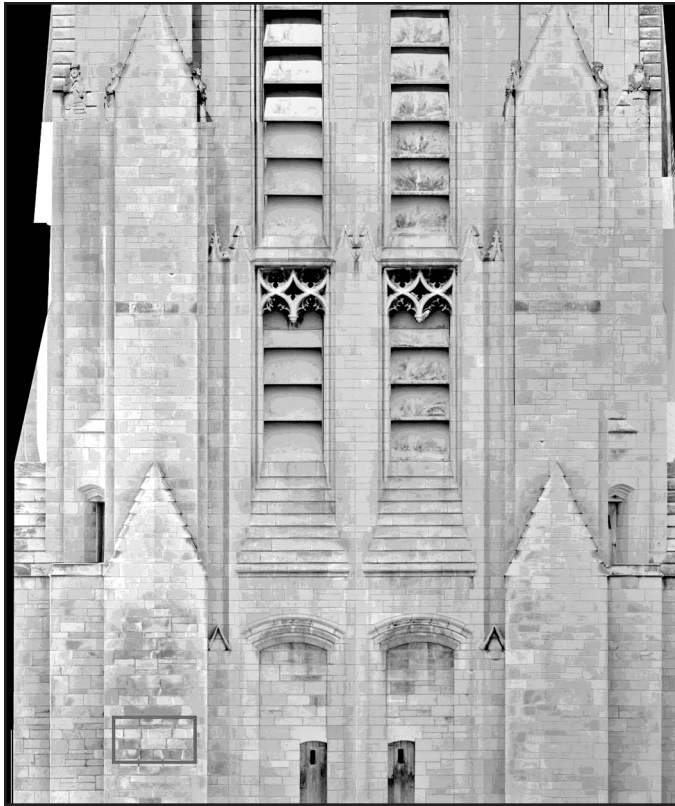
Photo 6 – Digital photogrammetry of partial east tower elevation.

In the absence of a full complement of original building drawings, digital photogrammetry was selected as a means to record present-day condition indices and was subsequently utilized as the primary method to graphically impart site-specific work scope locations and limits to the bidders (Photo 6). The high-resolution photography delivers a permanent record of the building and can be integrated with AutoCAD, accommodating manipulation of the images in full and partial elevations. The graphic representation derived from the photogrammetry yielded a significant reduction in cost over traditional methods of delivery (line drawings) while achieving unsurpassed interpretive quality of the building's varied features. Using the images, the engineering staff was able to view the building stone-by-stone, locating and cataloging over 4,000 individual units requiring varied

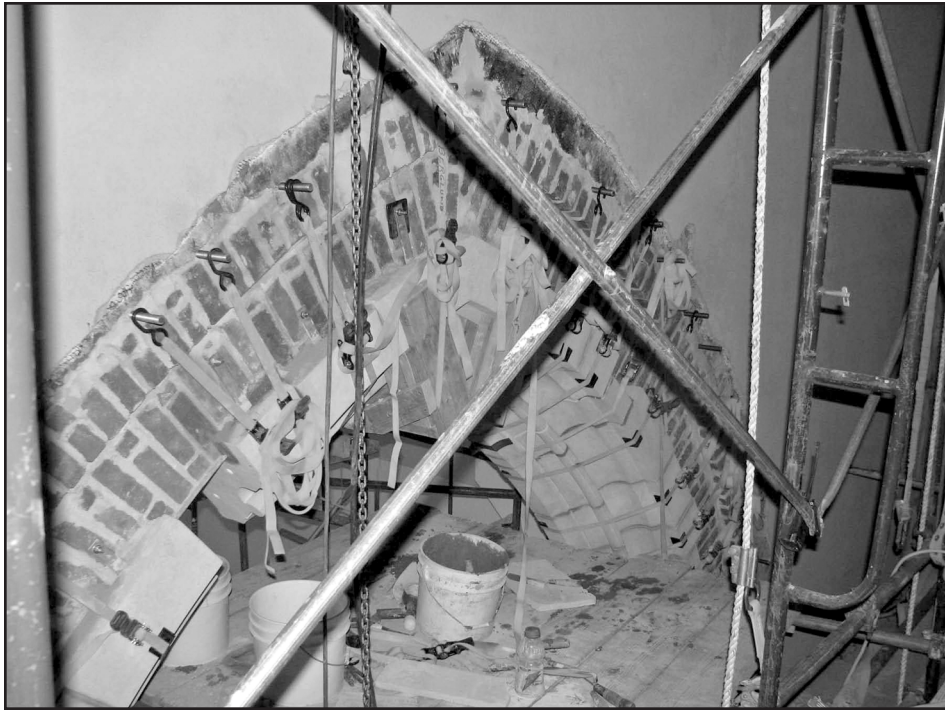
Photo 16 – Final setting of cut limestone surround in tonal opening.

limestone surround patterned after that found on the clerestory windows of the nave (Photo 16).

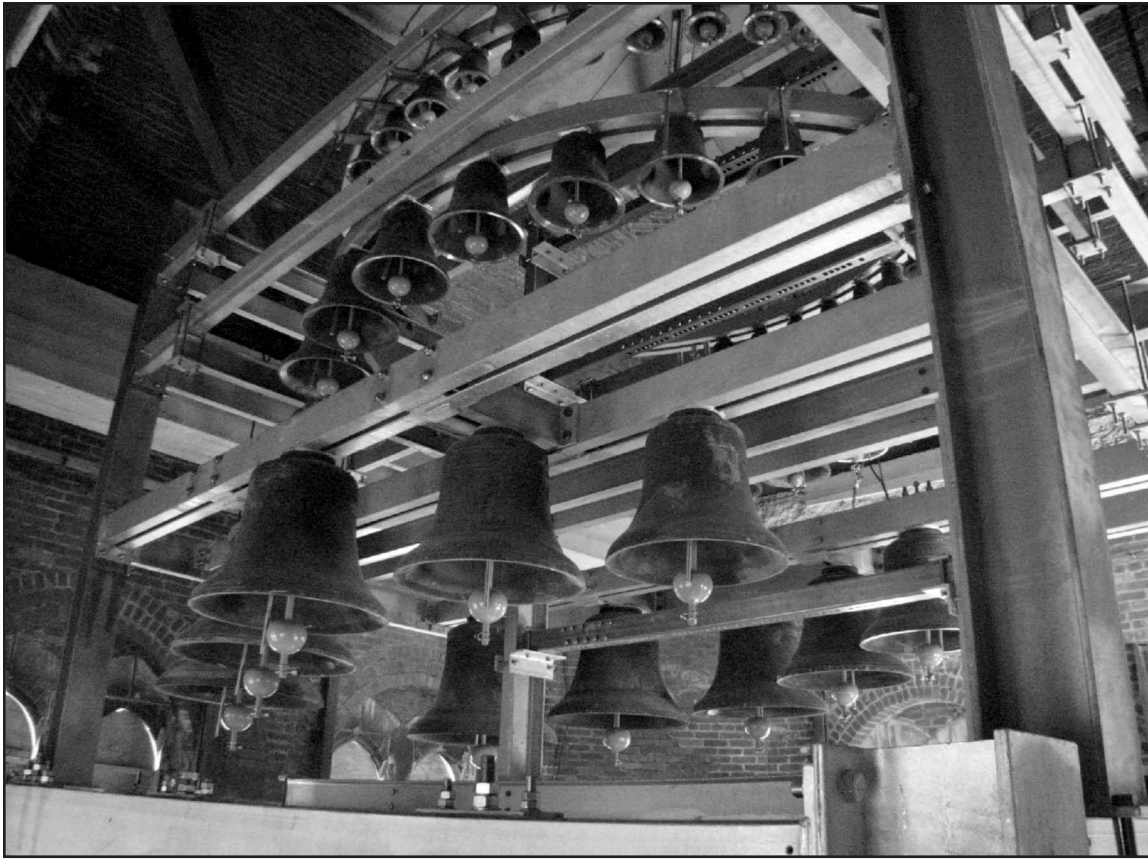
Photo 18 – Restored bell array above the playing cabin on the tower interior.

the tower interior. Above the lower 14 largest bells and playing cabin are the remaining 58 bells (weighing from 10 to 2,689 lbs) affixed to steel framing that is interfaced with the floor slab, projecting through and above the roof line of the cabin (*Photo 18*). Removed from past alterations to the once-operable louvers, occasional upgrades and repairs to the workings of the instrument, the carillon and the playing cabin remain largely as installed in 1932.
