Optimized Design of Combined Disciplines:

STEEP-SLOPE ROOFING AND EXTERIOR-WALL CLADDING

By Don Kilpatrick

Project Profile — Phased Steep-Slope Roof/Exterior Wall Rehabilitation

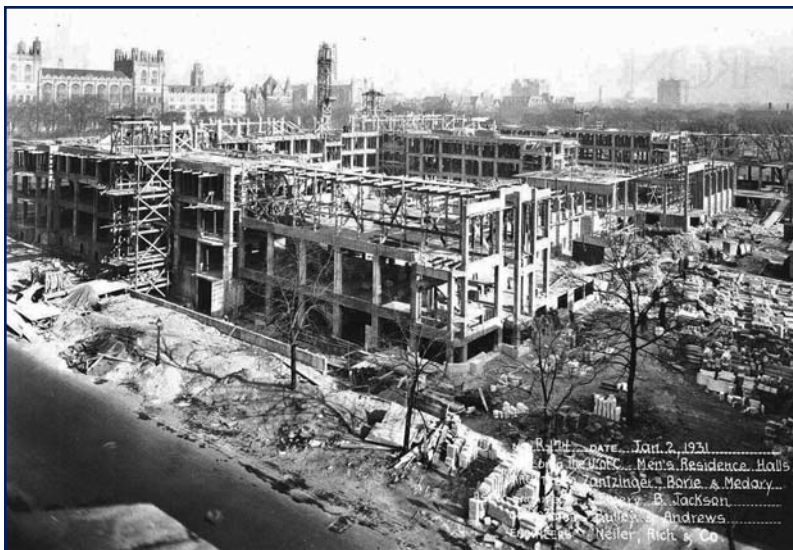
Photo 1 – Original construction of Burton Judson Courts, circa 1931.

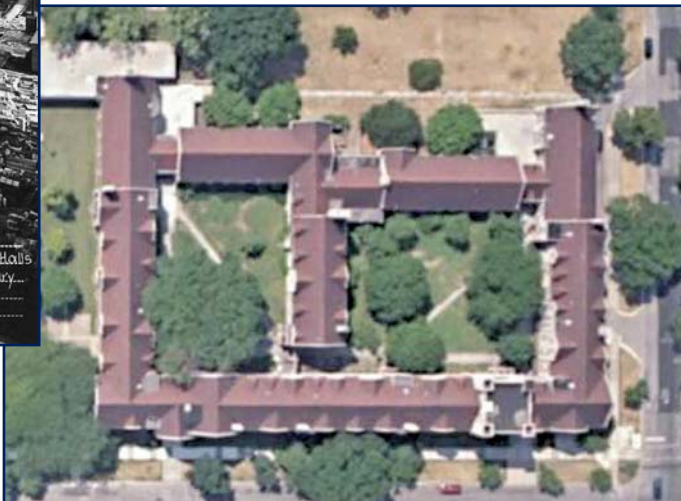
Photo 2 – Aerial photo of the Burton Judson facility.

Burton Judson Courts, completed in 1931, was built to house a burgeoning student population. Construction of the steel-reinforced, concrete, and wood-framed housing unit began in the late 1920s, providing work for skilled Depression-era craftsmen on what was, at the time, one of the largest private construction projects in all of Chicago (Photo 1 [Jean F. Block, *The Uses of Gothic Planning and Building on the Campus of the University of Chicago, 1892-1932*]). The building, clad with cut and carved limestone with roof slopes of clay tile exceeding 16:12, consumes an area equivalent to a quarter of a city block (Photo 2).

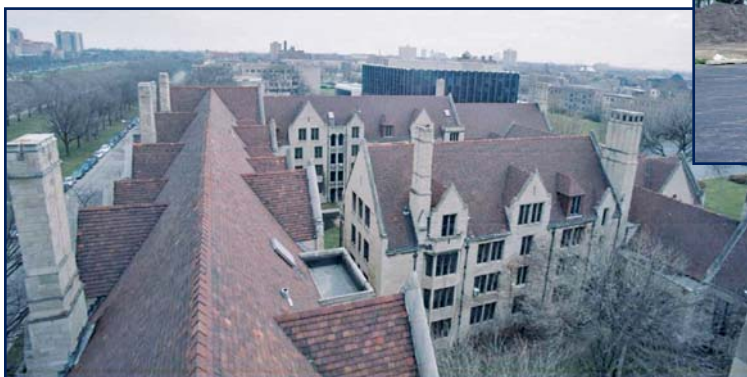
The magnitude of the combined steep roof/exterior wall rehabilitation, with a total cost in excess of \$10 million, justified an initial bid package centered on a projected five-year, phased construction period. Summer 2008 represented the start of Phase III as identified in the original solicitation of bids (Photo 3). The abbreviated annual construction window of June

Photo 3 – Overall view of pending Phases III and IV.

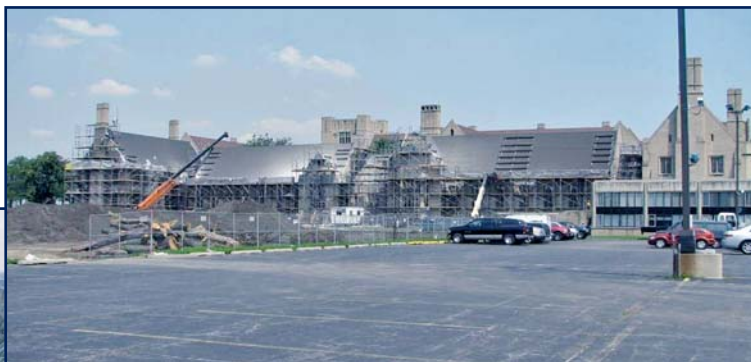
through September has presented a challenge during Phases I and II (Photo 4). The university is currently giving consideration to adding a sixth-year phase to provide reasonable assurance that the construction will be completed within the time constraints established by the annual scheduling parameters. With year-round occupancy by resident heads and the increased student traffic for spring departures and fall arrivals, the schedule, beyond the work itself, may be considered a determining factor in establishing the overall success of the project (Table 1).

Photo 4 – Phase I, south exposure.
