# RCI Interface

Journal of the Roof Consultants Institute

# THE INVESTIGATION OF PLAZA WATER Infiltration

By David Campbell, AIA

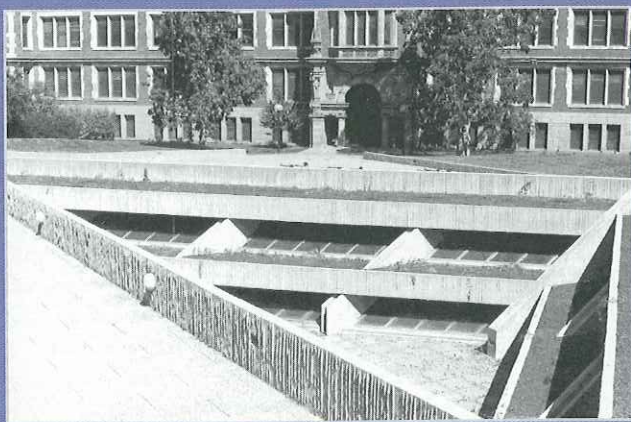
Figure 1 — Roof plaza (grade-related).

The scope of this paper will be limited to grade-related roof plazas, which will hereafter be referred to simply as "plazas" (see *Figures 1 and 2*).

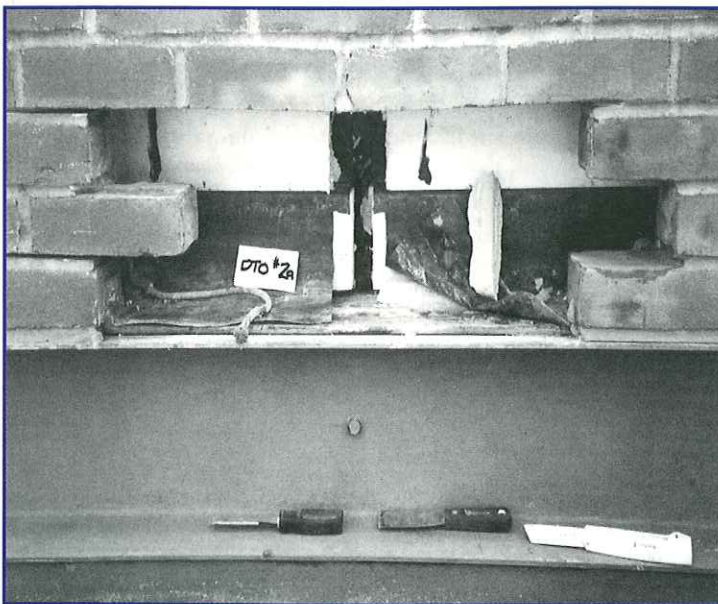
Figure 4 — Destructive test opening (DTO) through a wall feature.

Original documents, or even as-builts, should not be the only source of information when documenting existing conditions. These documents can be very helpful, however, *there is no substitute for DTOs* and the high degree of accuracy that is obtained by observing first hand the installed materials. See Figures 3 and 4.

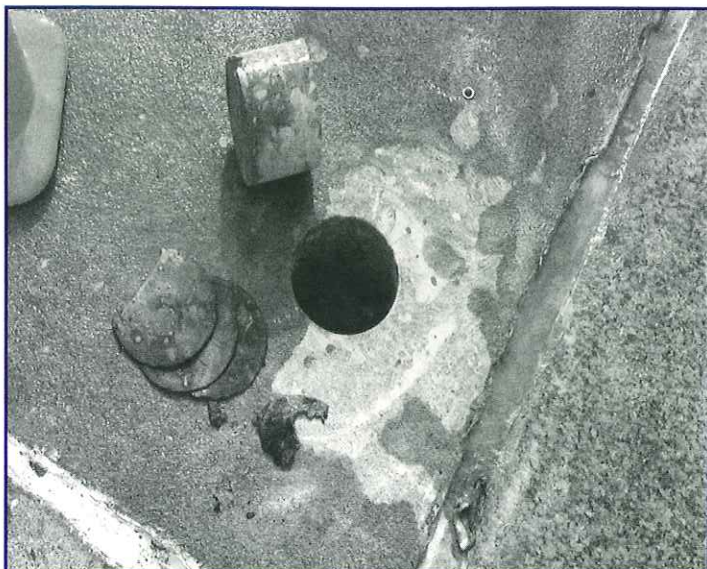
Figure 10 — Core drilled test opening.

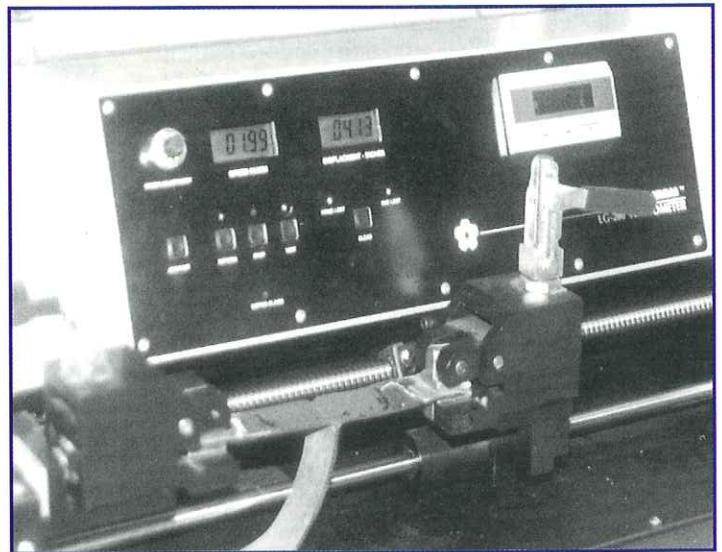
Figure 12 — A tensiometer for evaluating peel strength of membrane seams..

- Has it retained its original elastic properties? This is especially important if there are numerous expansion joints or if the pre-cast deck has no concrete topping.
- Are the seams still well adhered? A tensiometer can be

used to determine this if there is any doubt. See Figure 12.

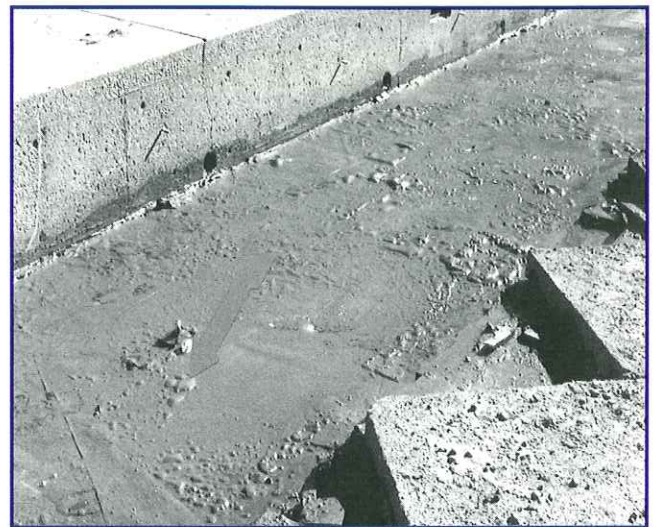
Figure 15 — Disbonding blisters on existing fluid-applied membranes.

- If it's an adhered membrane, is it still well bonded to the substrate?
- Is there any evidence of shrinkage? Look for stress tears or bridging at plane changes.
- Are there any blisters or fishmouths? See Figures 14 and 15.

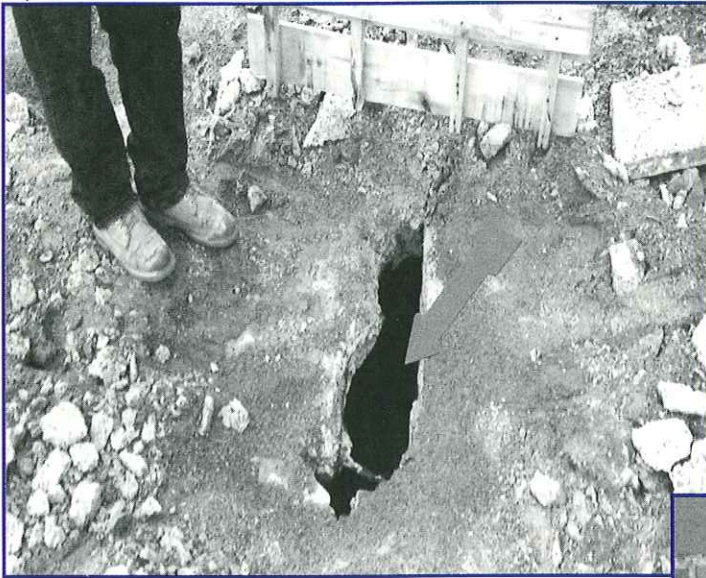
Figure 18 — Structural deck degradation.

- a. If moisture has been held against the structural deck for a considerable length of time, there may be some serious structural degradation (i.e., spalling, reinforcement corrosion). See Figures 18 and 19. This alone may make it necessary to replace the entire membrane rather than just repair it, since all materials must be removed to expose the structure, anyway.
- b. If the structural deck is pre-cast plank and there is no concrete topping on the plank, then a case for complete waterproofing replacement would be strengthened. Grout key joints alone do not do an adequate job of tying the entire pre-cast system together. Resultant joint movement places stress on the waterproofing membrane.
- c. If there is no pitch to the top surface of the structure

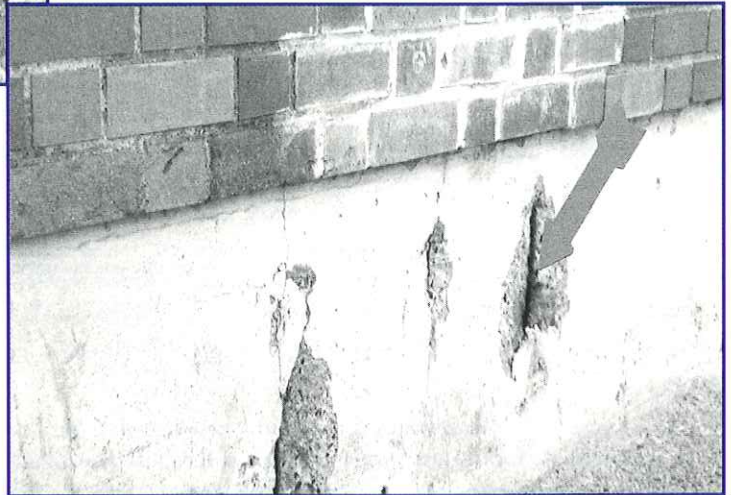
Figure 19 — Plaza wall degradation.

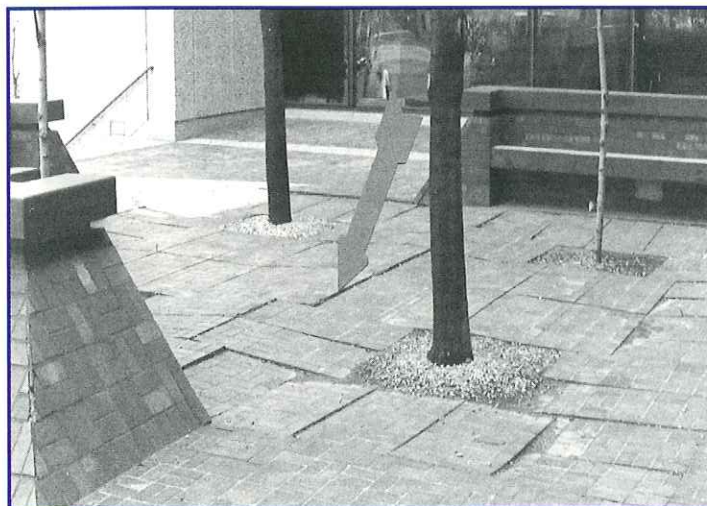
Figure 20 — Frost heaved wearing surface with trip hazards.

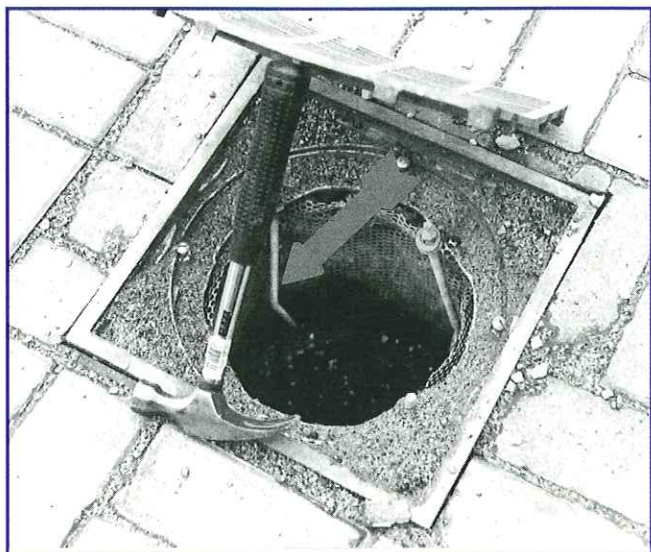
Figure 21 — A crushed plaza drain due to vehicular traffic.

- c. The location and number of plaza drains should be able to accommodate a worst-case rainfall event.
- d. The drain should be equipped with a clamping ring so the membrane is secured.
- e. Have the plaza drains been "crushed" by vehicles? If so, either bollards should be installed to limit vehicle access or more appropriate drains should be installed. See Figure 21.

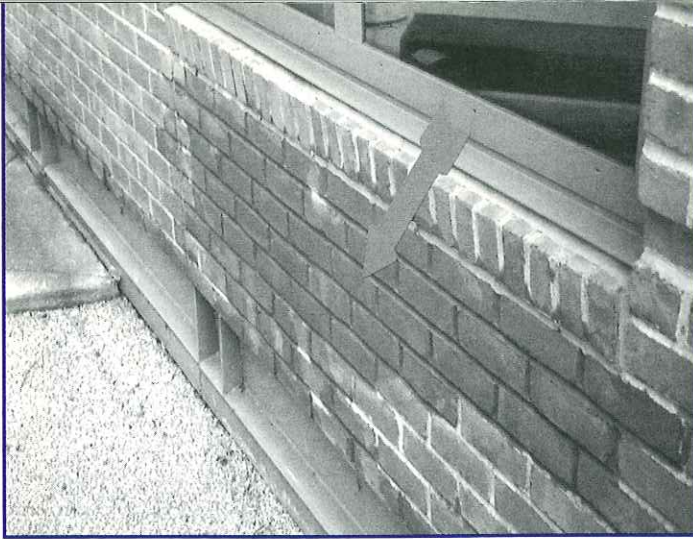
Figure 25 — Water trapped in cavity wall.

- a. If there are open joints, cracks, or other openings in the wall face above the plaza, sometimes the entering water can circumvent the waterproofing and enter the building. See Figures 22 and 23.
- b. Something similar can occur if a masonry cavity wall has no through-wall flashing or is weeped below the plaza surface. See Figure 24.
- c. Sometimes the source of water entry into an above plaza wall is quite evident. If window sill flashings are failing badly, either moisture or efflorescence may appear on the brick face. See Figure 25.
