Part 3: Structural Clay Tile and Plywood

By Lyle D. Hogan, RRC, FRCI, PE; Donald Kilpatrick; and Richard Koziol, AIA, NCARB

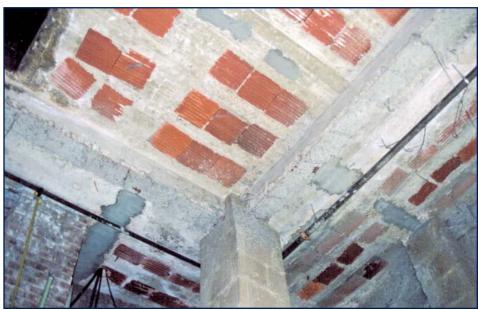
Figure 1 – With the general appearance of a closed book, these units were popular during the late 1800s and early 1900s.

Book tile is a form of structural clay tile that was popular during the late 1800s and early 1900s. The name is descriptive of the tile unit itself, which has the general appearance of a closed book, as shown in *Figure 1*. Book tile units were manufactured with concave and convex edges so that they would interlock when laid into position. This shape allowed units to abut one another. A common book tile unit dimension was 3 in thick by 12 in wide, supplied in lengths varying from 11 to 24 in. This thickness weighs approximately 18 pounds per sq ft.

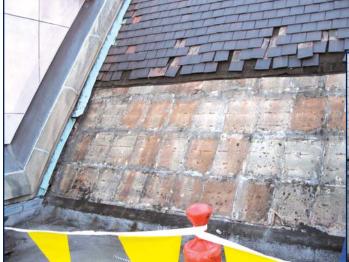
Figure 5 – Tile covering on clay tile deck on a vintage pitched roof.

roofs, structural clay tile was considered an acceptable substrate for slate, copper, or roofing tile (*Figure 5*). Other variations could be structural tiles and a concrete slurry topping with integrated wood nailers or battens across the roof plane to which slates or tile would be anchored. These same vintage structures might also have tiles cast into the inboard face of parapets (*Figure 6*).

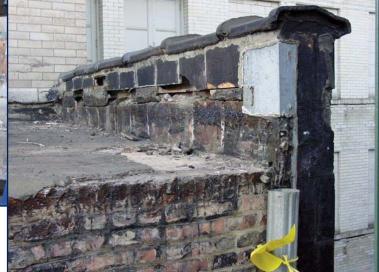
Figure 7 – Attachment of new plywood cladding using toggle bolts.

Low-slope clay tile decks are best suited for adhered or ballasted membrane systems. Mechanical fastening is generally discouraged because drilling and attachment may generate spalls and cracking of the tile. On pitched framing, reroofing can be carried out by attaching wood sheathing over the existing deck using toggle bolts (*Figure 7*) fitted

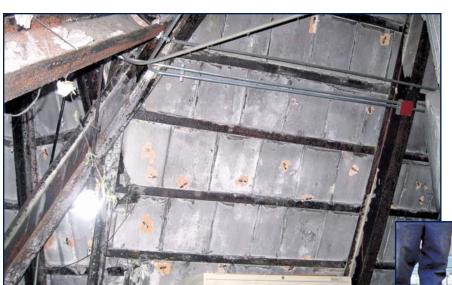
Figure 8 – Delamination and spalling of mortar topping course.

Structural clay tile decks are susceptible to deterioration as well as corrosion of the embedded steel components. Failure of the tees can cause cracking in the tile units, which can allow leakage and further deterioration of the steel components. There is also potential for cracking of the top shell of the units if care is not exercised during removal and installation of the roof system. Less serious but equally important issues are delamination and spalling of the mortar topping from the top surface of tile units (Figure 8). Hammer-sounding the surface-or removing a test square before proceeding with full-scale tear-off-is a prudent step.
